- 4.1. West Montrose Covered Bridge Rehabilitation Project (Region of Waterloo, Doug Dixon & Associates, Unterman McPhail Associates)

West Montrose Covered Bridge

Study Introduction

The West Montrose Bridge requires a complete structural rehabilitation in order to ensure that the structure will continue to serve the public through the current century.

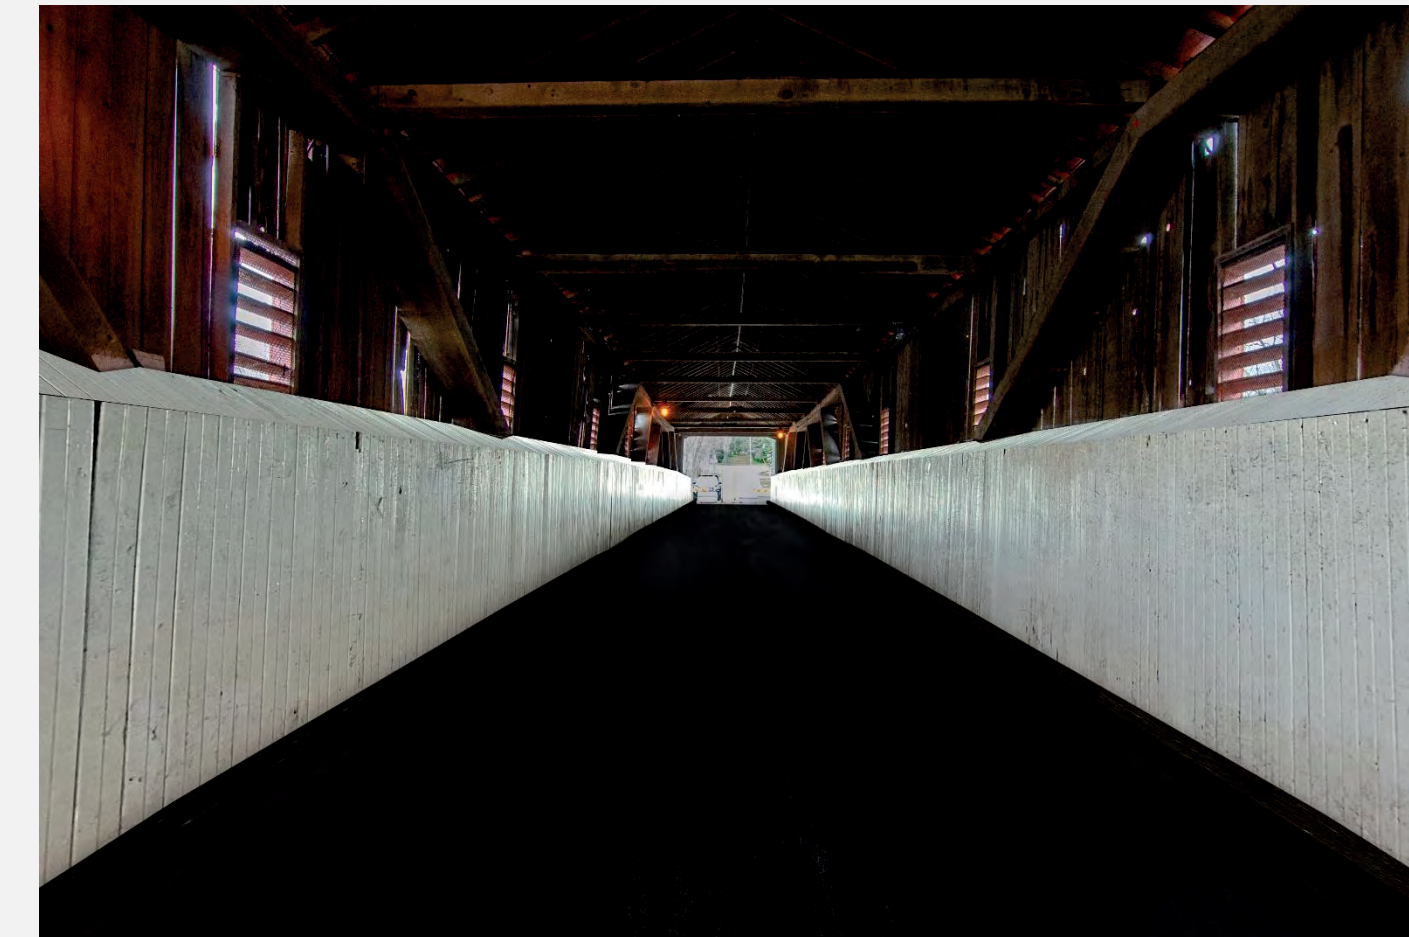
Steel Girder Reinforcement

- Remove Bailey trusses and replace with steel girders
- Replace interior white cladding
- Width of driving lane would become slightly more narrow

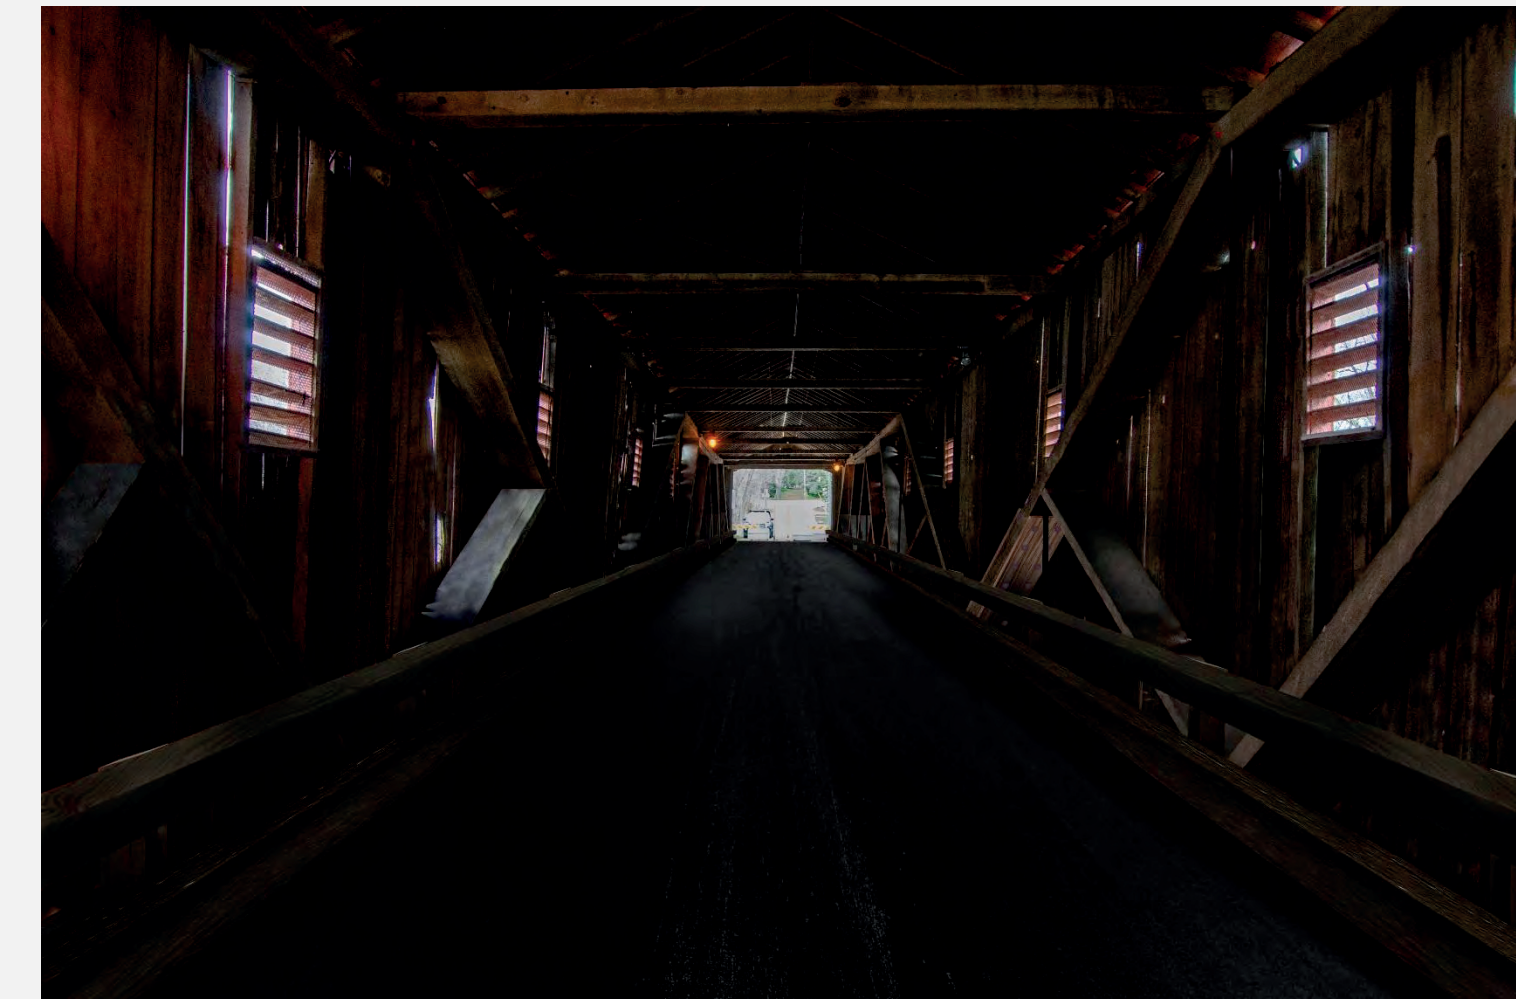
Timber Truss Reinforcement

- Remove Bailey truss and strengthen existing wooden truss with high-strength fibre-reinforced polymer (FRP)
- Increase to height of bridge by 300mm (1 foot) due to increased depth of bottom chord of truss
- Remove interior white cladding
- Install timber guardrail to protect wooden truss

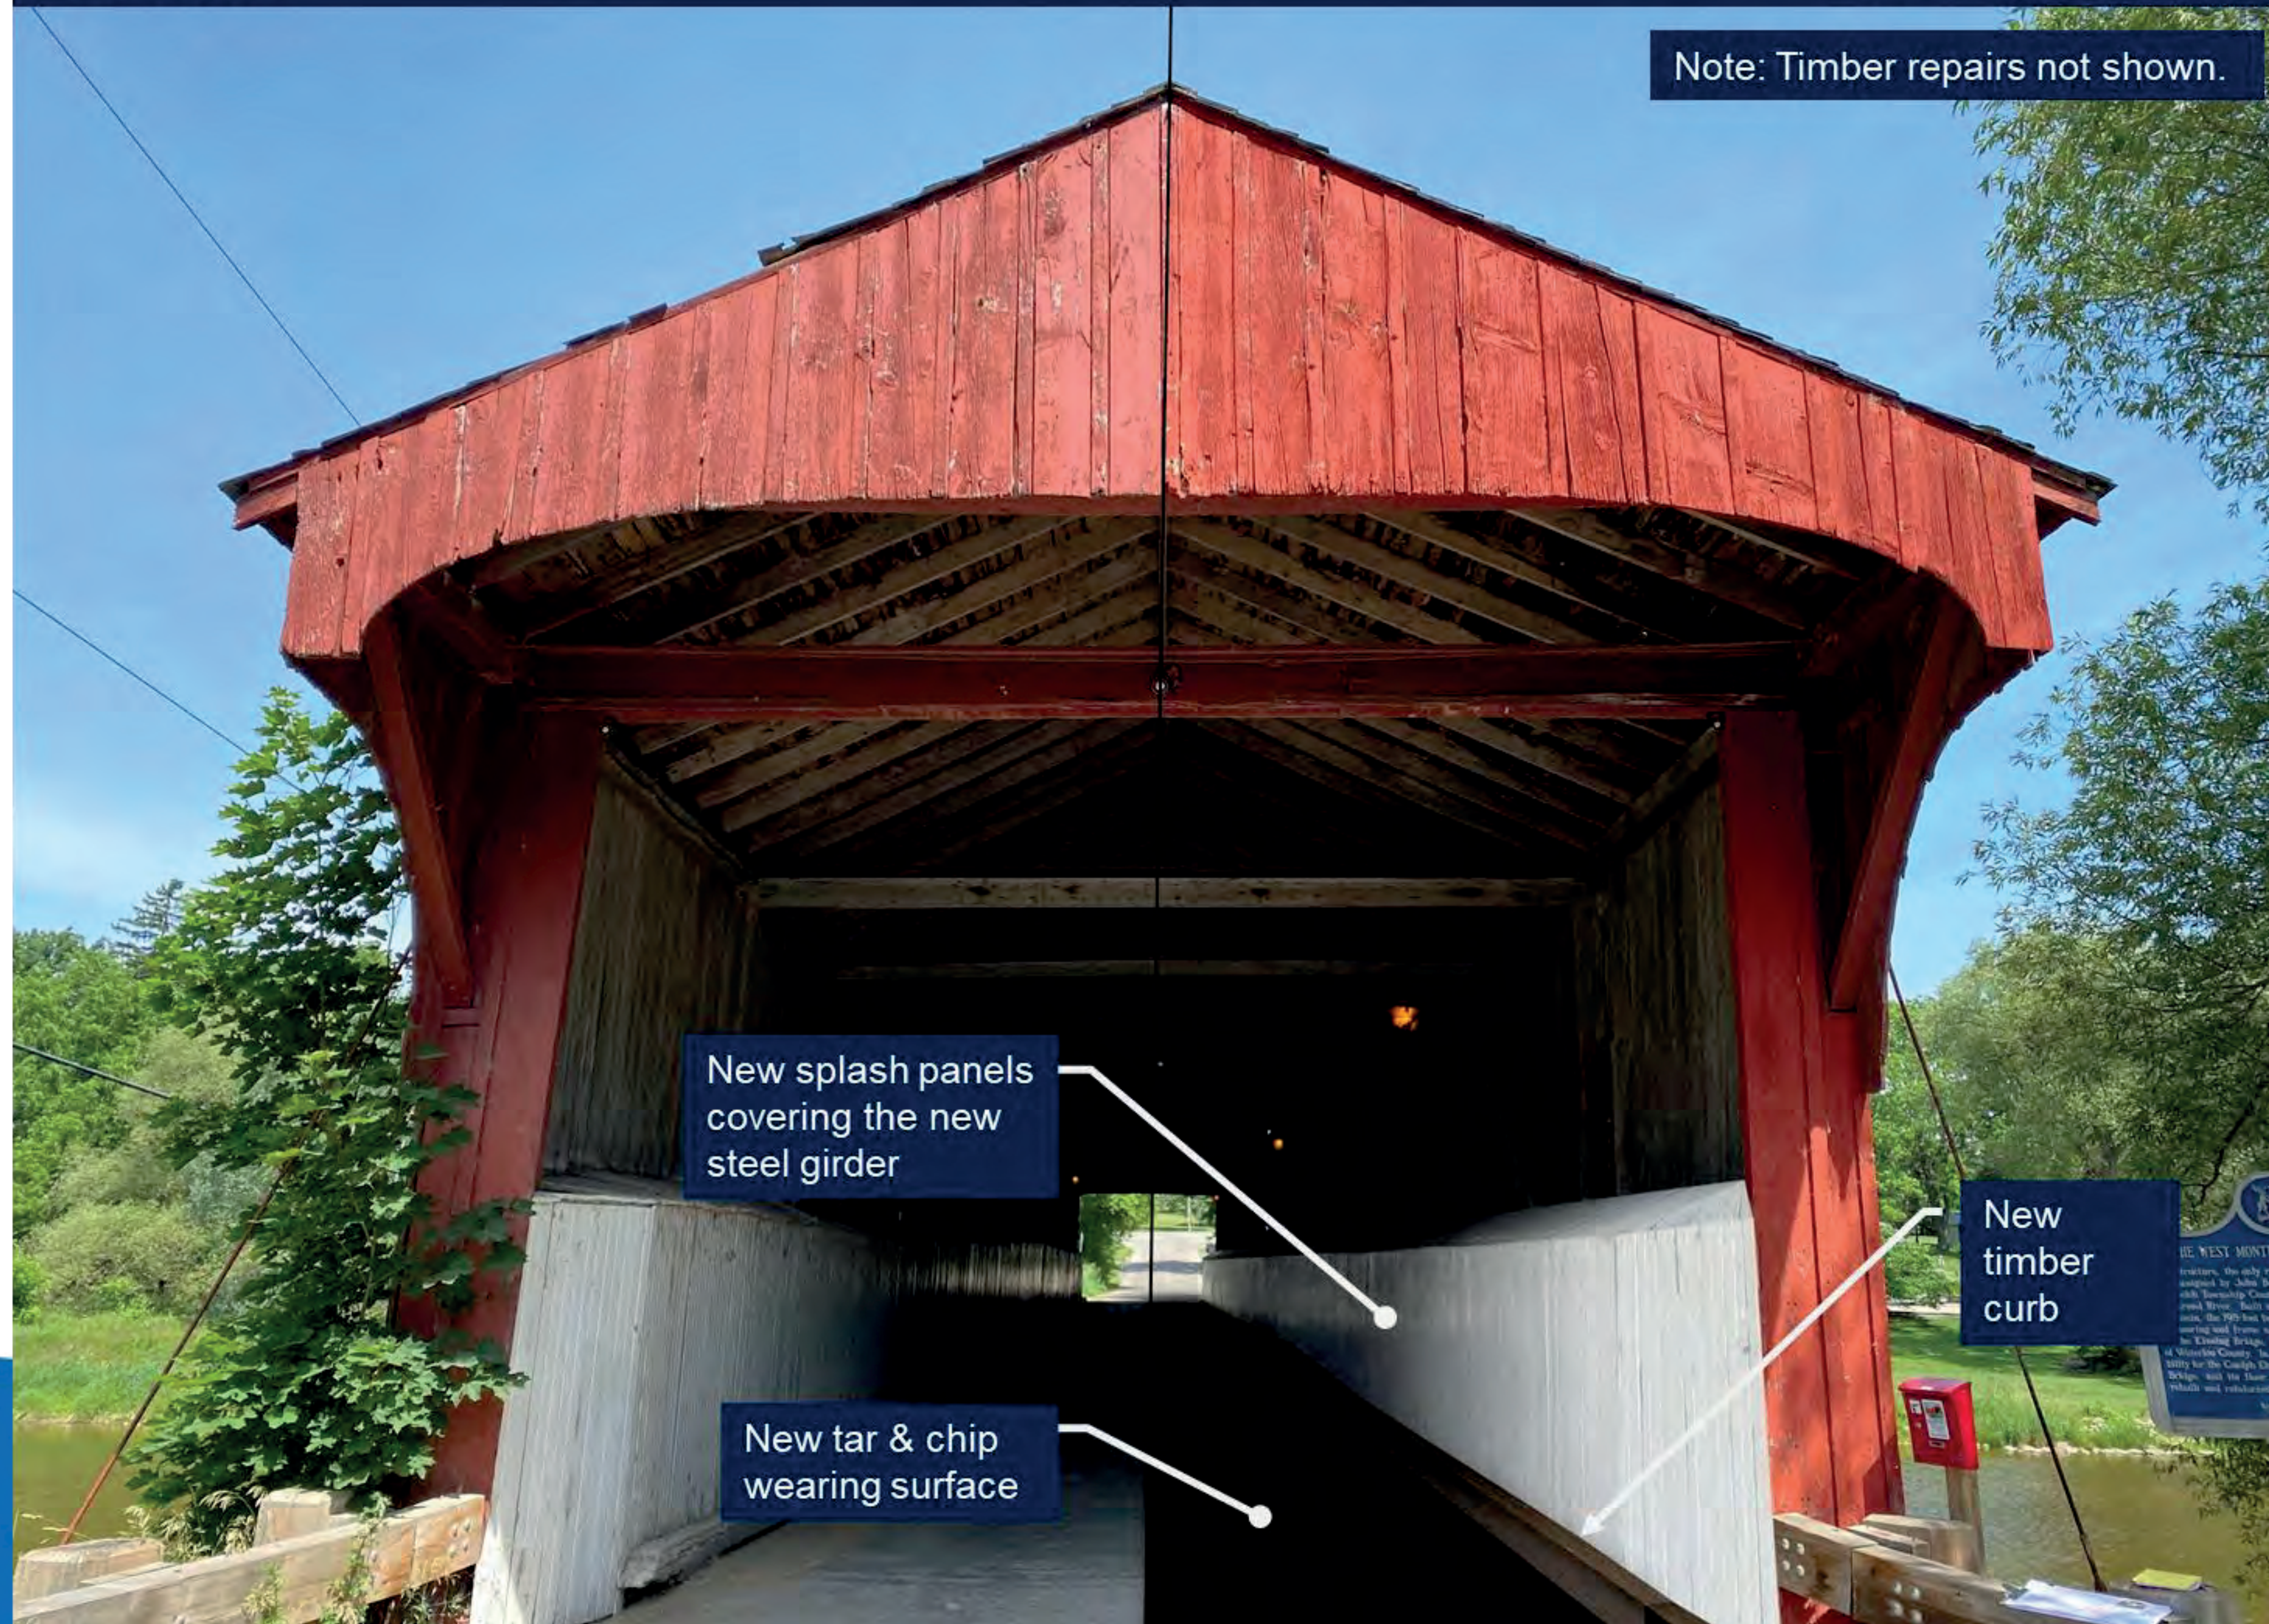
Alternative A – Front View

Note: Timber repairs not shown.

New splash panels covering the new steel girder

New tar & chip wearing surface

New timber curb

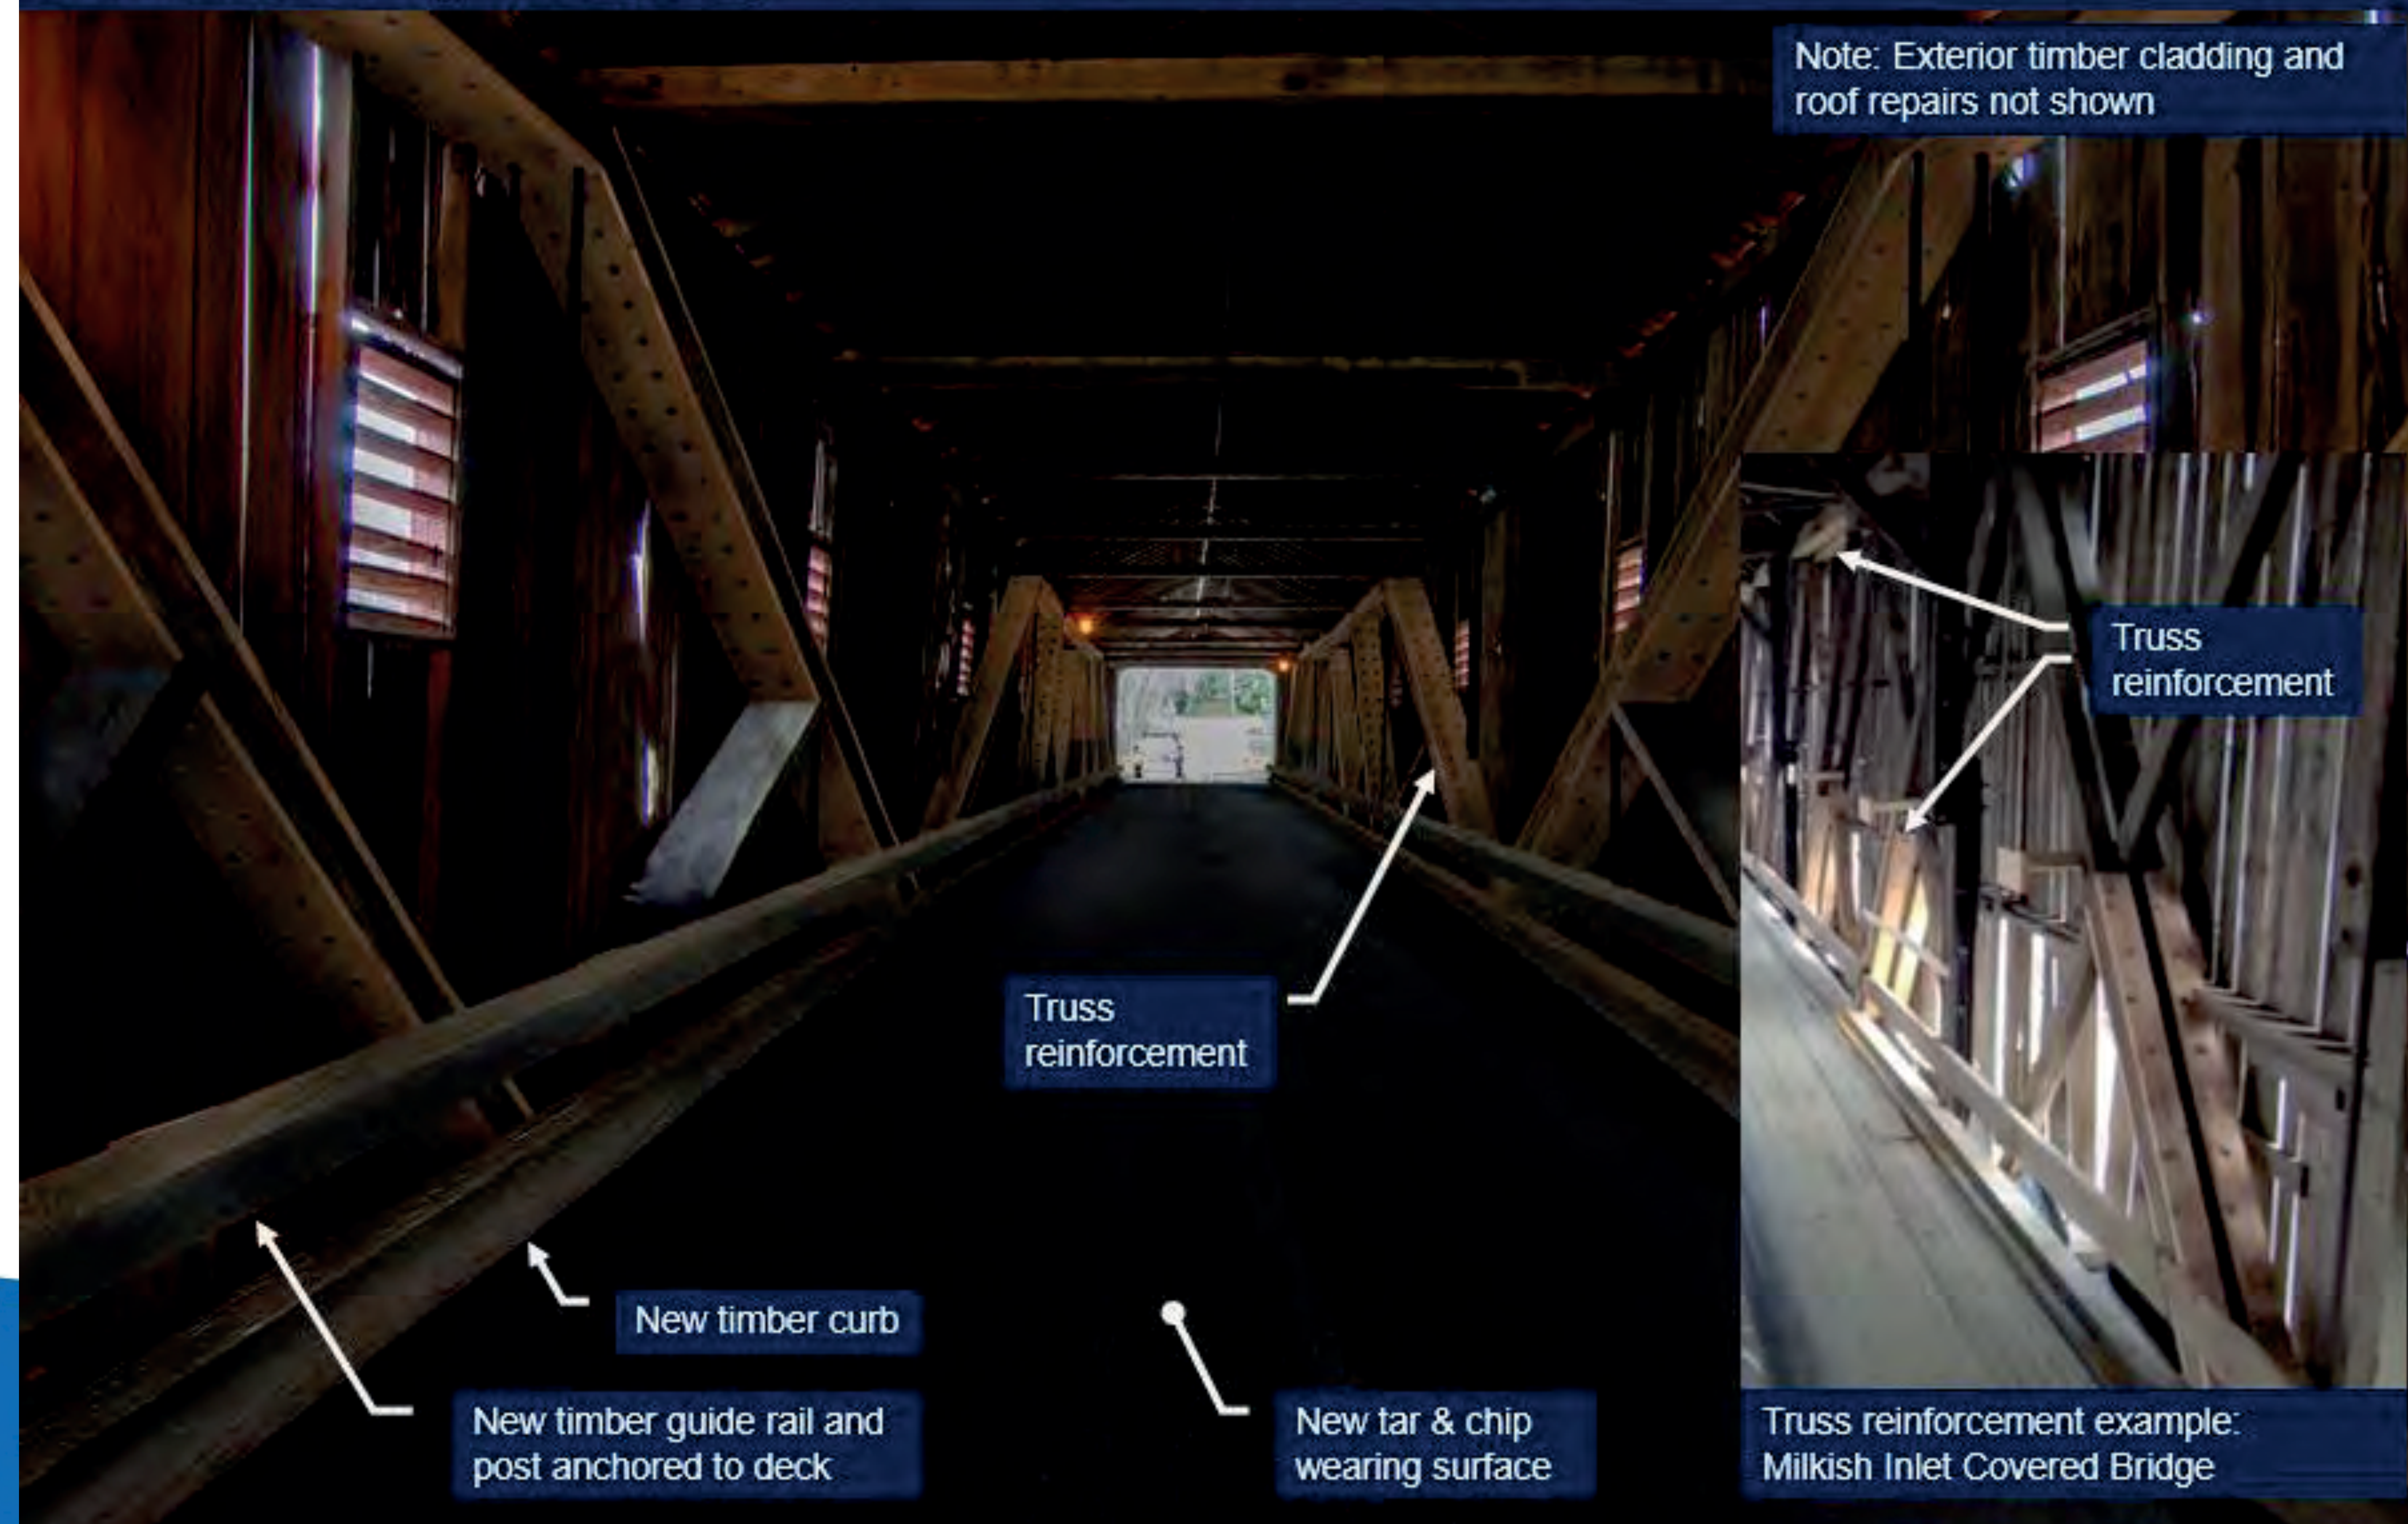
Alternative B – Interior View

ALTERNATIVE B (PREFERRED)
