**Township of Woolwich
Heritage Committee
Agenda**

West Montrose Covered Bridge Rehabilitation

Township of Woolwich Heritage Committee Meeting

Project Purpose

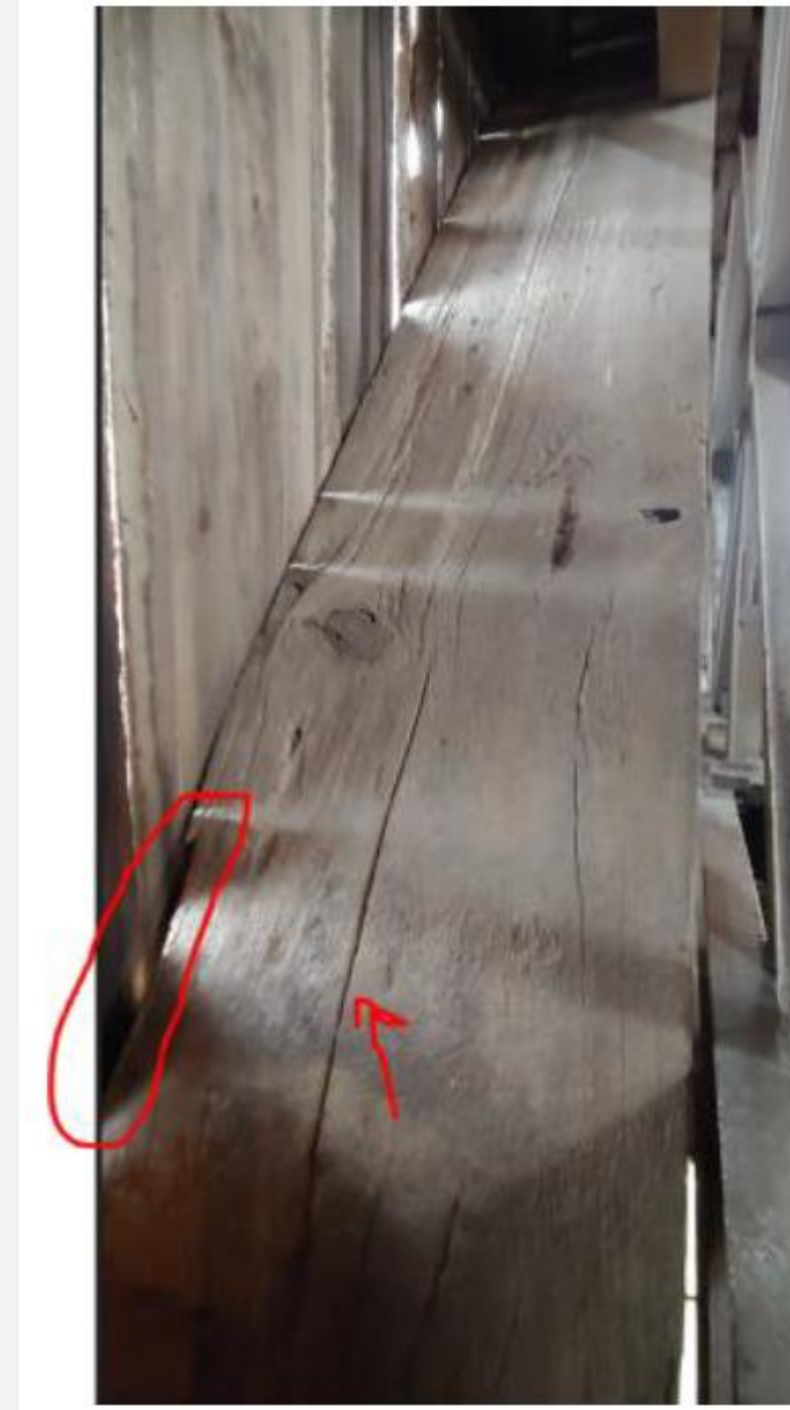
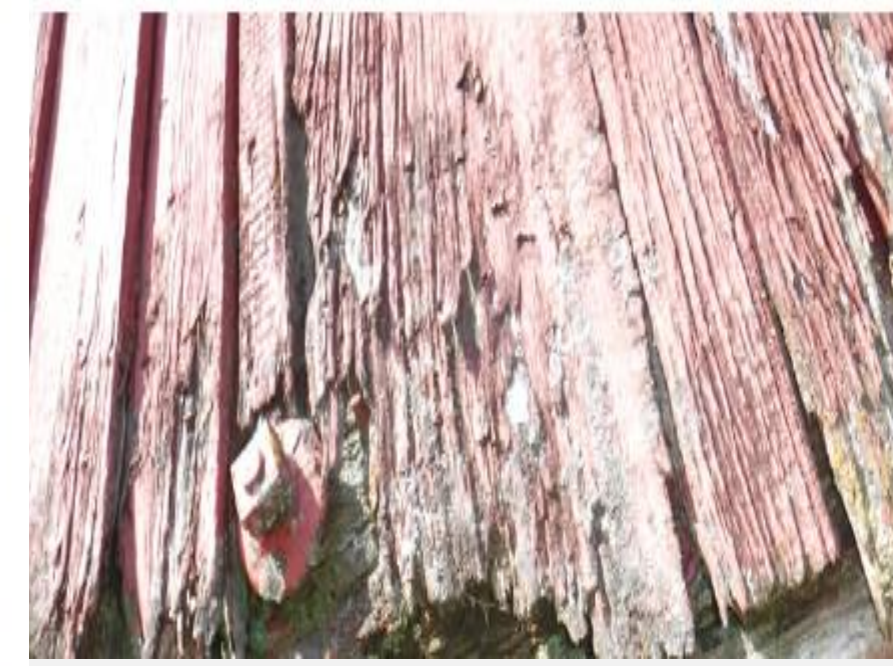
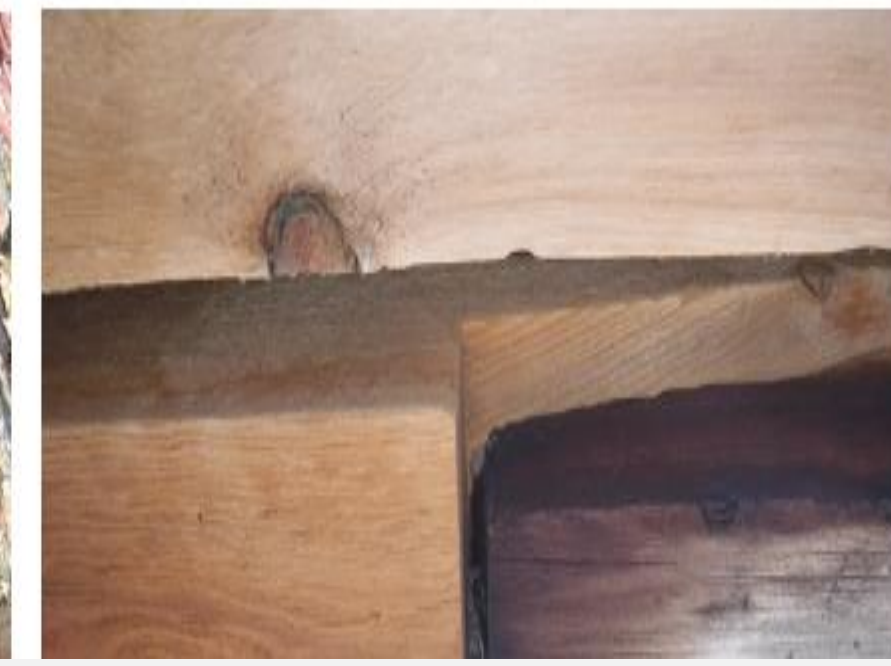
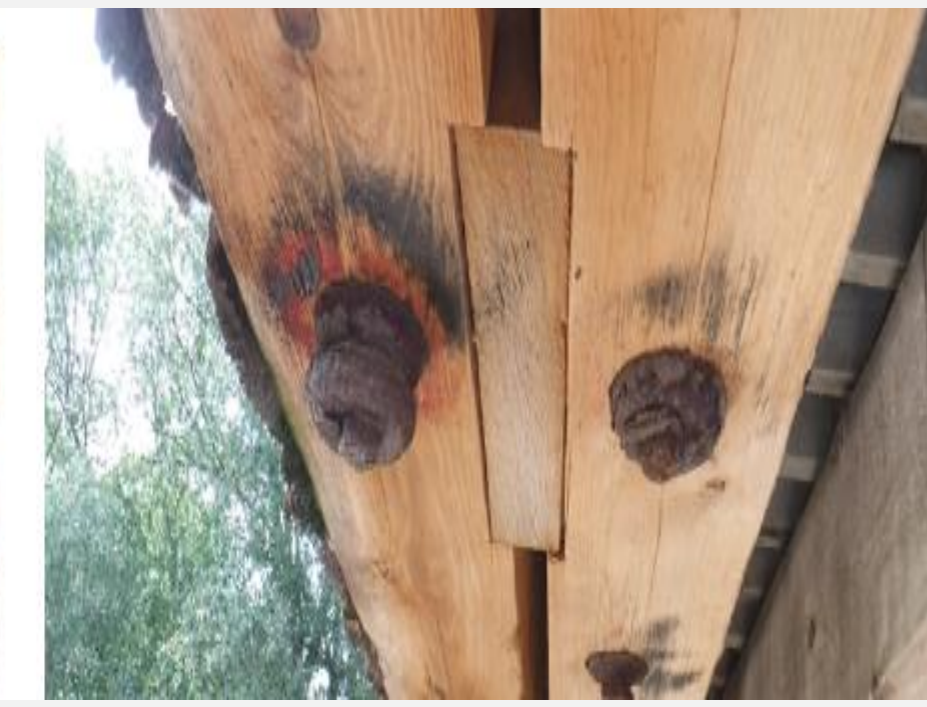
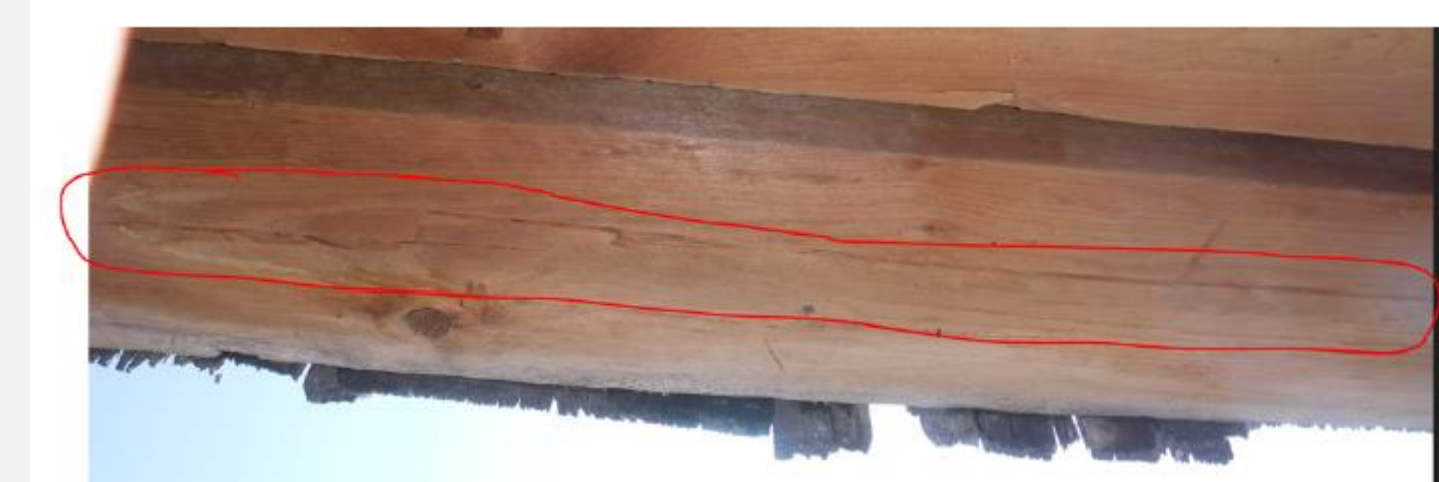
Background Studies – Existing Wooden Truss Conditions

Elements recommended for replacement based on condition:

- Deck
- Stringers
- Floor beams and needle beams
- Bottom chord
- Steel hanger rods
- Sway bracing
- Exterior red cladding
- Bottom lateral bracing
- End diagonals at the pier
- Roof shingles
- Replace the following items as necessary:
 - Tie beams
 - Squash blocks
 - Vertical posts
 - Roof rafters

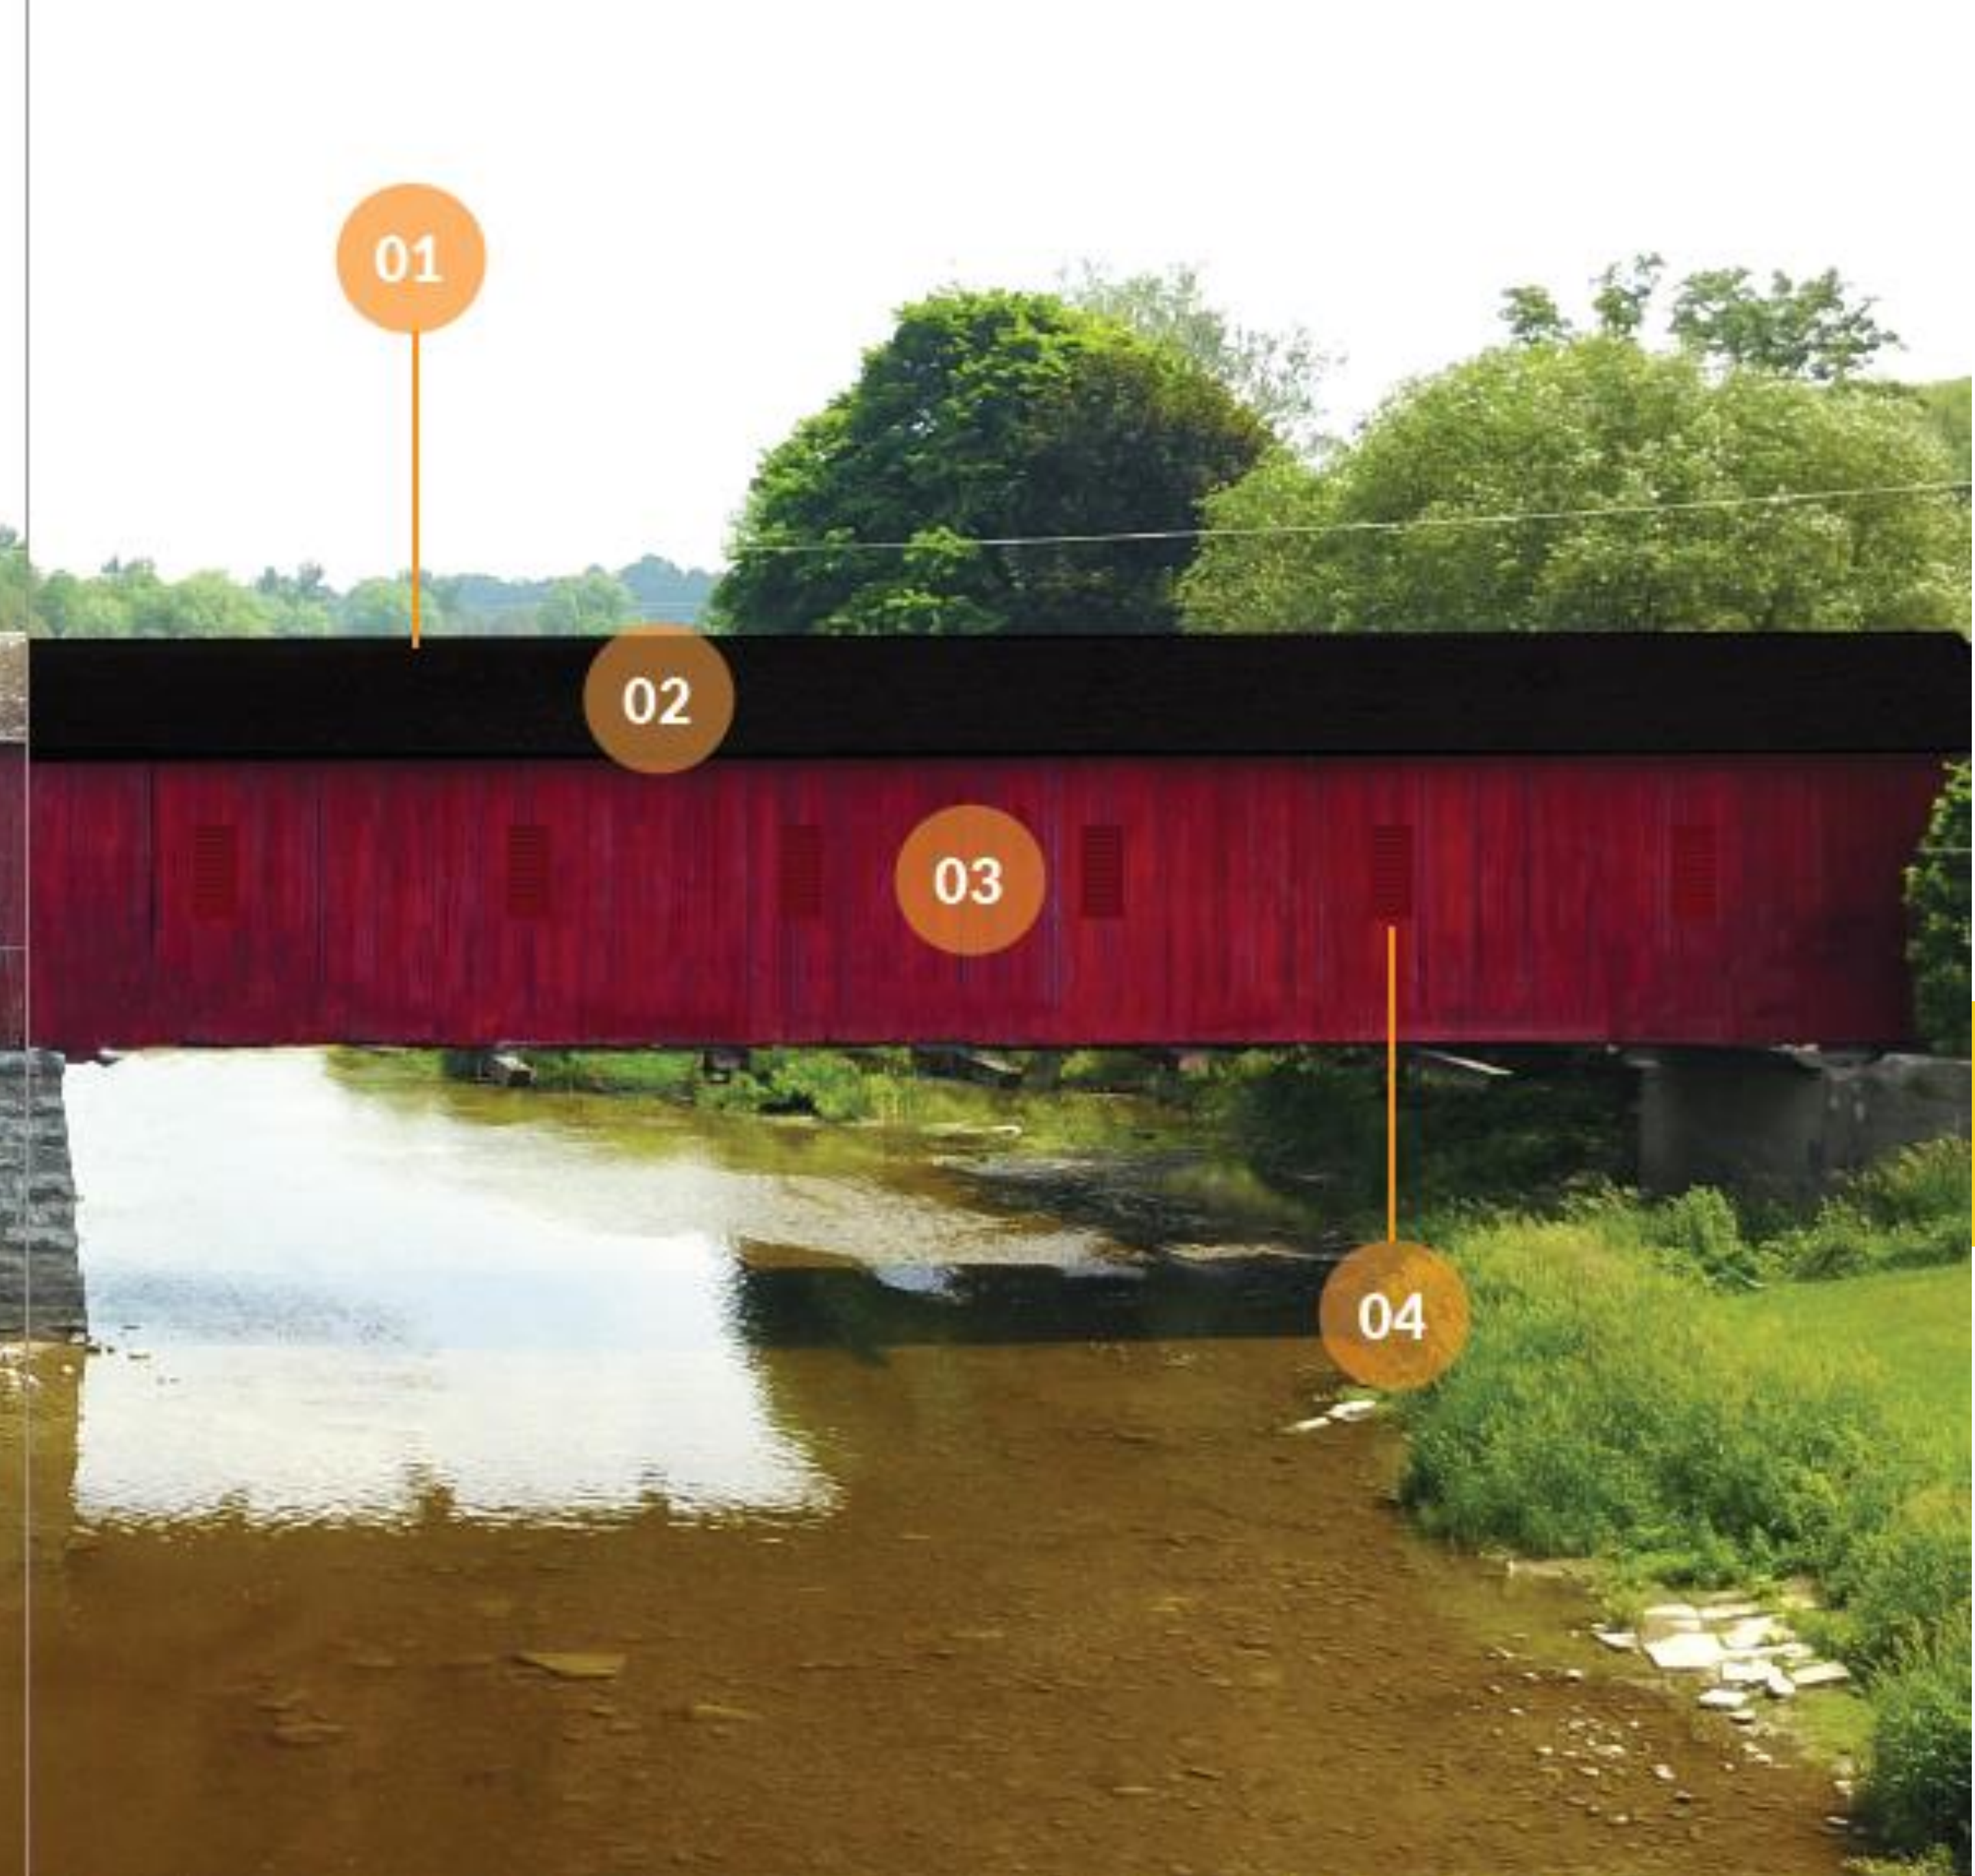
Post rehabilitation

1 Bridge sag reduced

2 Replace roof with new cedar shingles

3 Replace exterior wood cladding

4 Replace window louvres

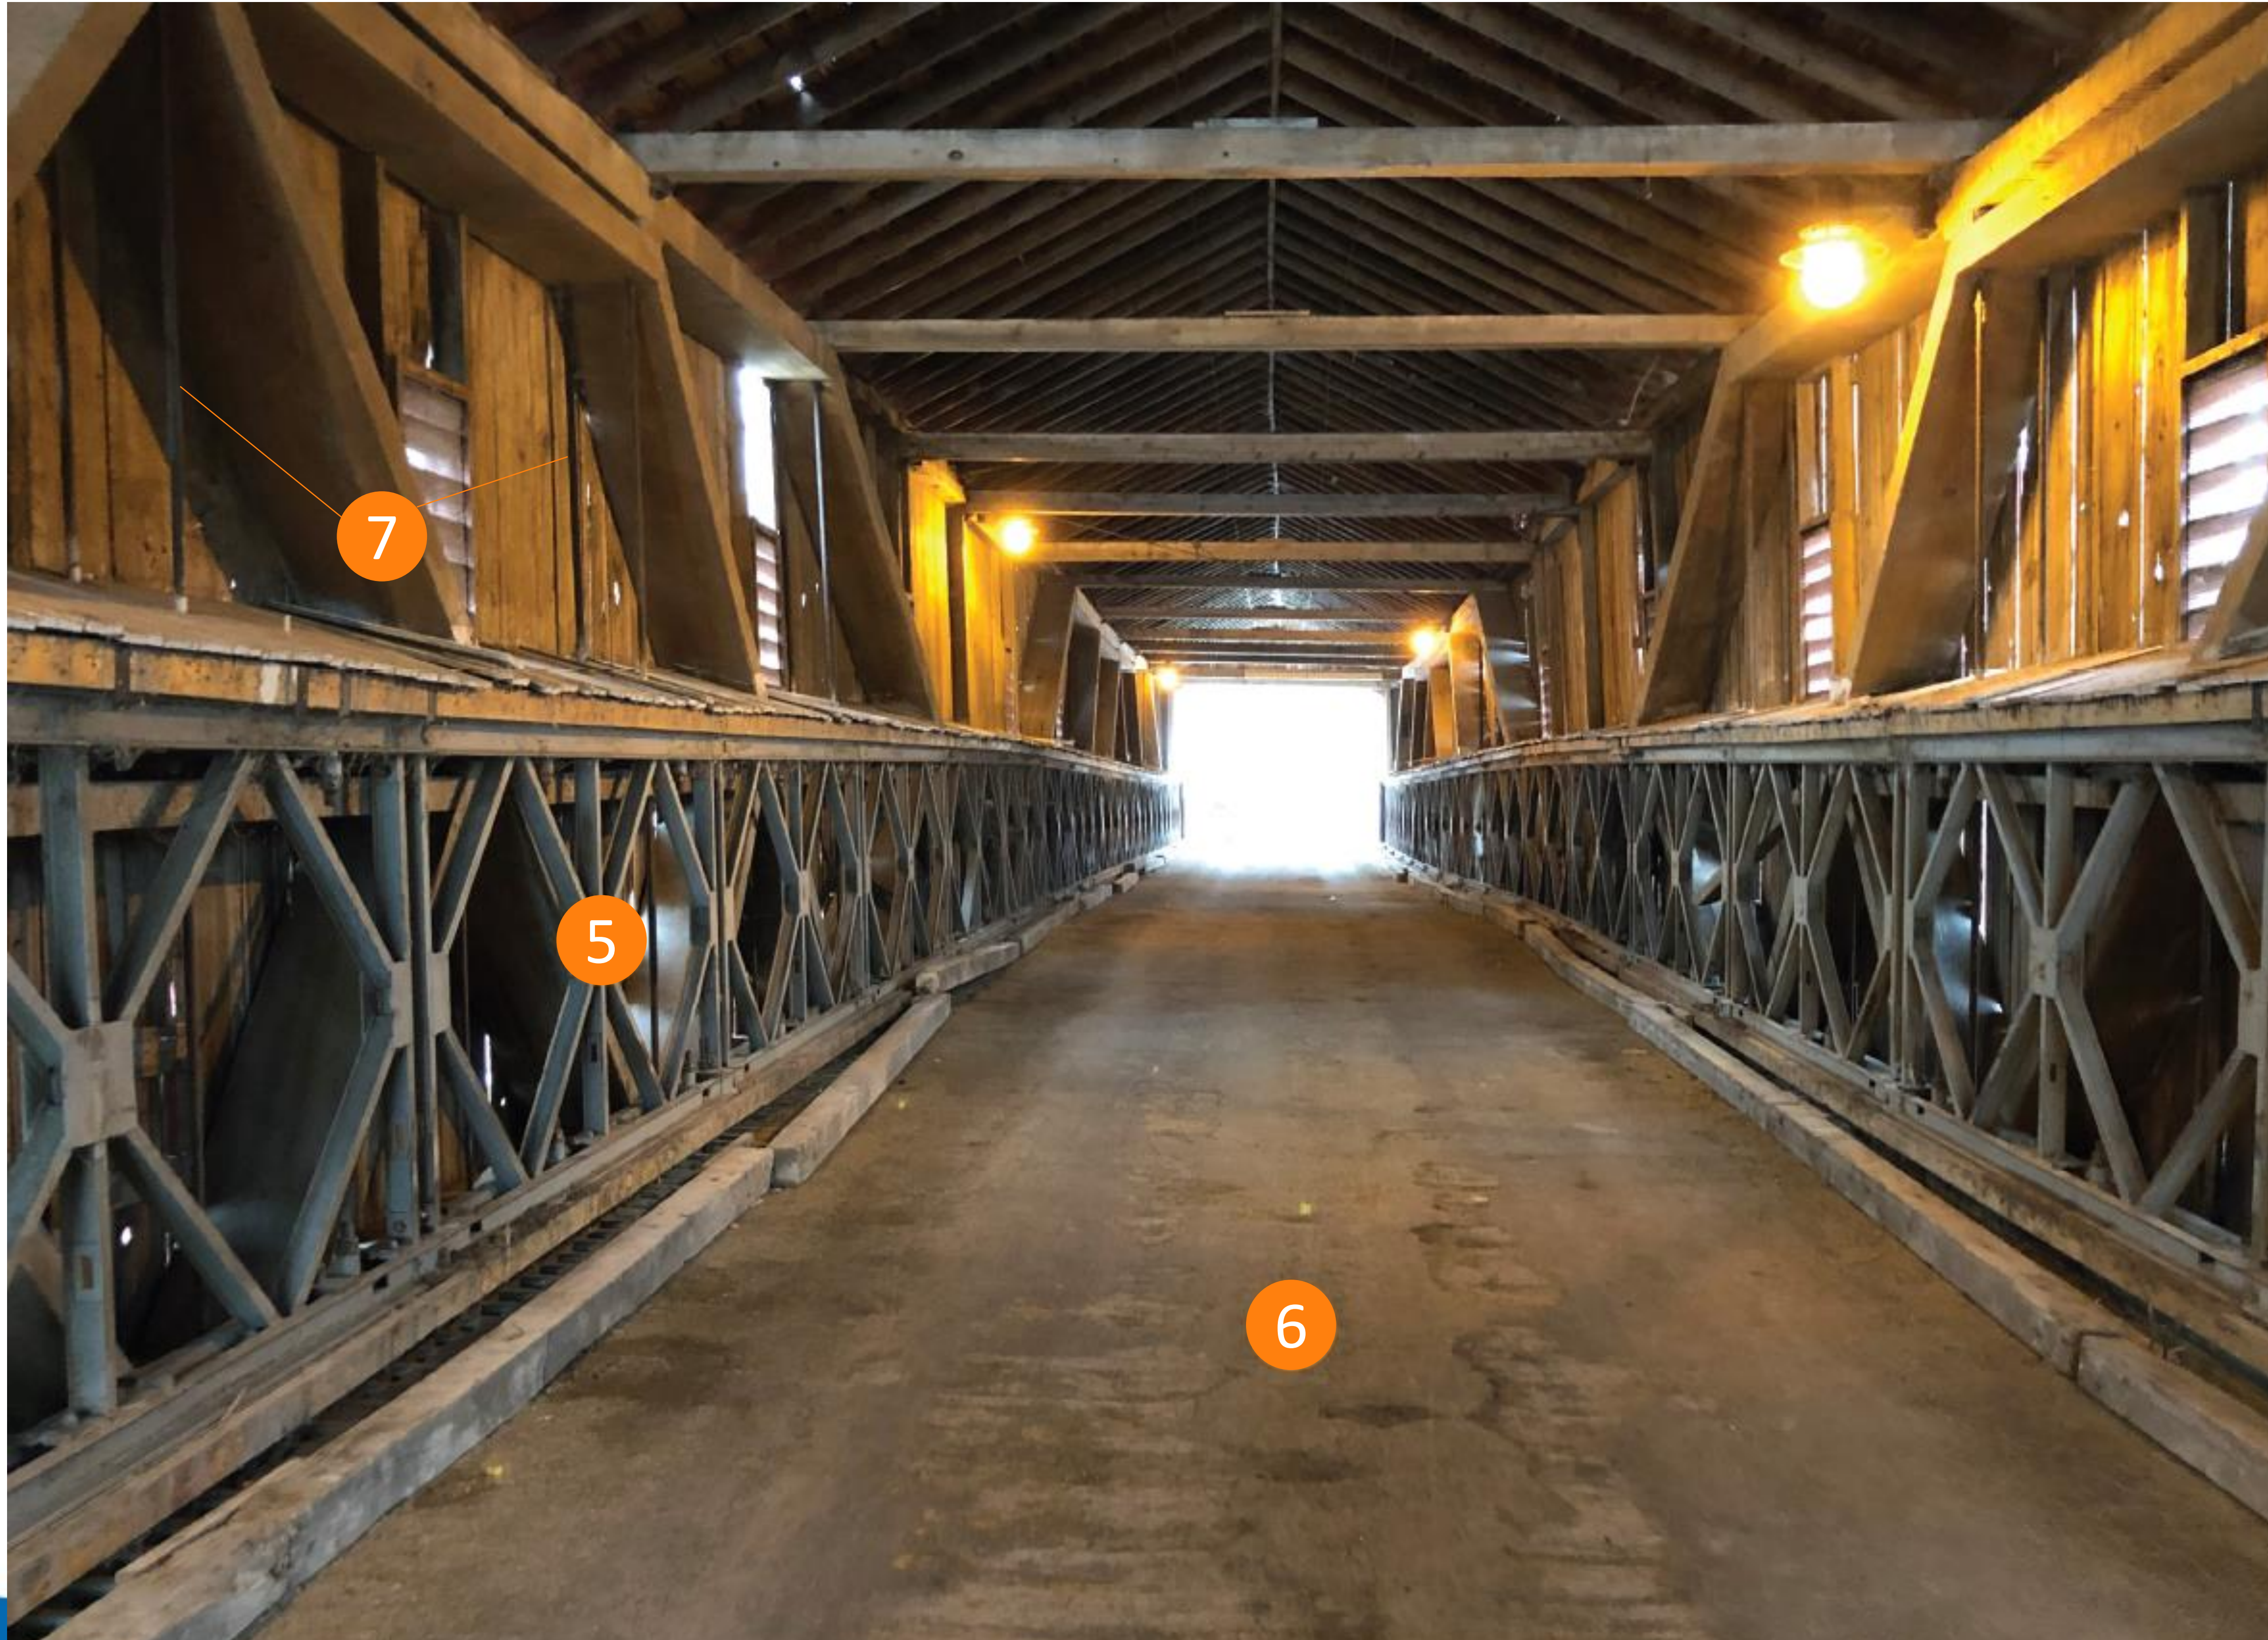
- 5 Remove steel Bailey truss
- 6 Re-instate tar and chip wearing surface after replacement of nail-laminated deck
- 7 Replace steel hanger rods

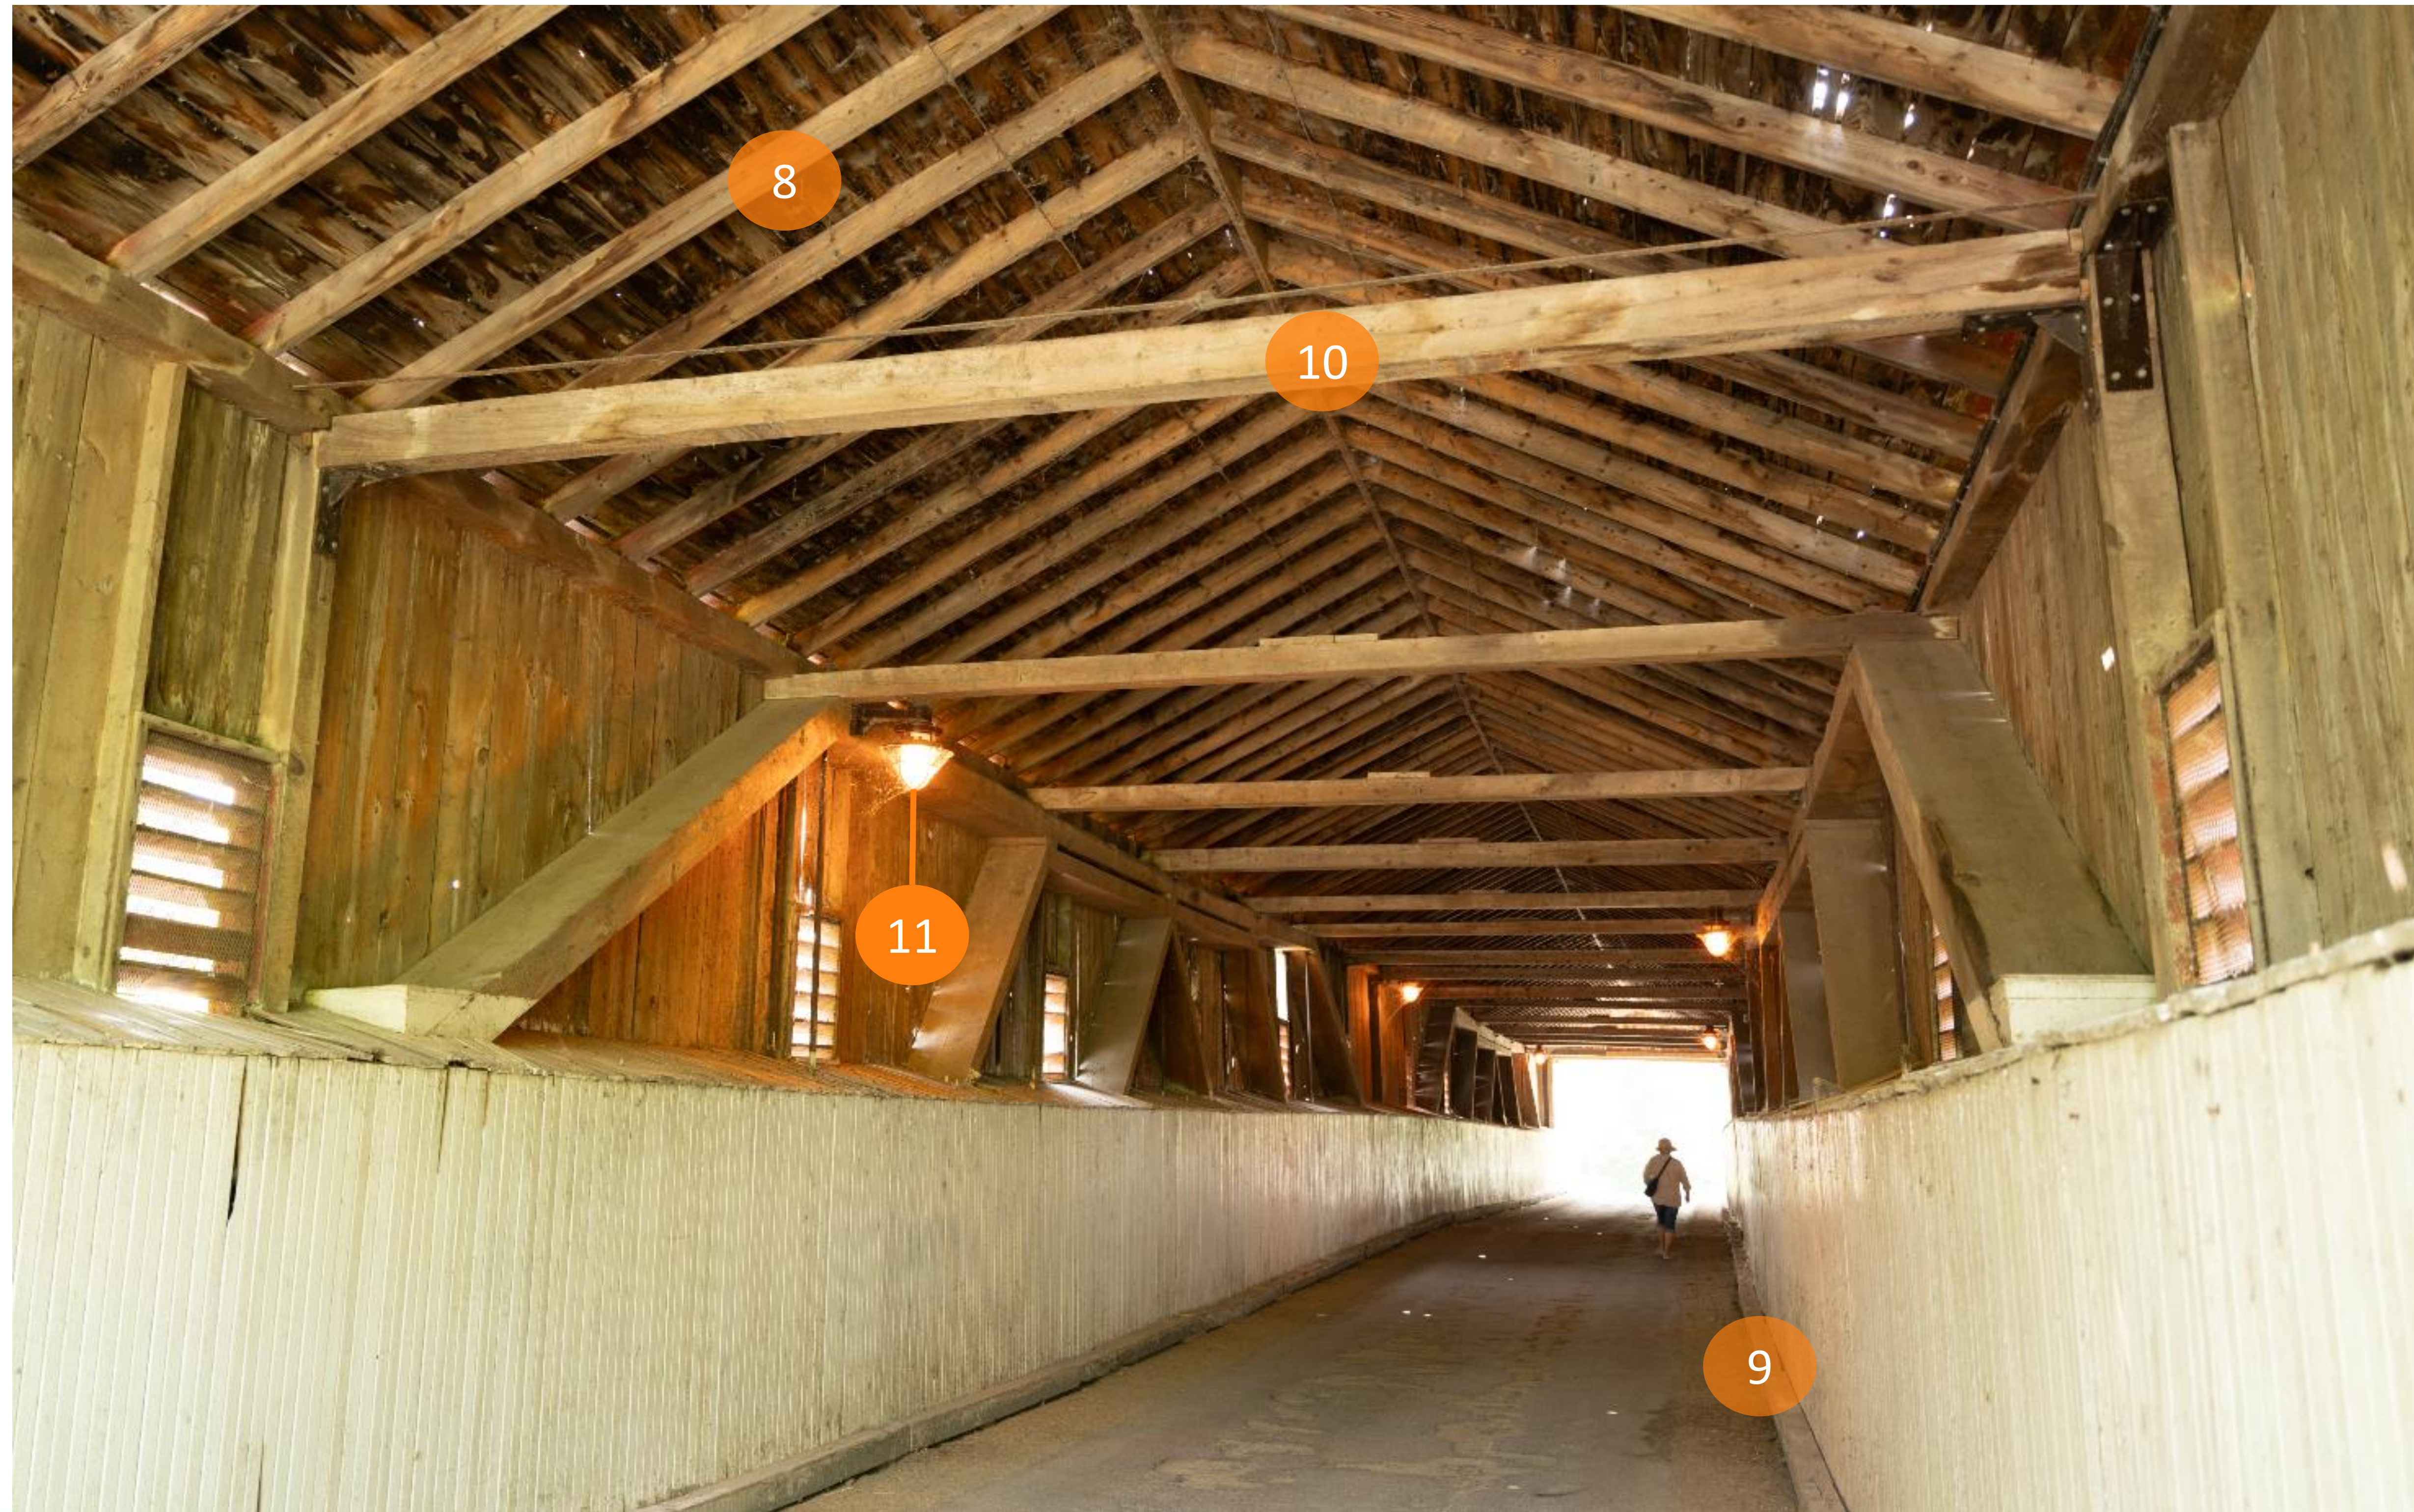
8 Replace rafters as necessary

9 Replace wood curbs

10 Replace tie beams as necessary

11 Replace light bulbs as necessary

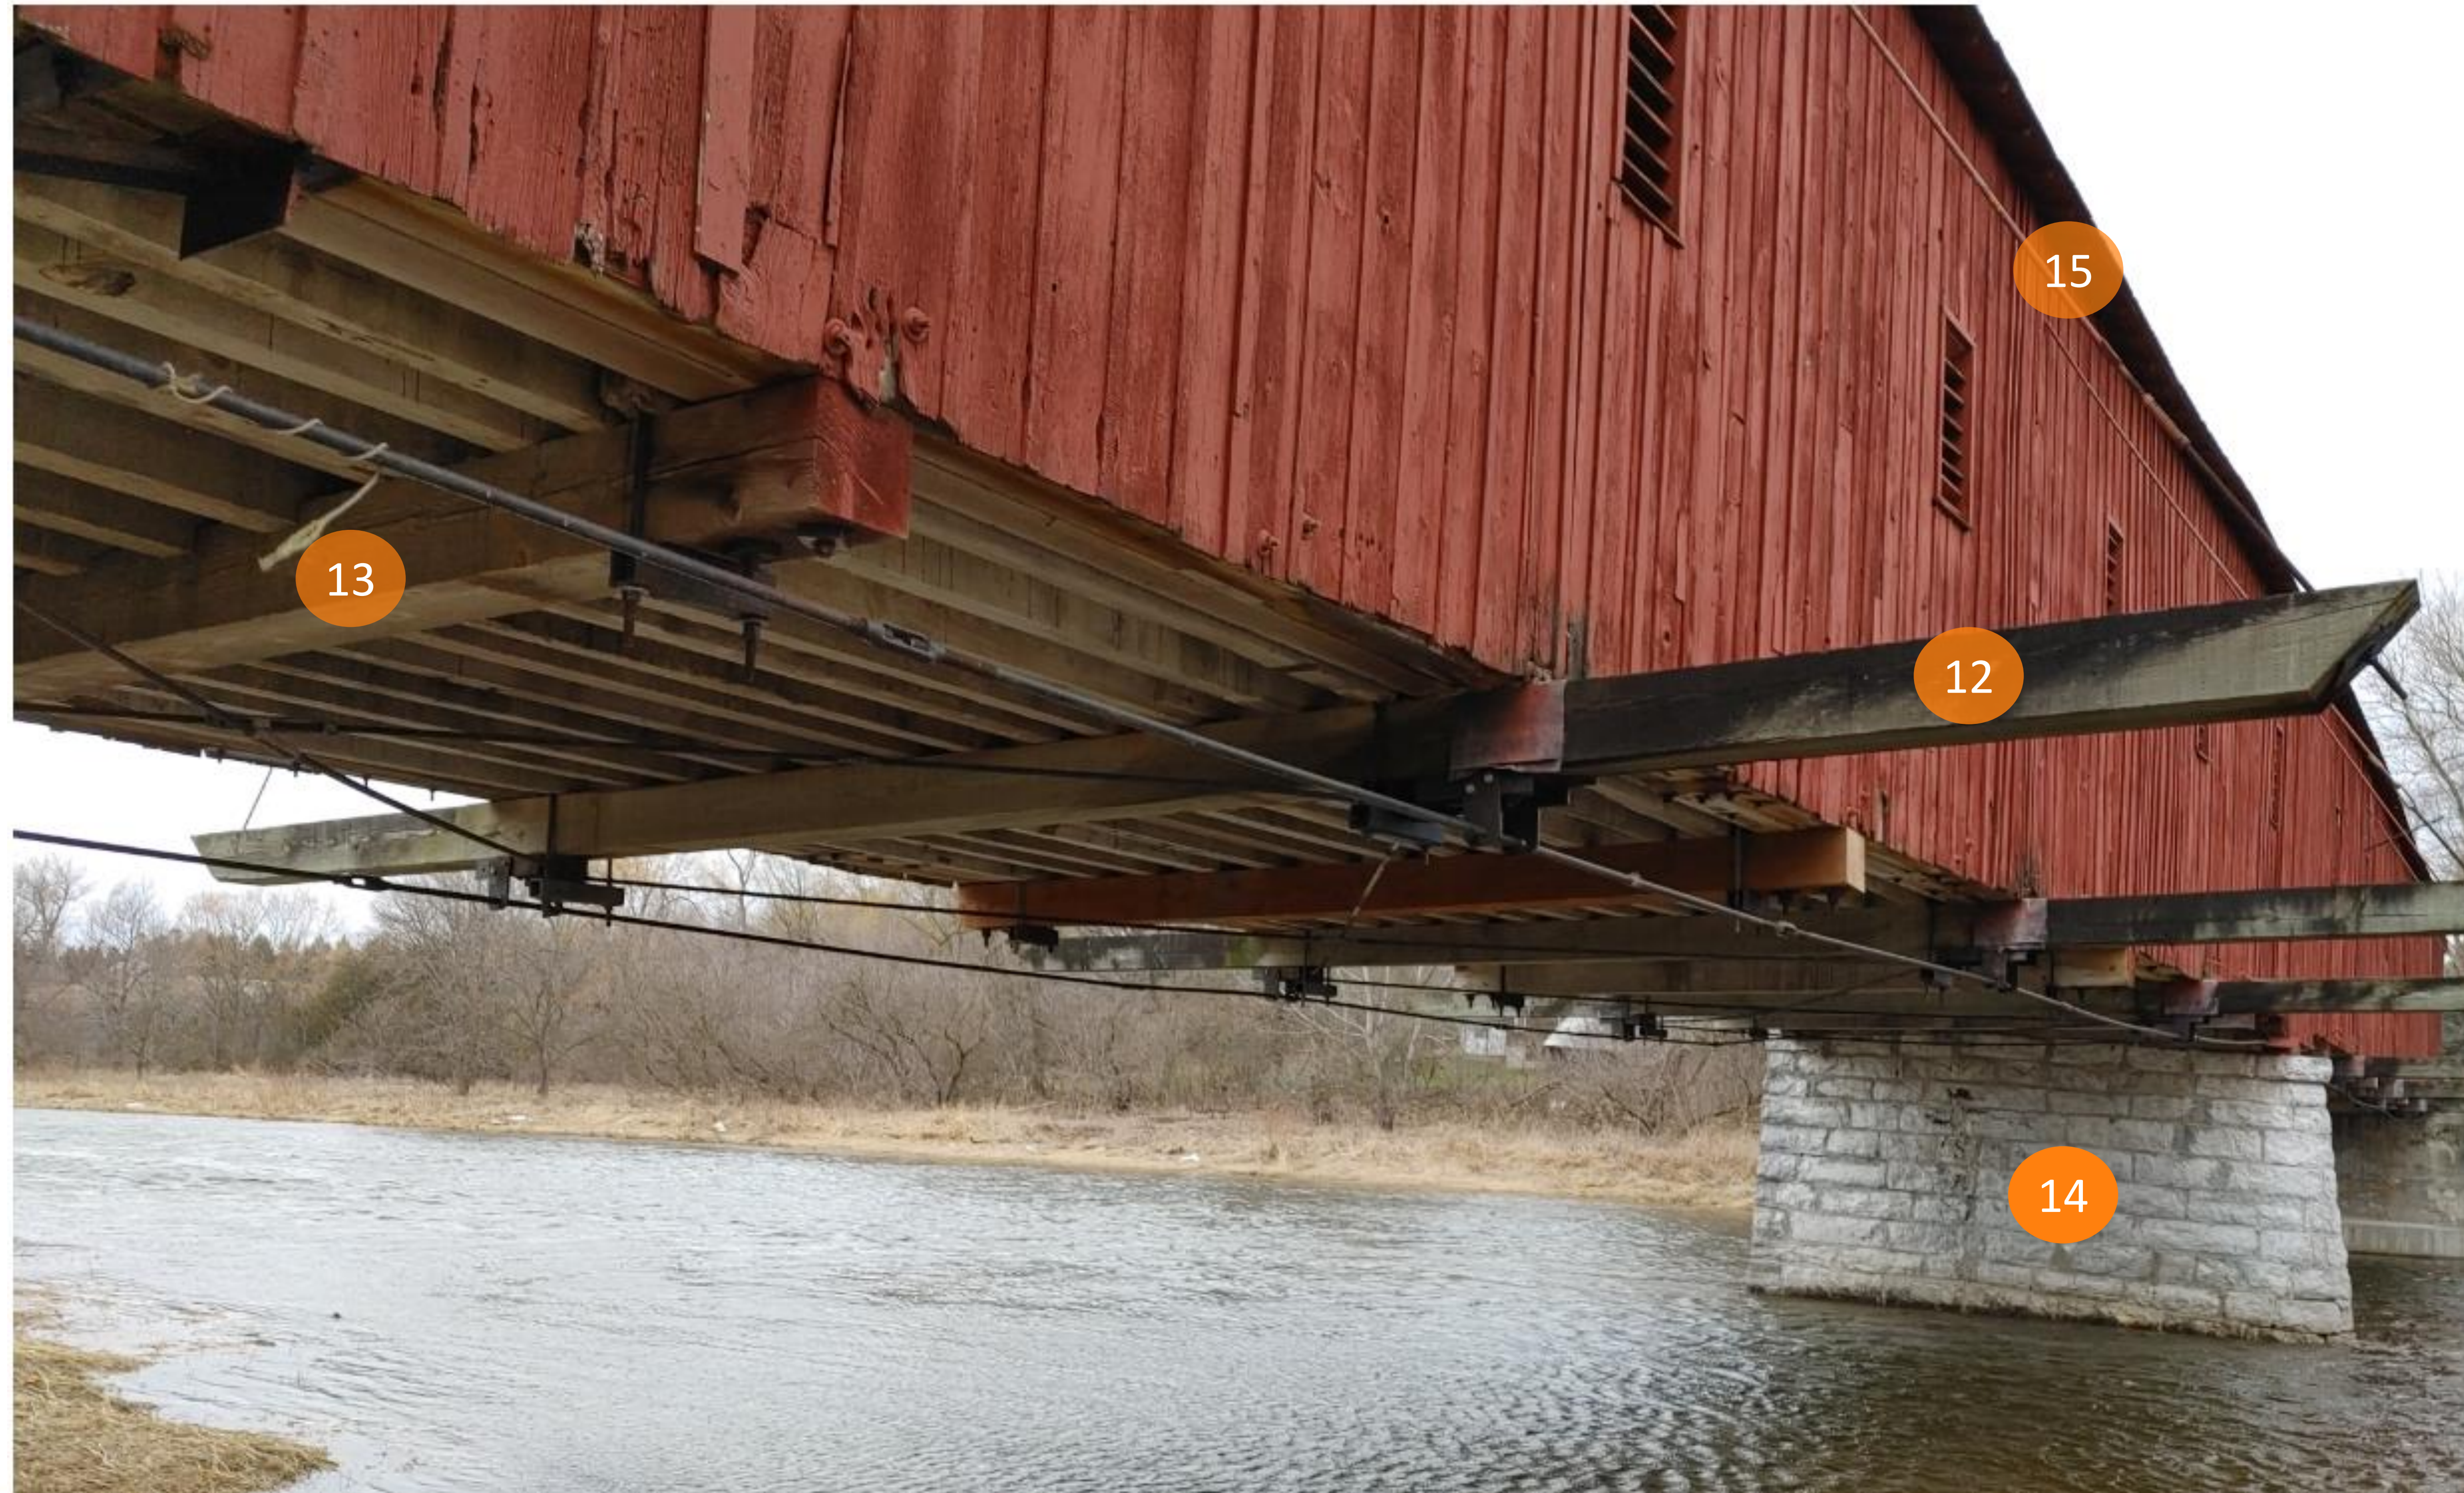
12 Replace needle beams

13 Replace floor beams

14 Repairs to center pier

15 Replace sway bracing

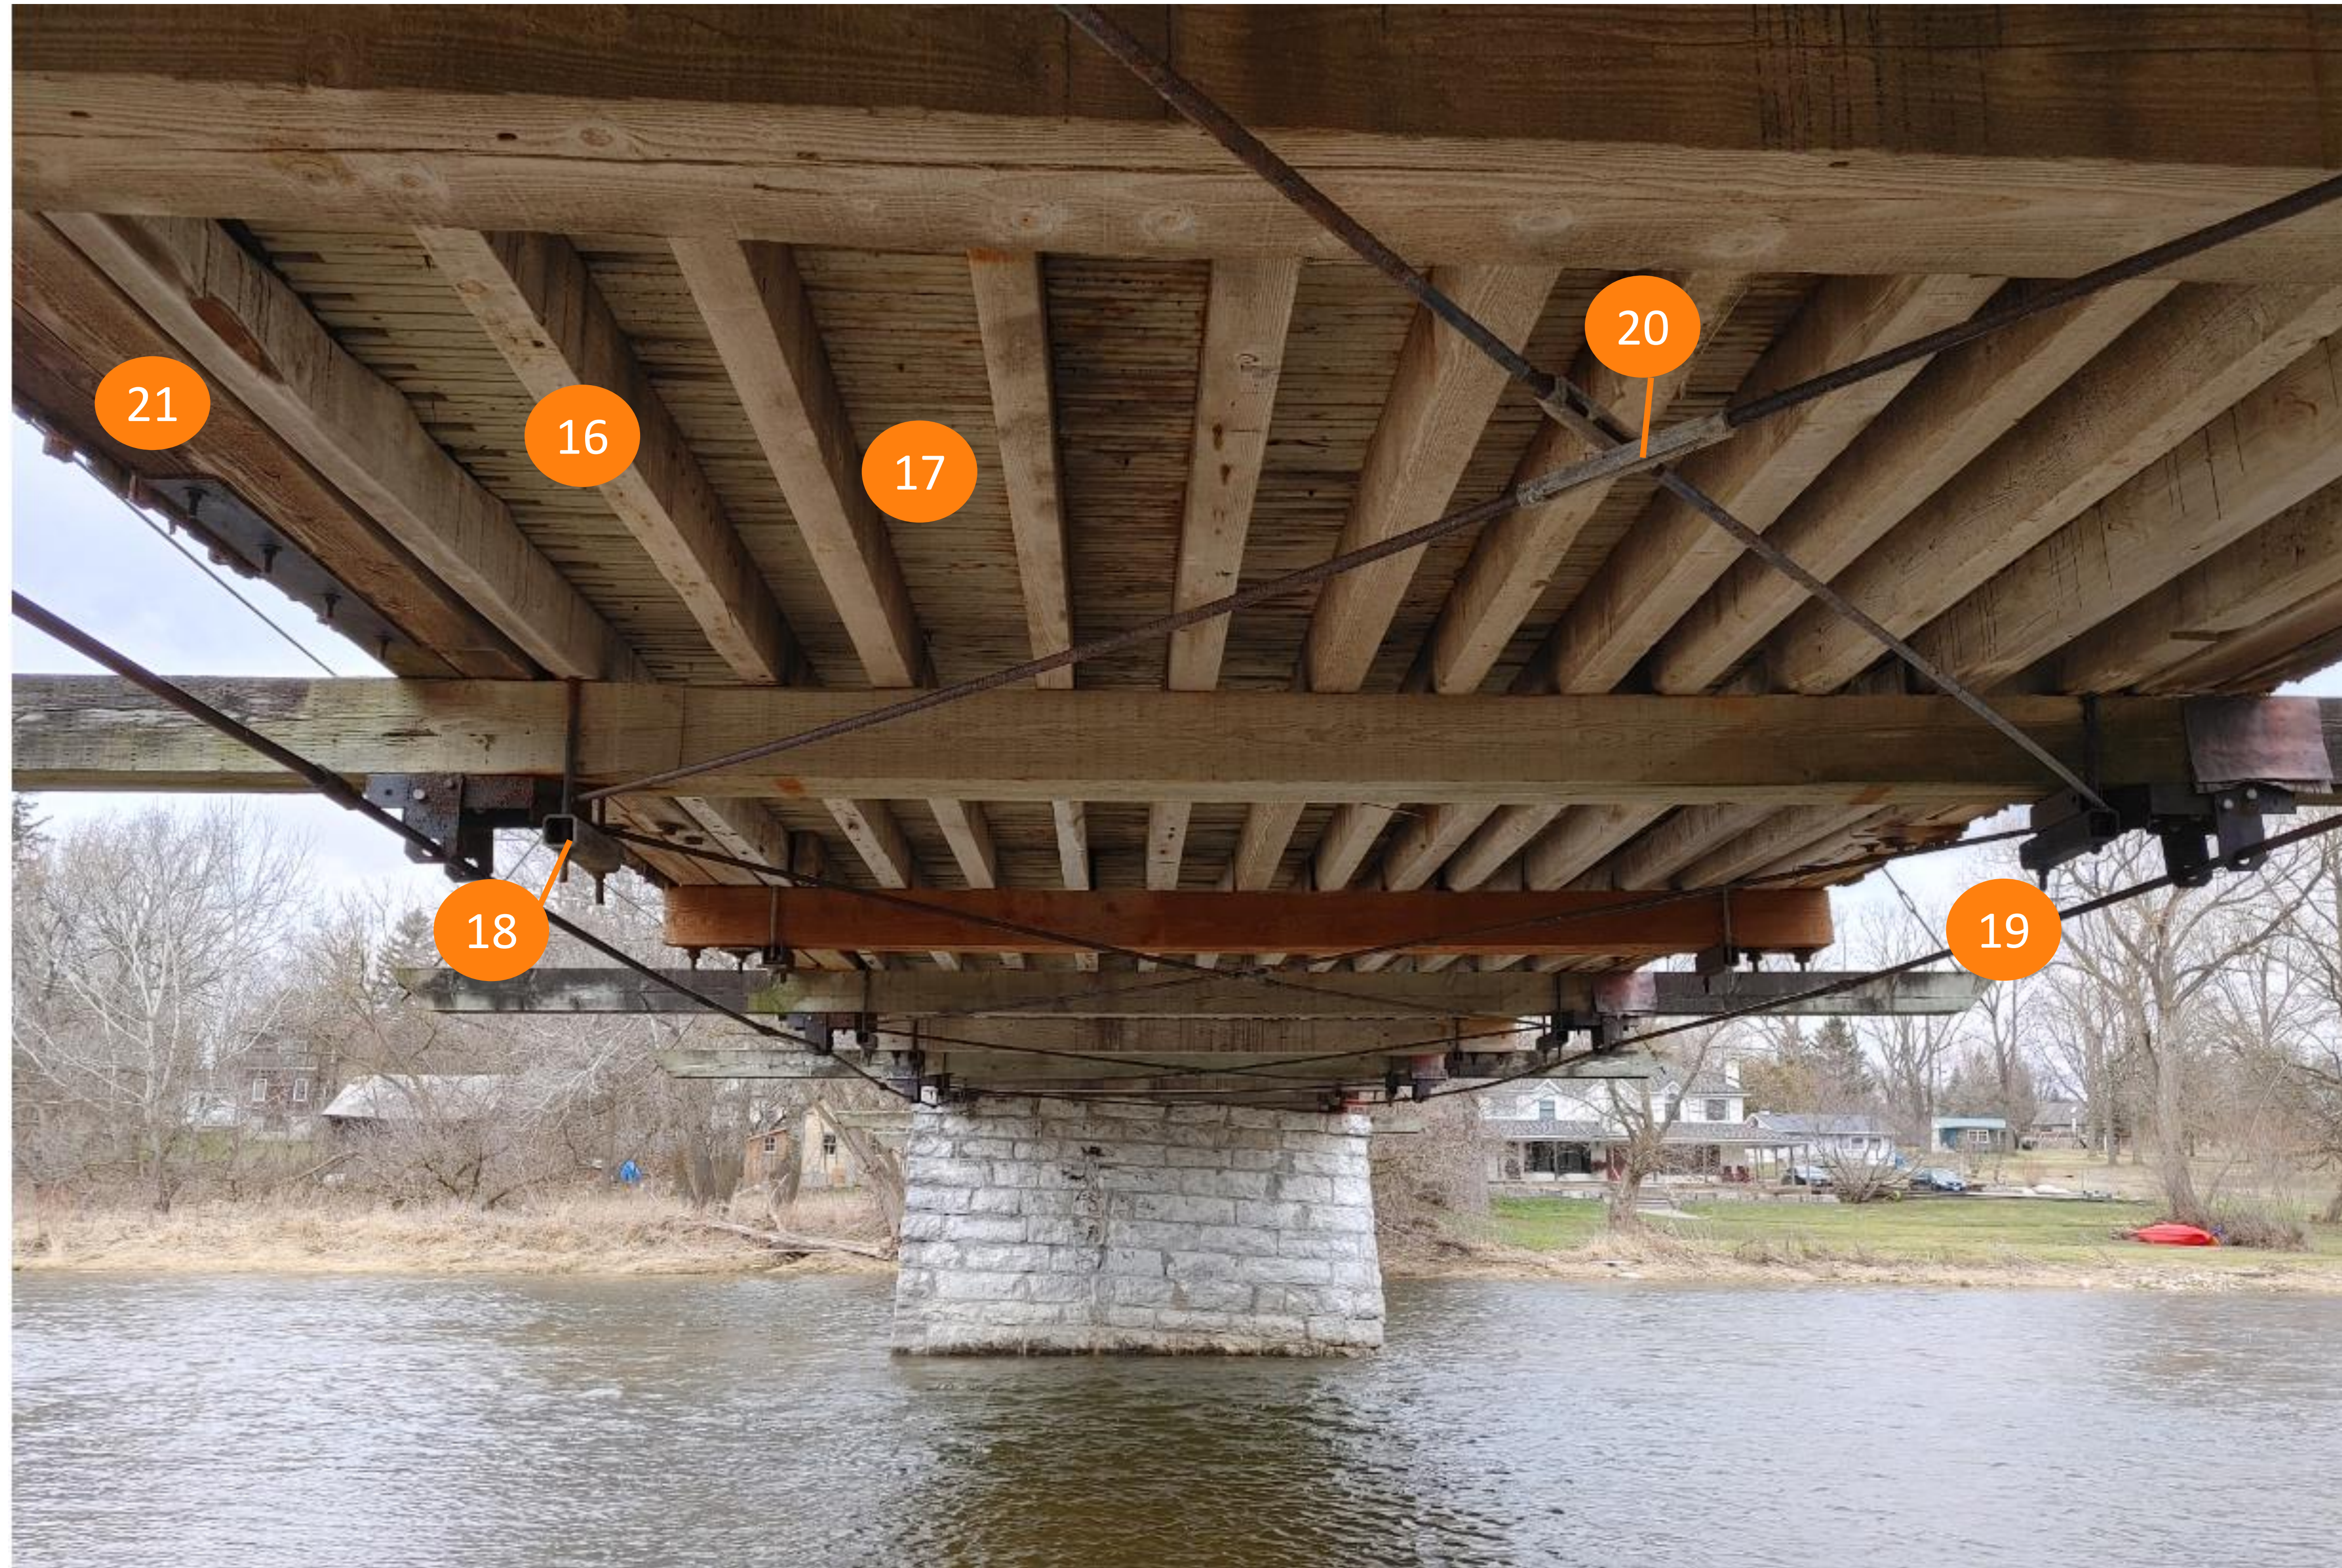
16 Replace stringers

17 Replace nail-laminated deck

18 Remove Bailey truss hanger system

19 Remove non-functioning tension rods (1959)

20 Replace Bottom lateral bracing

21 Replace bottom chord
