**Township of Woolwich
Heritage Committee
Agenda**

West Montrose Covered Bridge Rehabilitation

Township of Woolwich Heritage Committee Meeting

Project Purpose

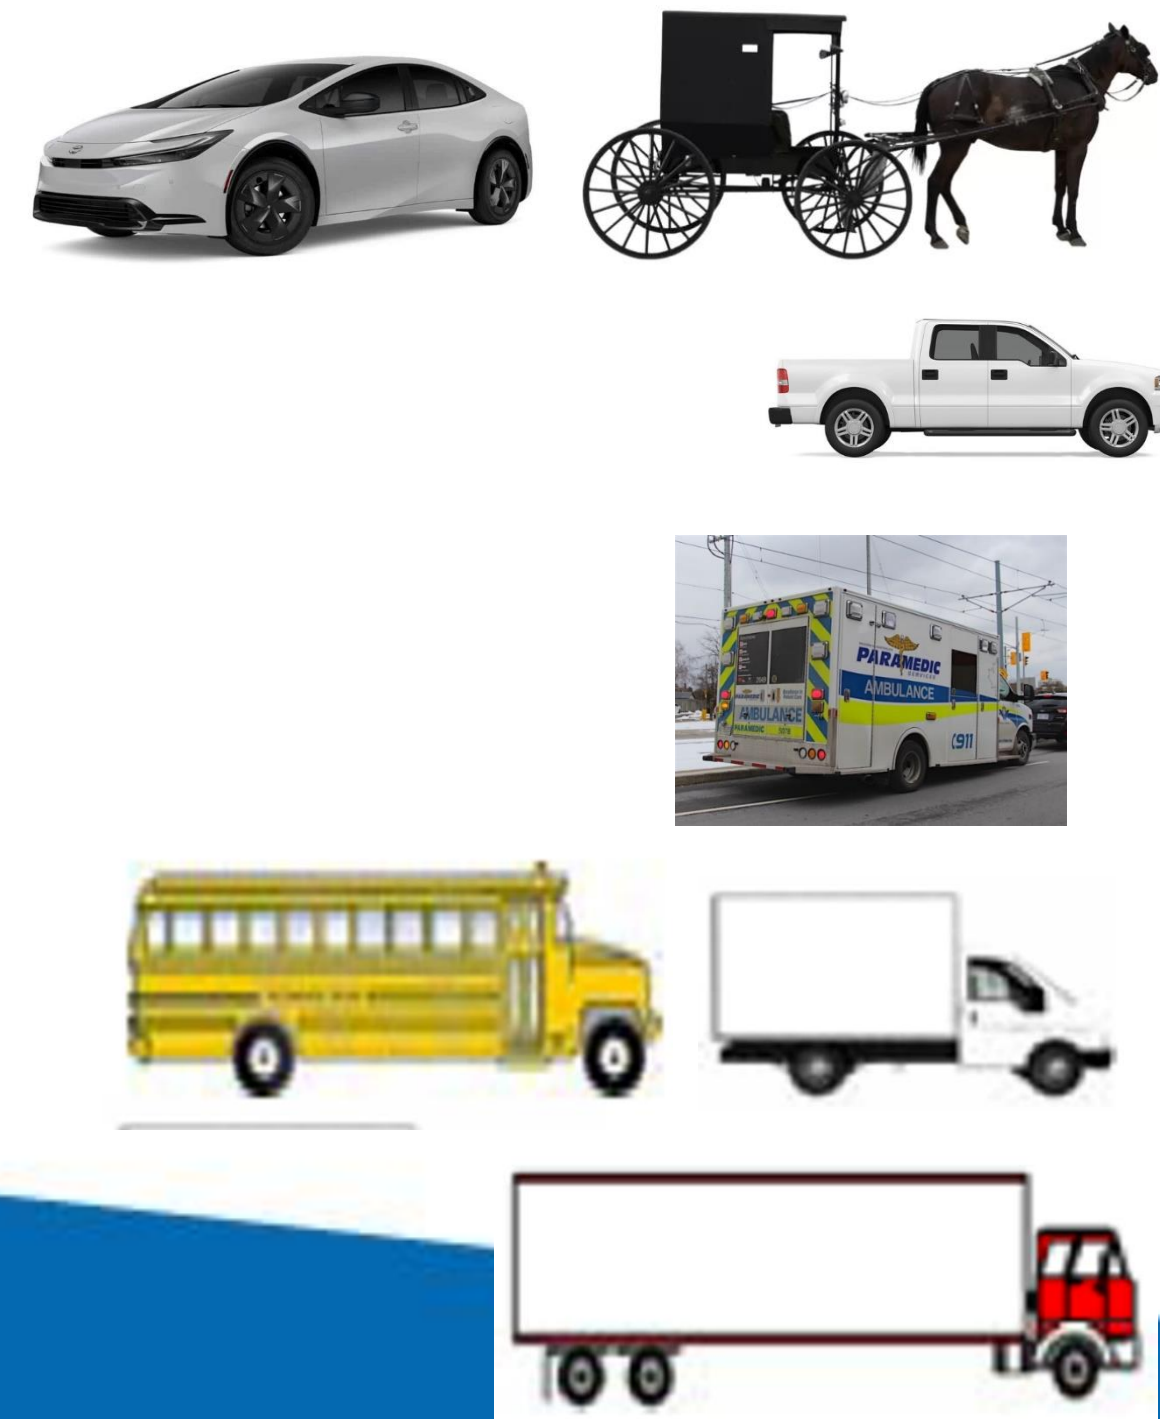
3 tonne posted load limit to be maintained

✓ Small Cars, SUVs, Horse & Buggies	1 - 3 tonnes
✓ ✗ Pick-up Trucks	1.7 – 3.5 tonnes
✗ EMS Vehicles	4 - 8 tonnes
✗ School Bus/Small Truck	6 - 12 tonnes
✗ Large truck	13+ tonnes

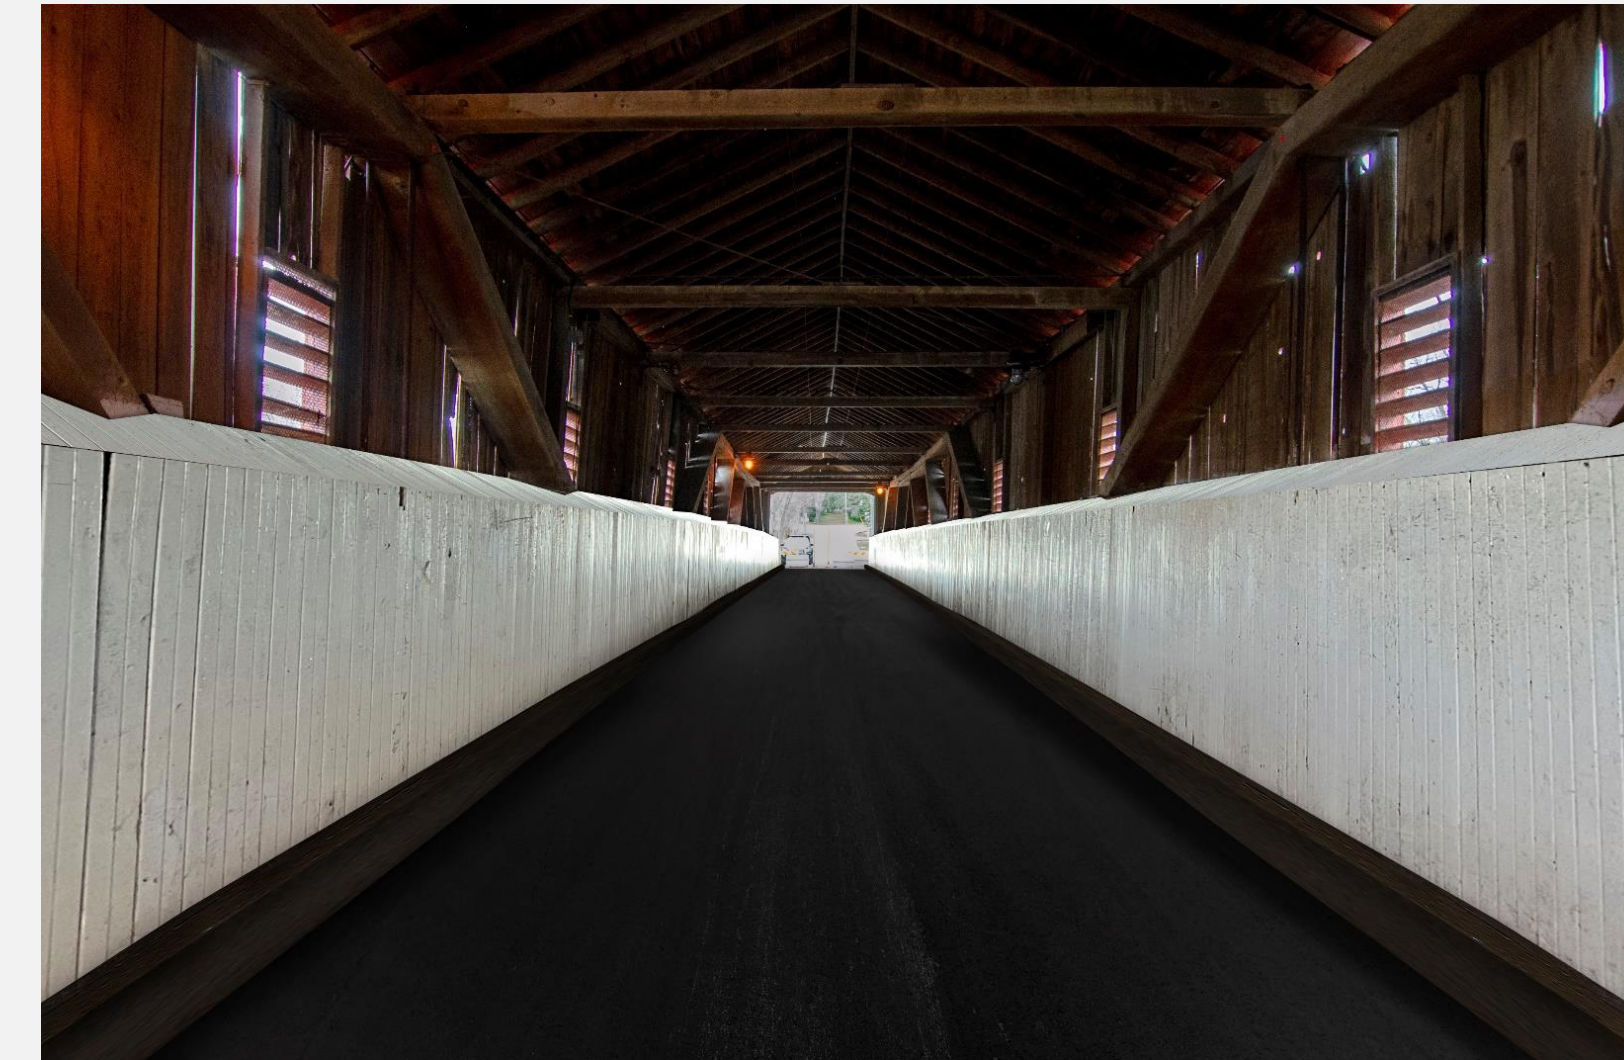
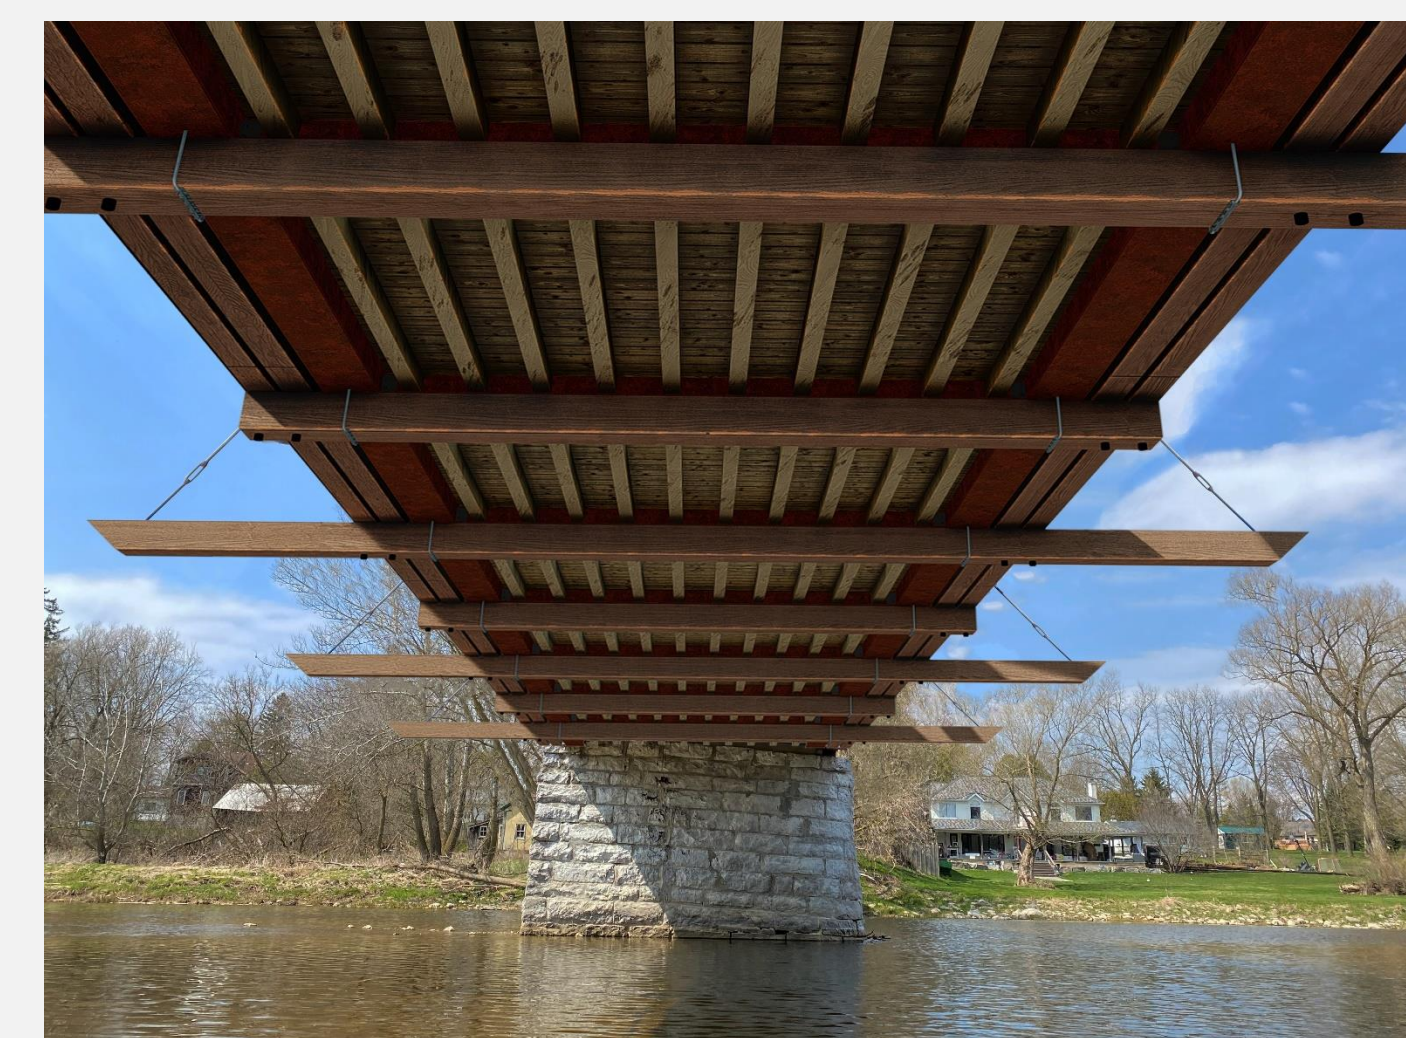
Alternative A – Steel Girder Reinforcement

- Remove Bailey trusses and replace with new steel girders
- New steel girders would be the primary structural system
- Replace interior white cladding
- Bridge interior would look similar to the way it looks today
- Width of driving lane would become slightly more narrow
- Includes new steel floor beams
- Can accommodate a design live load of approximately 15 tonnes

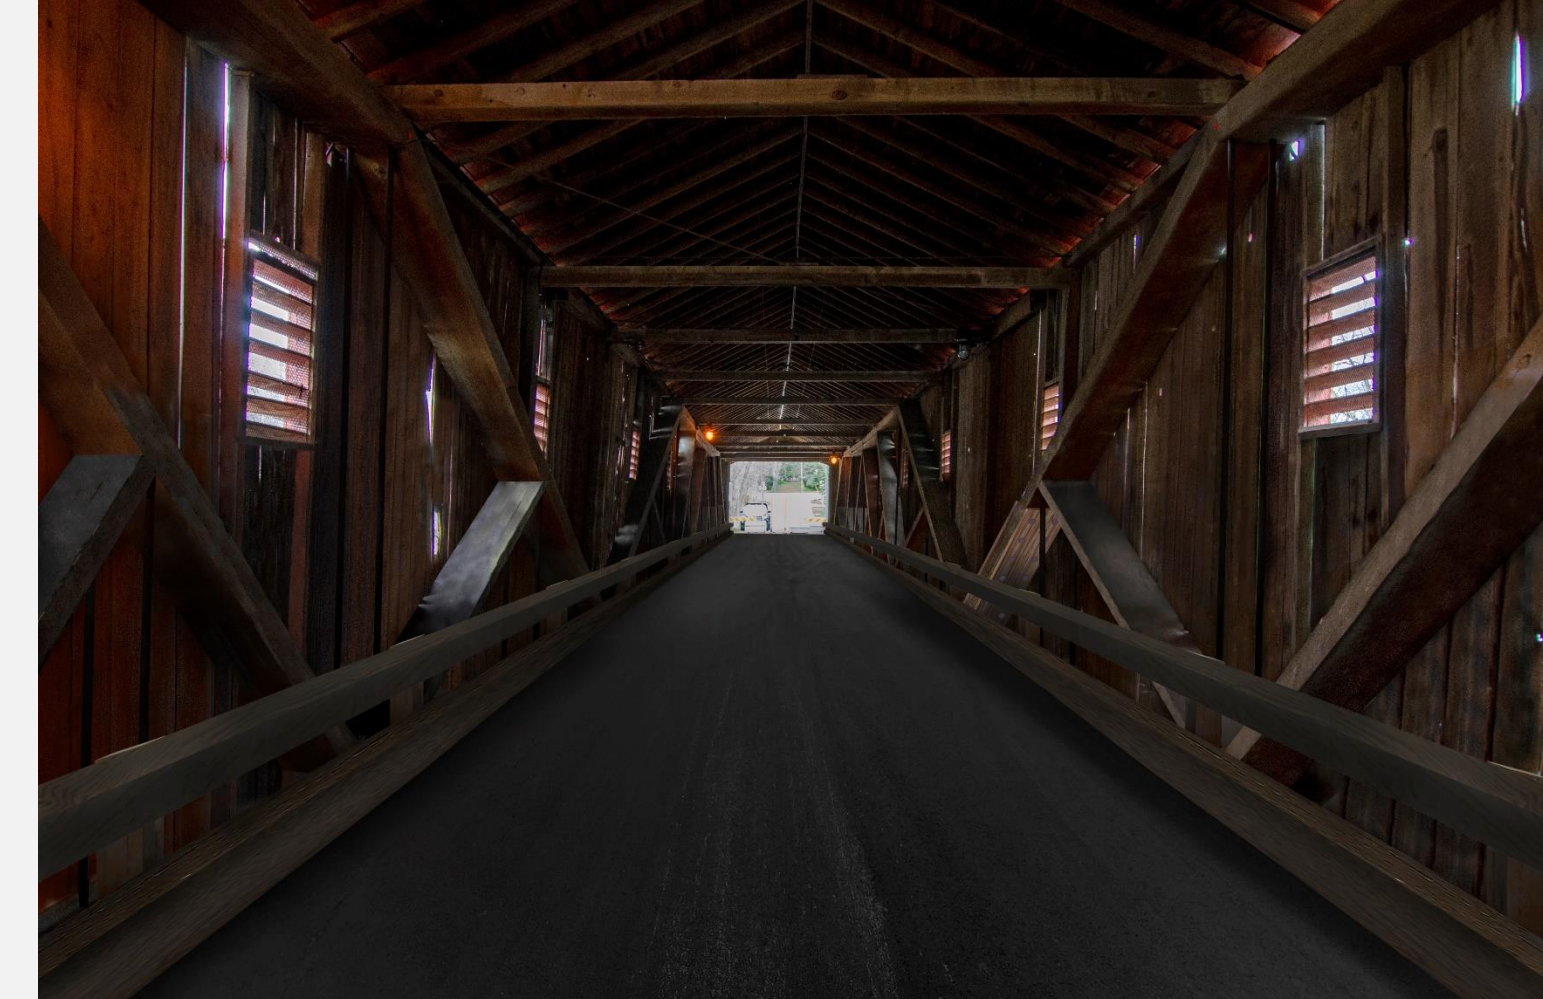
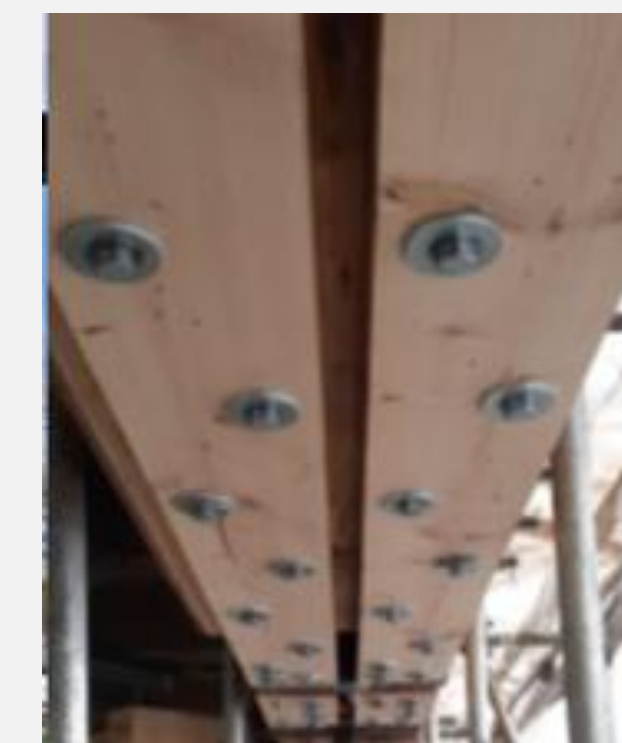
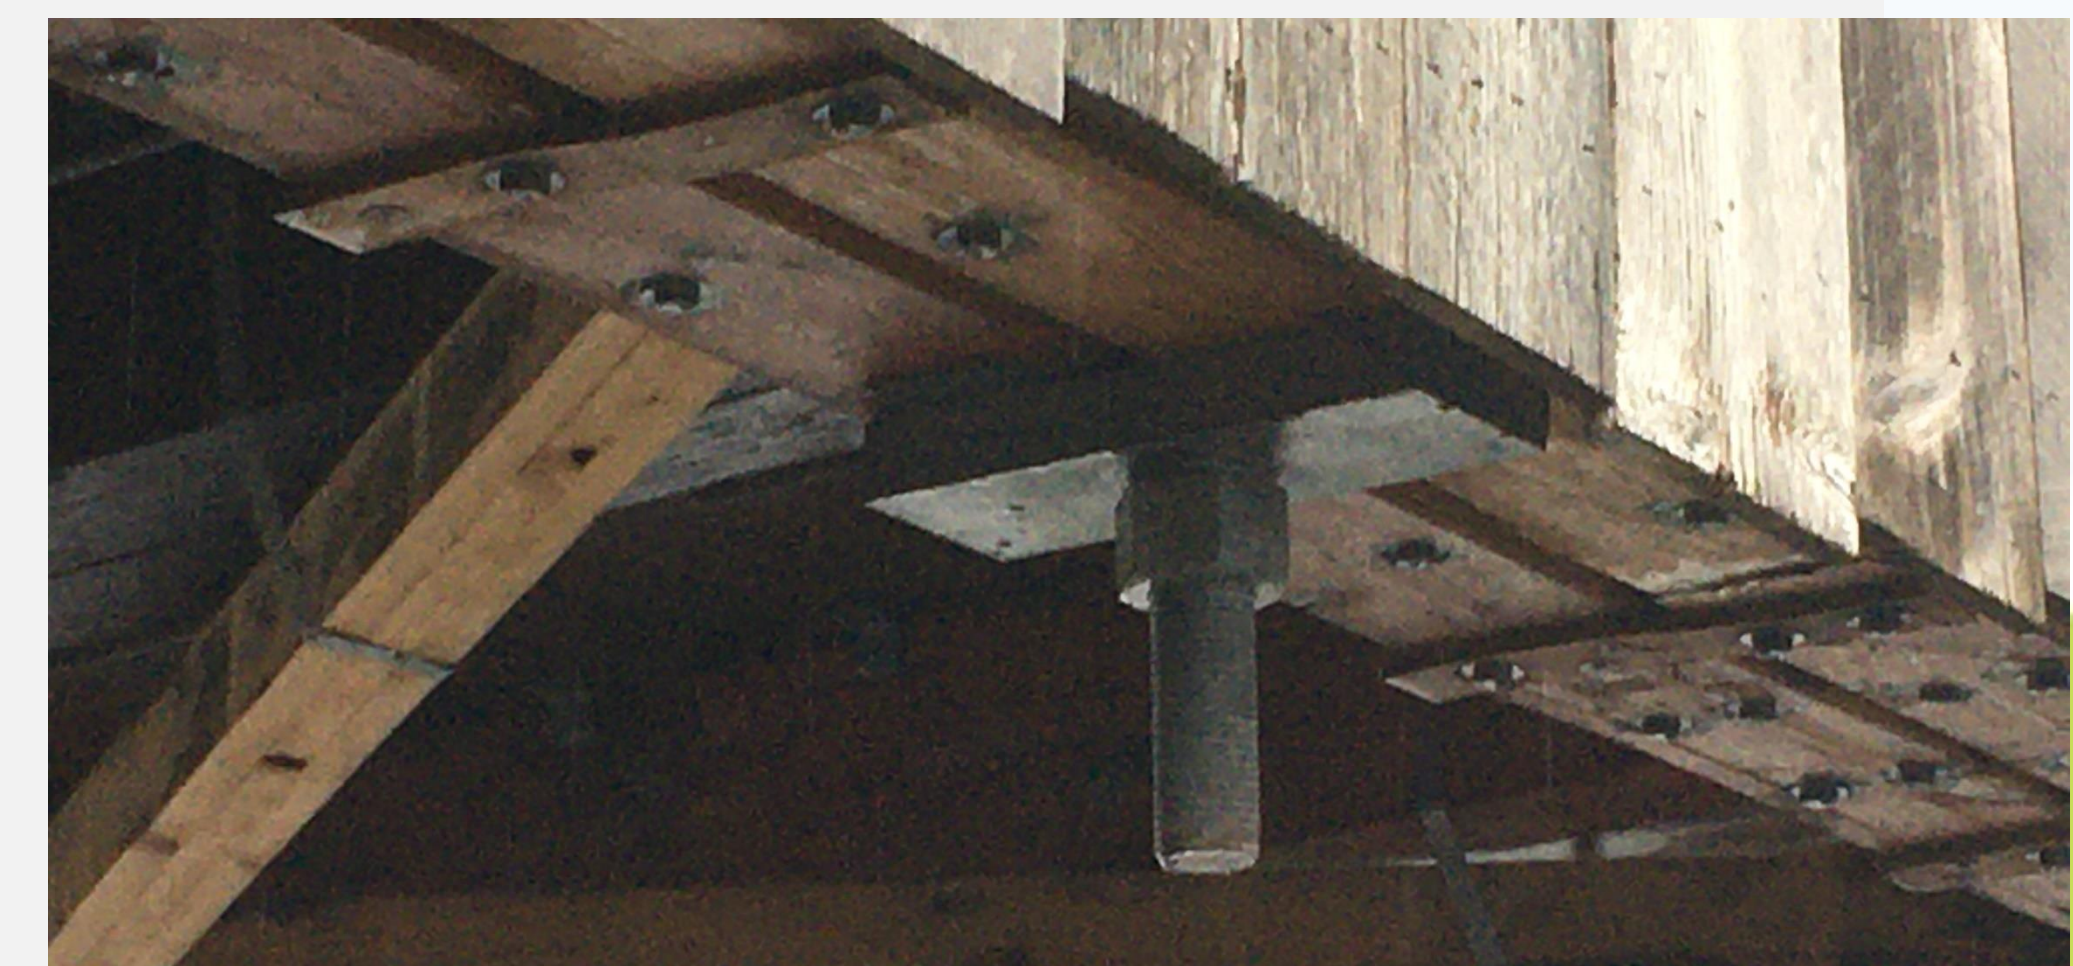
Alternative B – Timber Truss Reinforcement with Fibre-reinforced Polymer (FRP)

- Remove Bailey truss and strengthen the existing wooden truss with high-strength fibre reinforcement attached to the bottom chord
- Reinforce deteriorated truss members
- Remove interior white cladding
- Install timber guardrail to protect wooden truss
- FRP bonding to the bottom chord of the truss was determined to be **unsuitable** due to the deteriorated condition of the bottom chord discovered during the timber inspection. The bottom chord is recommended for replacement.

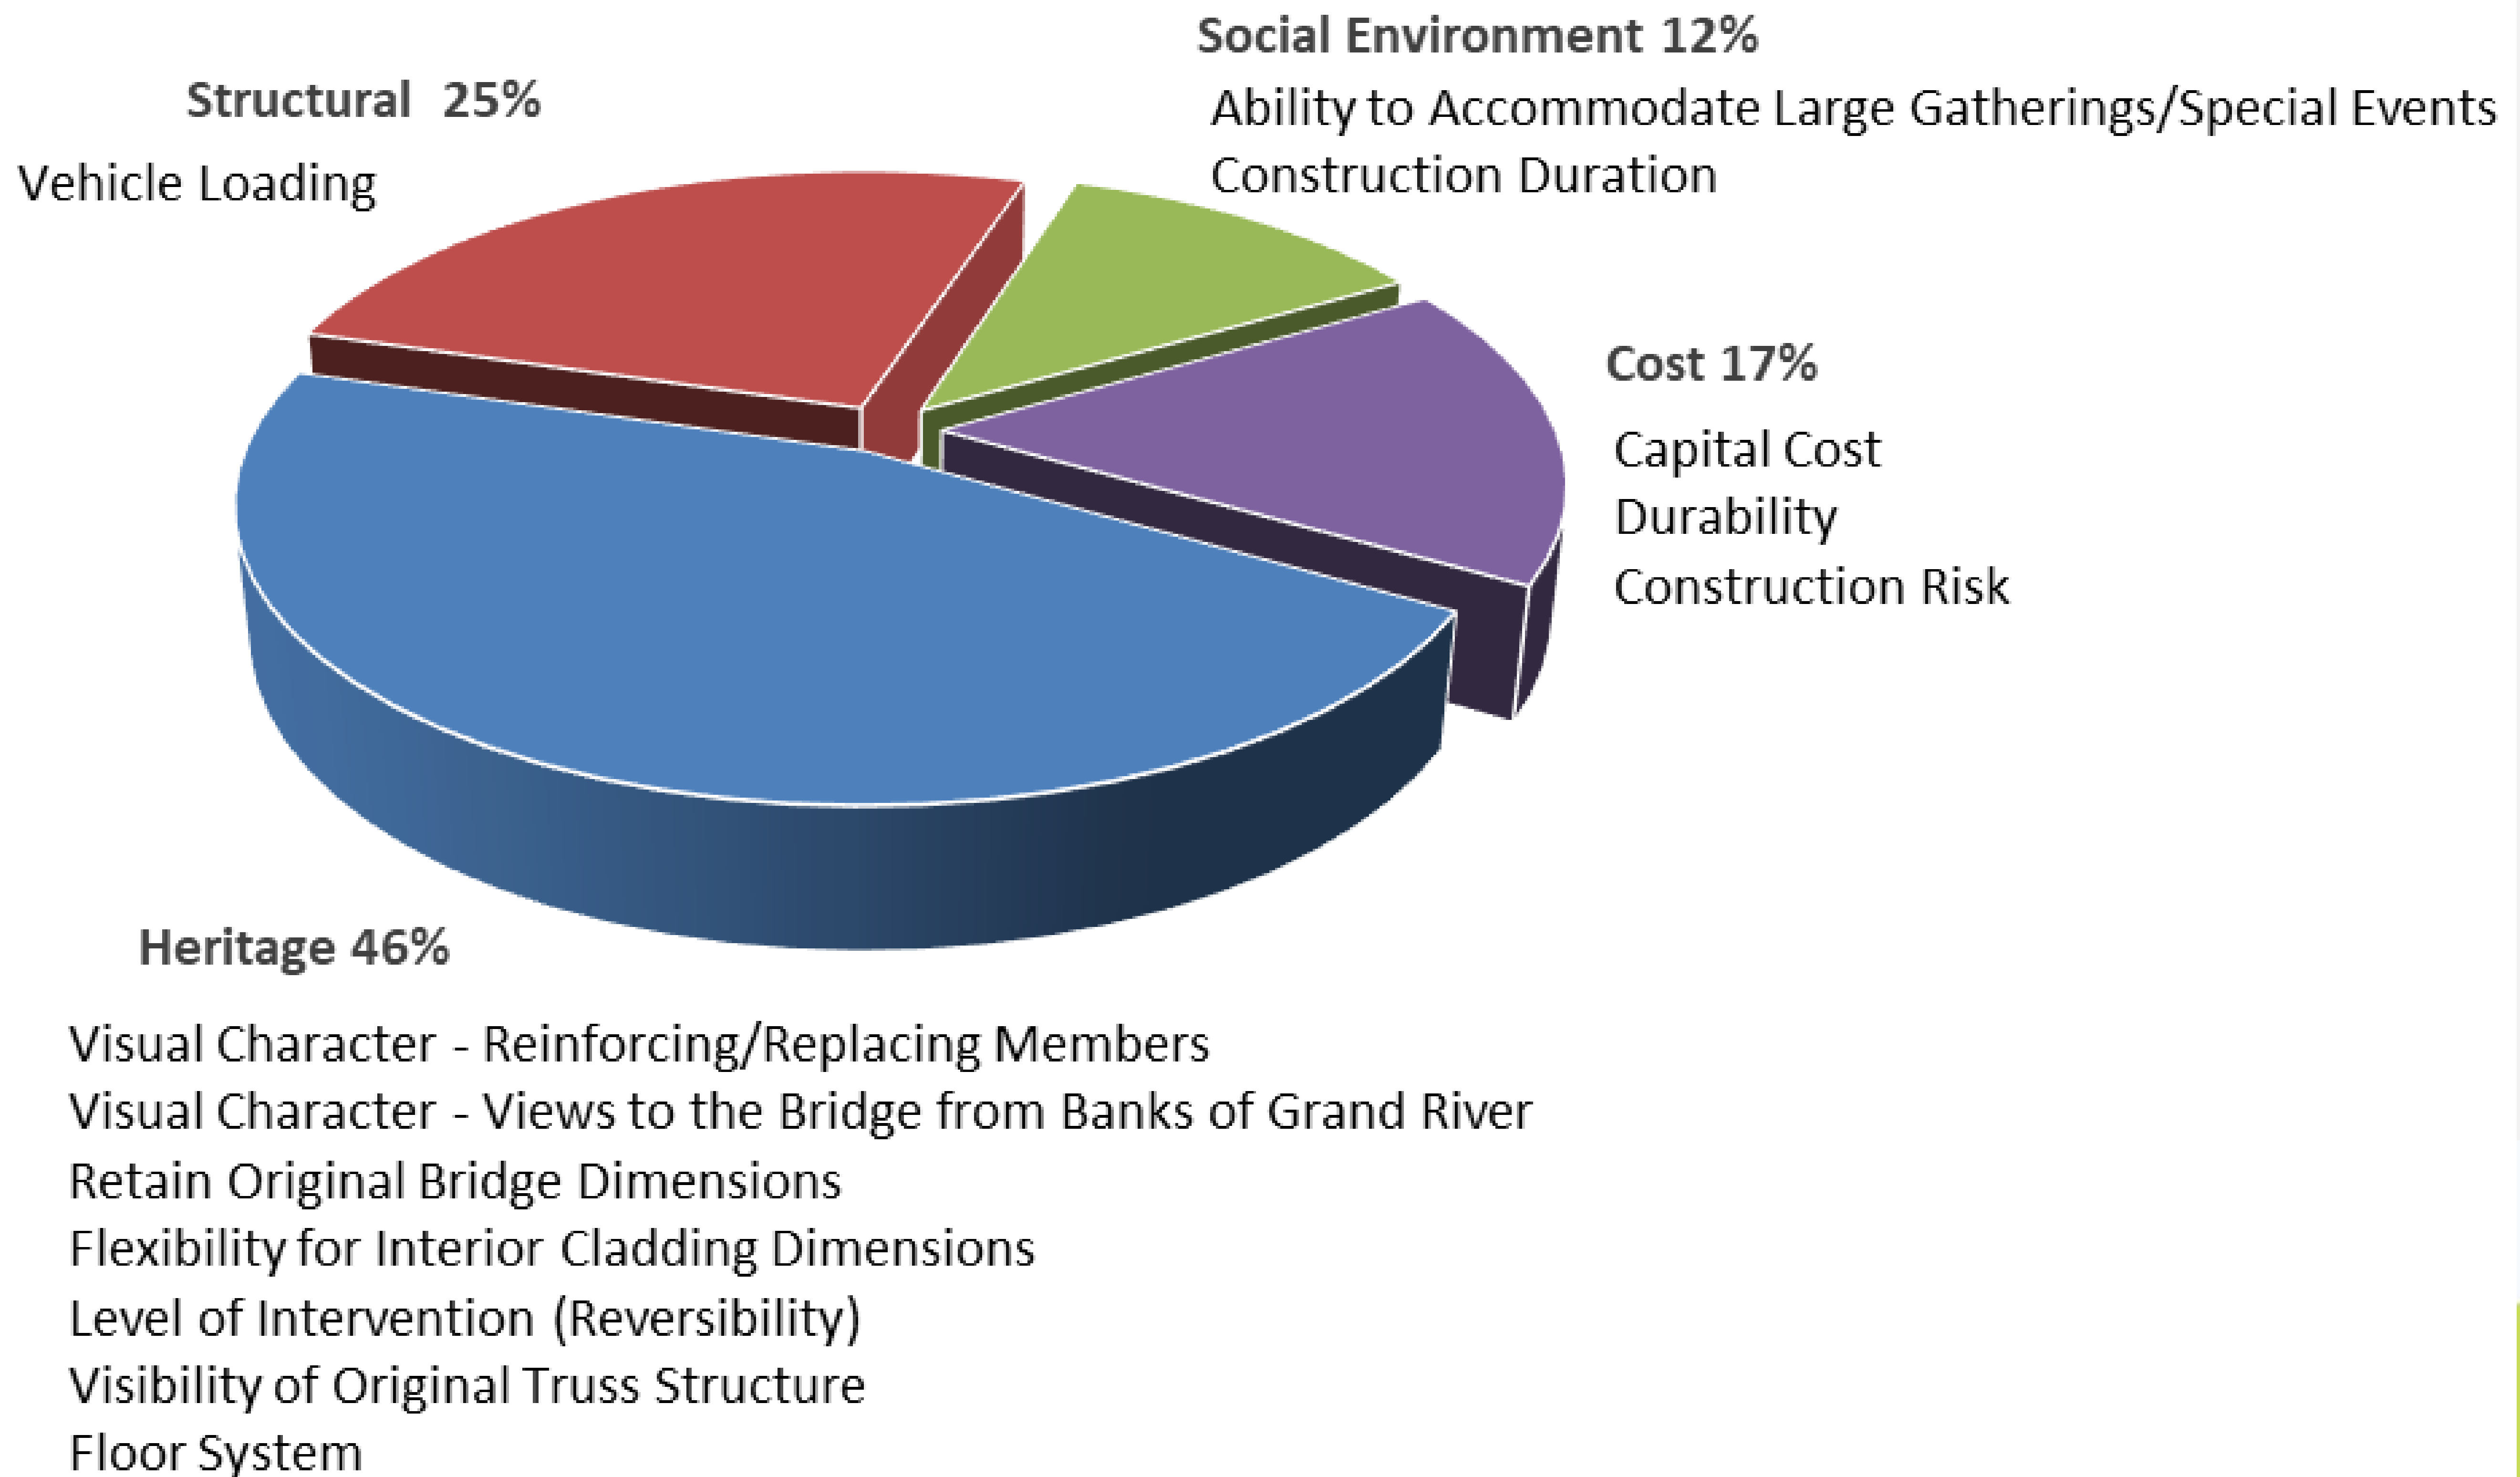
The criteria were assigned weightings in the evaluation by the Project Team:

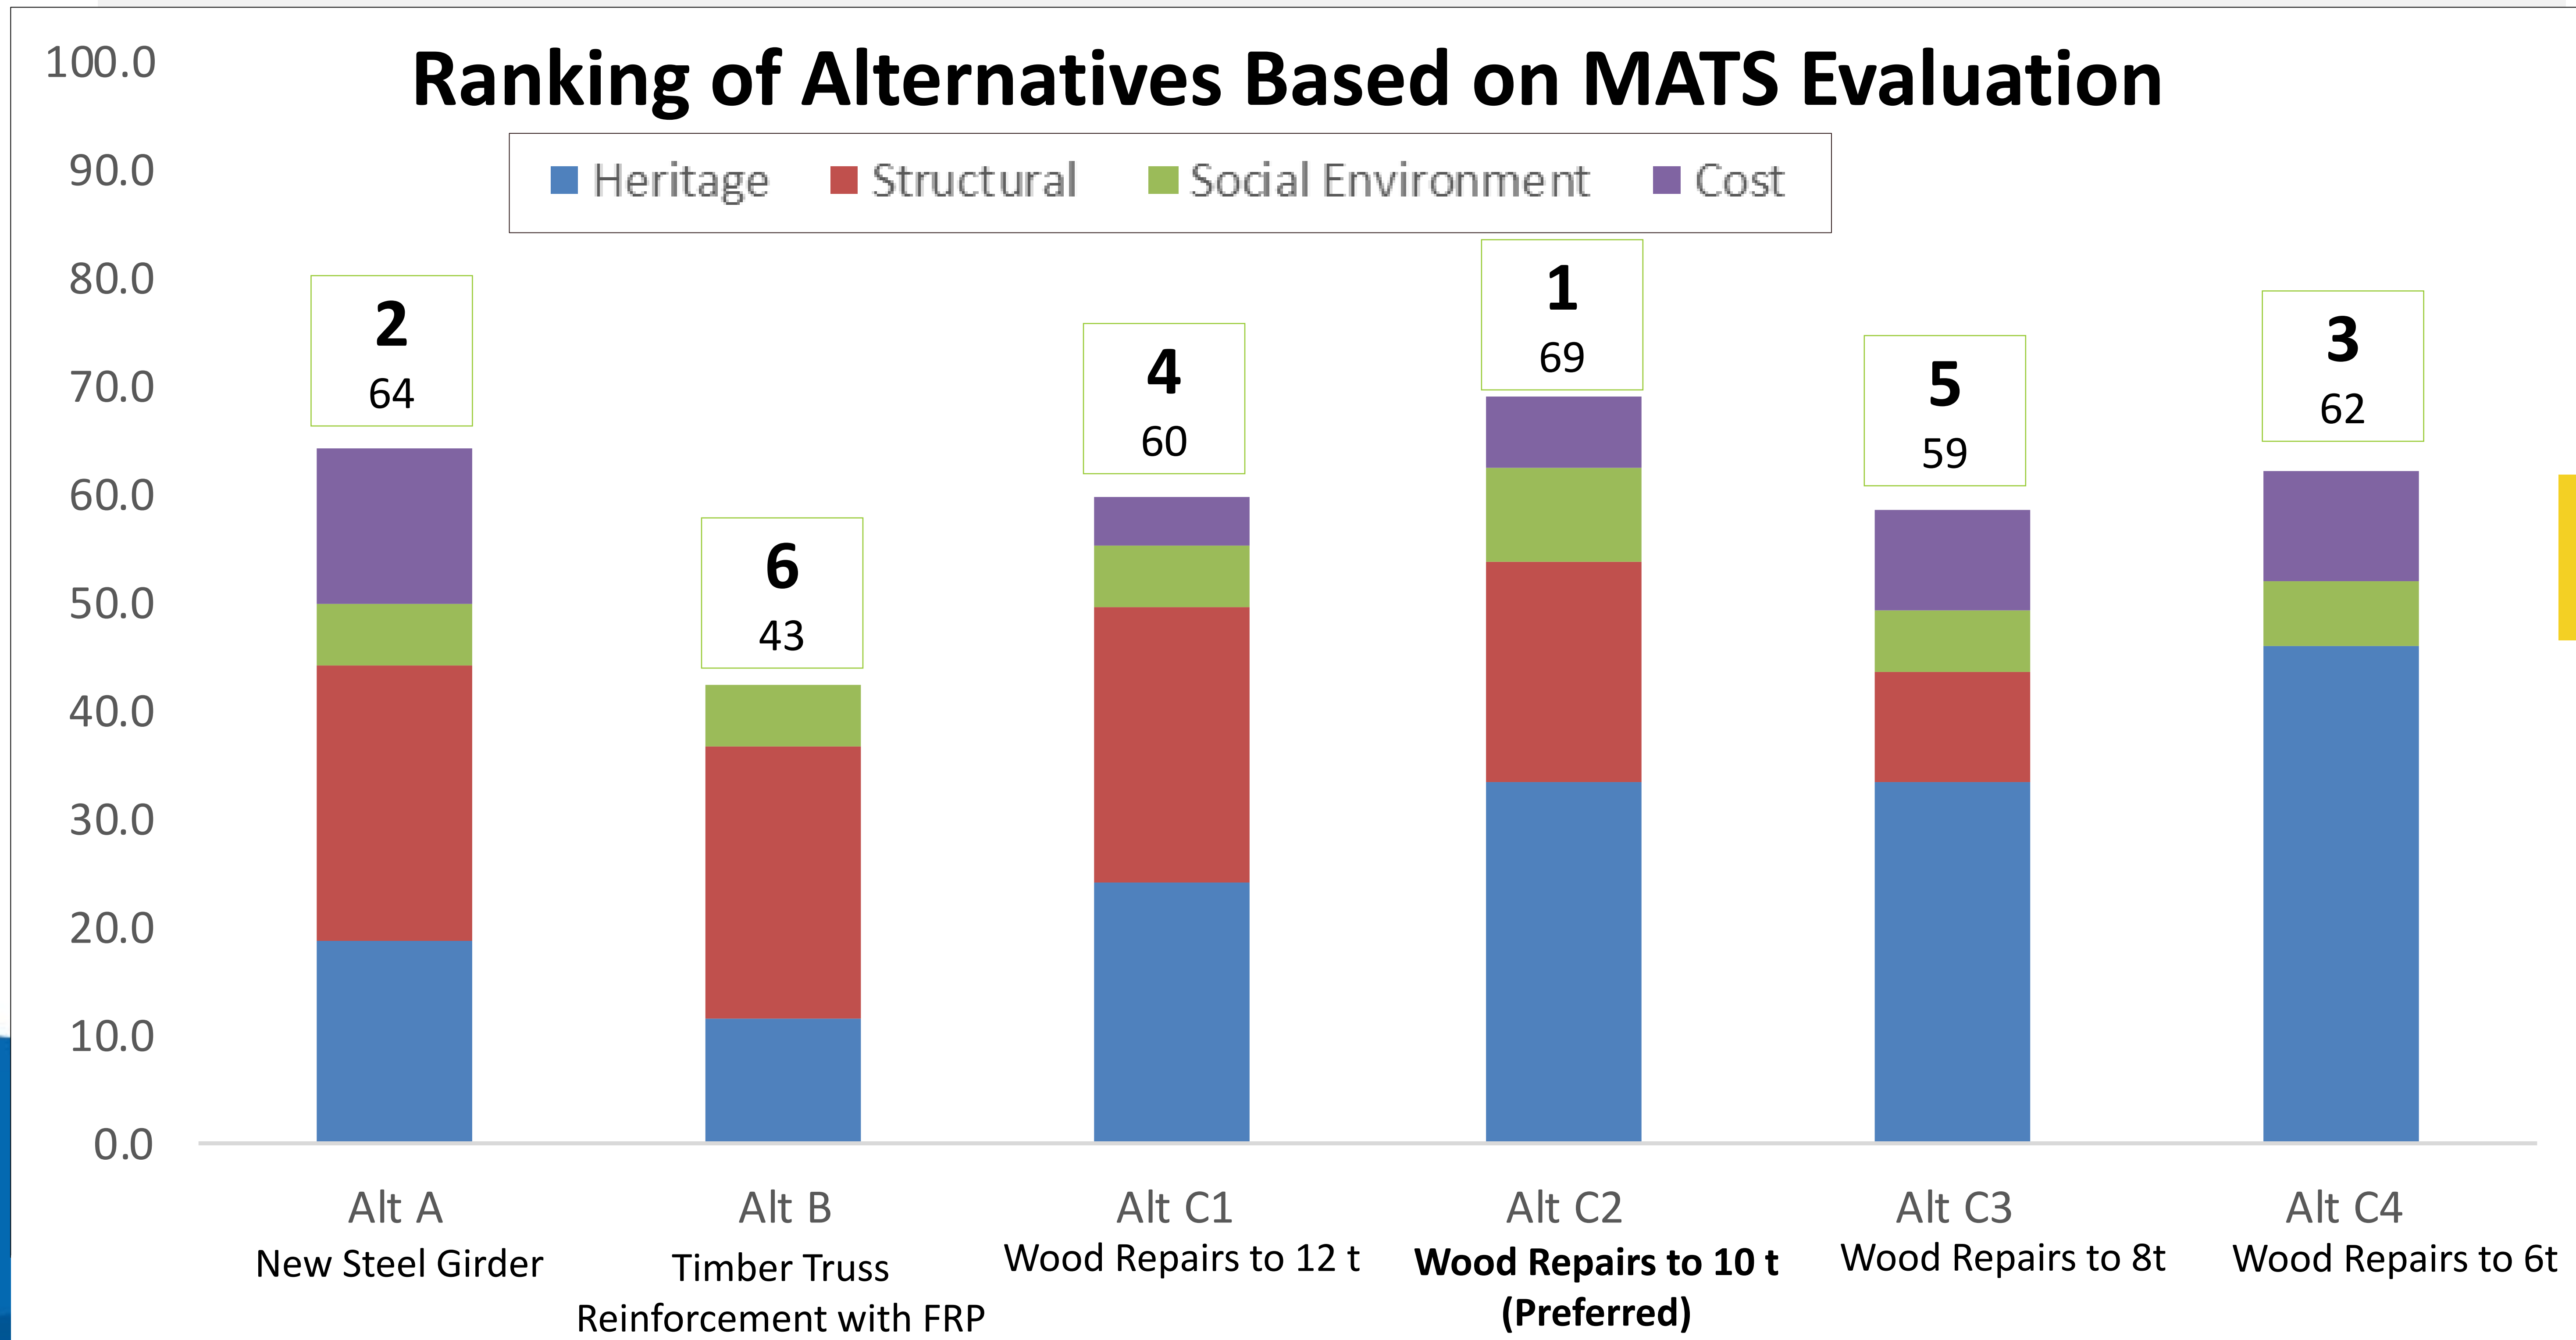
Alternative scores are determined through the use of a mathematical relationship to equate impacts to scores.

The results of the MATS evaluation are illustrated on the following exhibit.

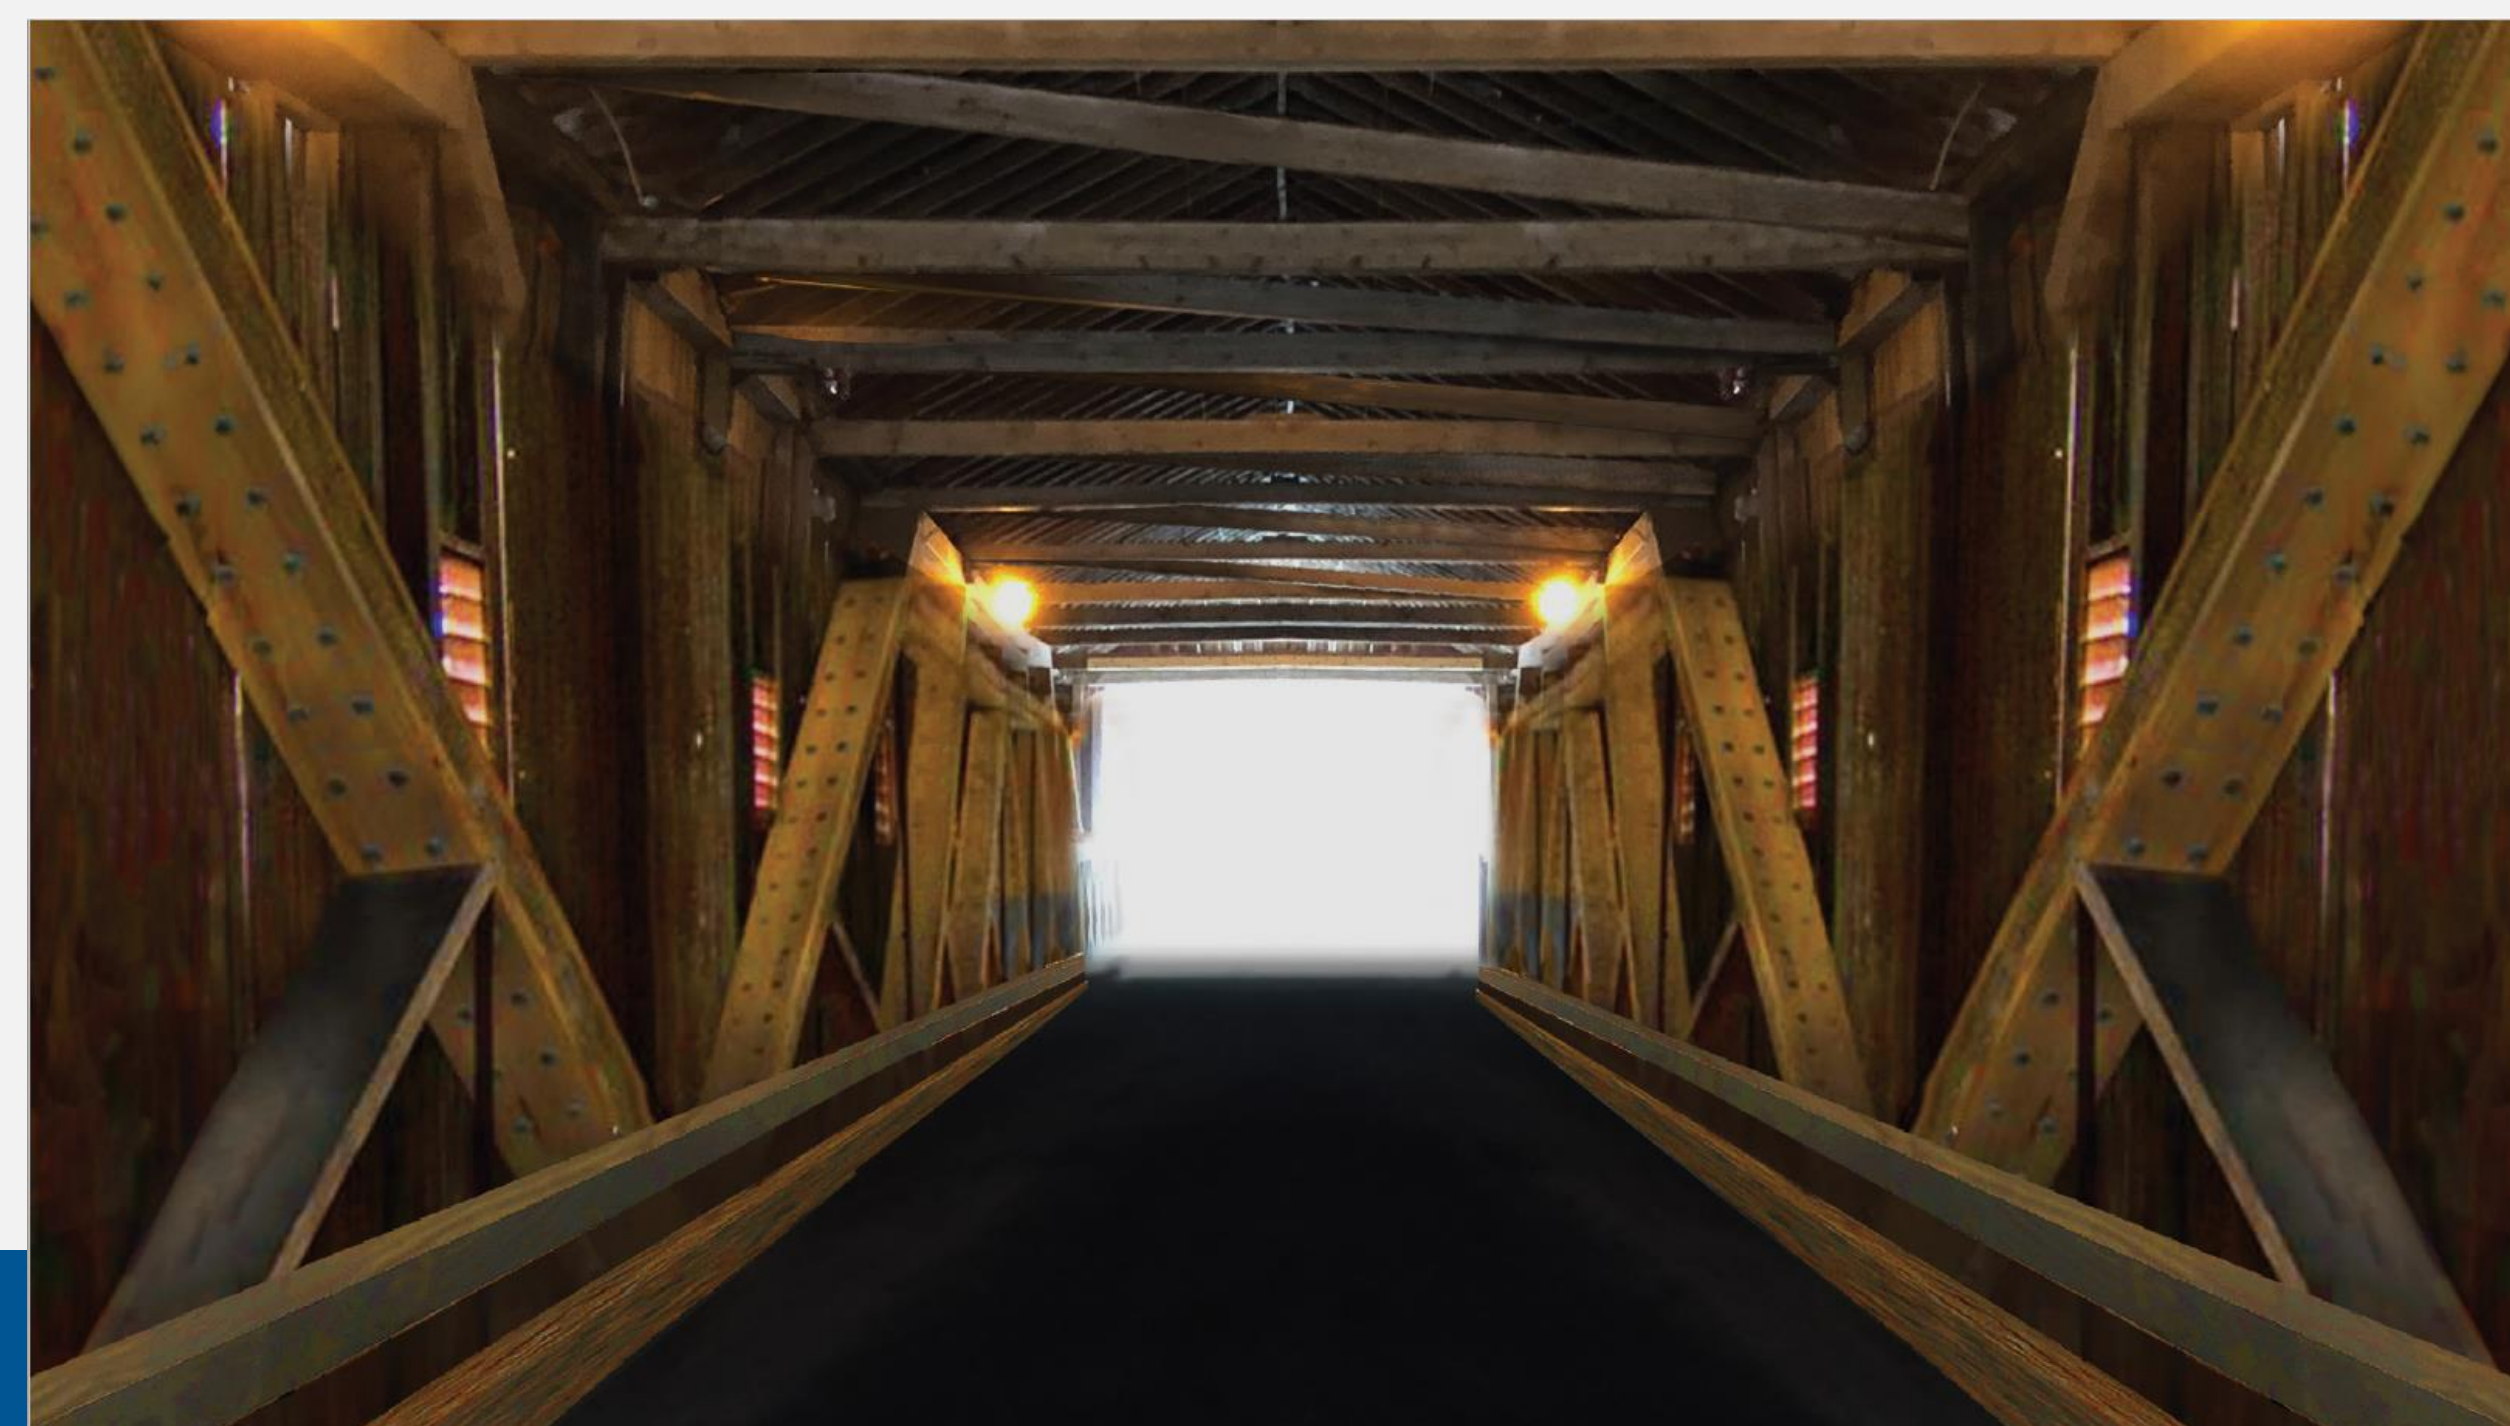
Recommended Rehabilitation Alternative

Removal of the existing Bailey truss and strengthening of the existing wooden truss to a **10 tonne design live load**, by replacing and/or strengthening specific wooden truss members, including:

- Replace floor beams and needle beams with new 16"x16" Douglas fir beams
- Replace bottom chord with new Douglas Fir members
- Make lower top chord composite with top chord by adding wood plate between top chord and lower top chord and fastening together
- Strengthen end diagonals by fastening on new 4" (89mm) thick wood planks
- Remove interior cladding and reinstate in short sections in each corner
