**Township of Woolwich
Heritage Committee
Agenda**

West Montrose Covered Bridge Rehabilitation

Township of Woolwich Heritage Committee Meeting

Project Purpose

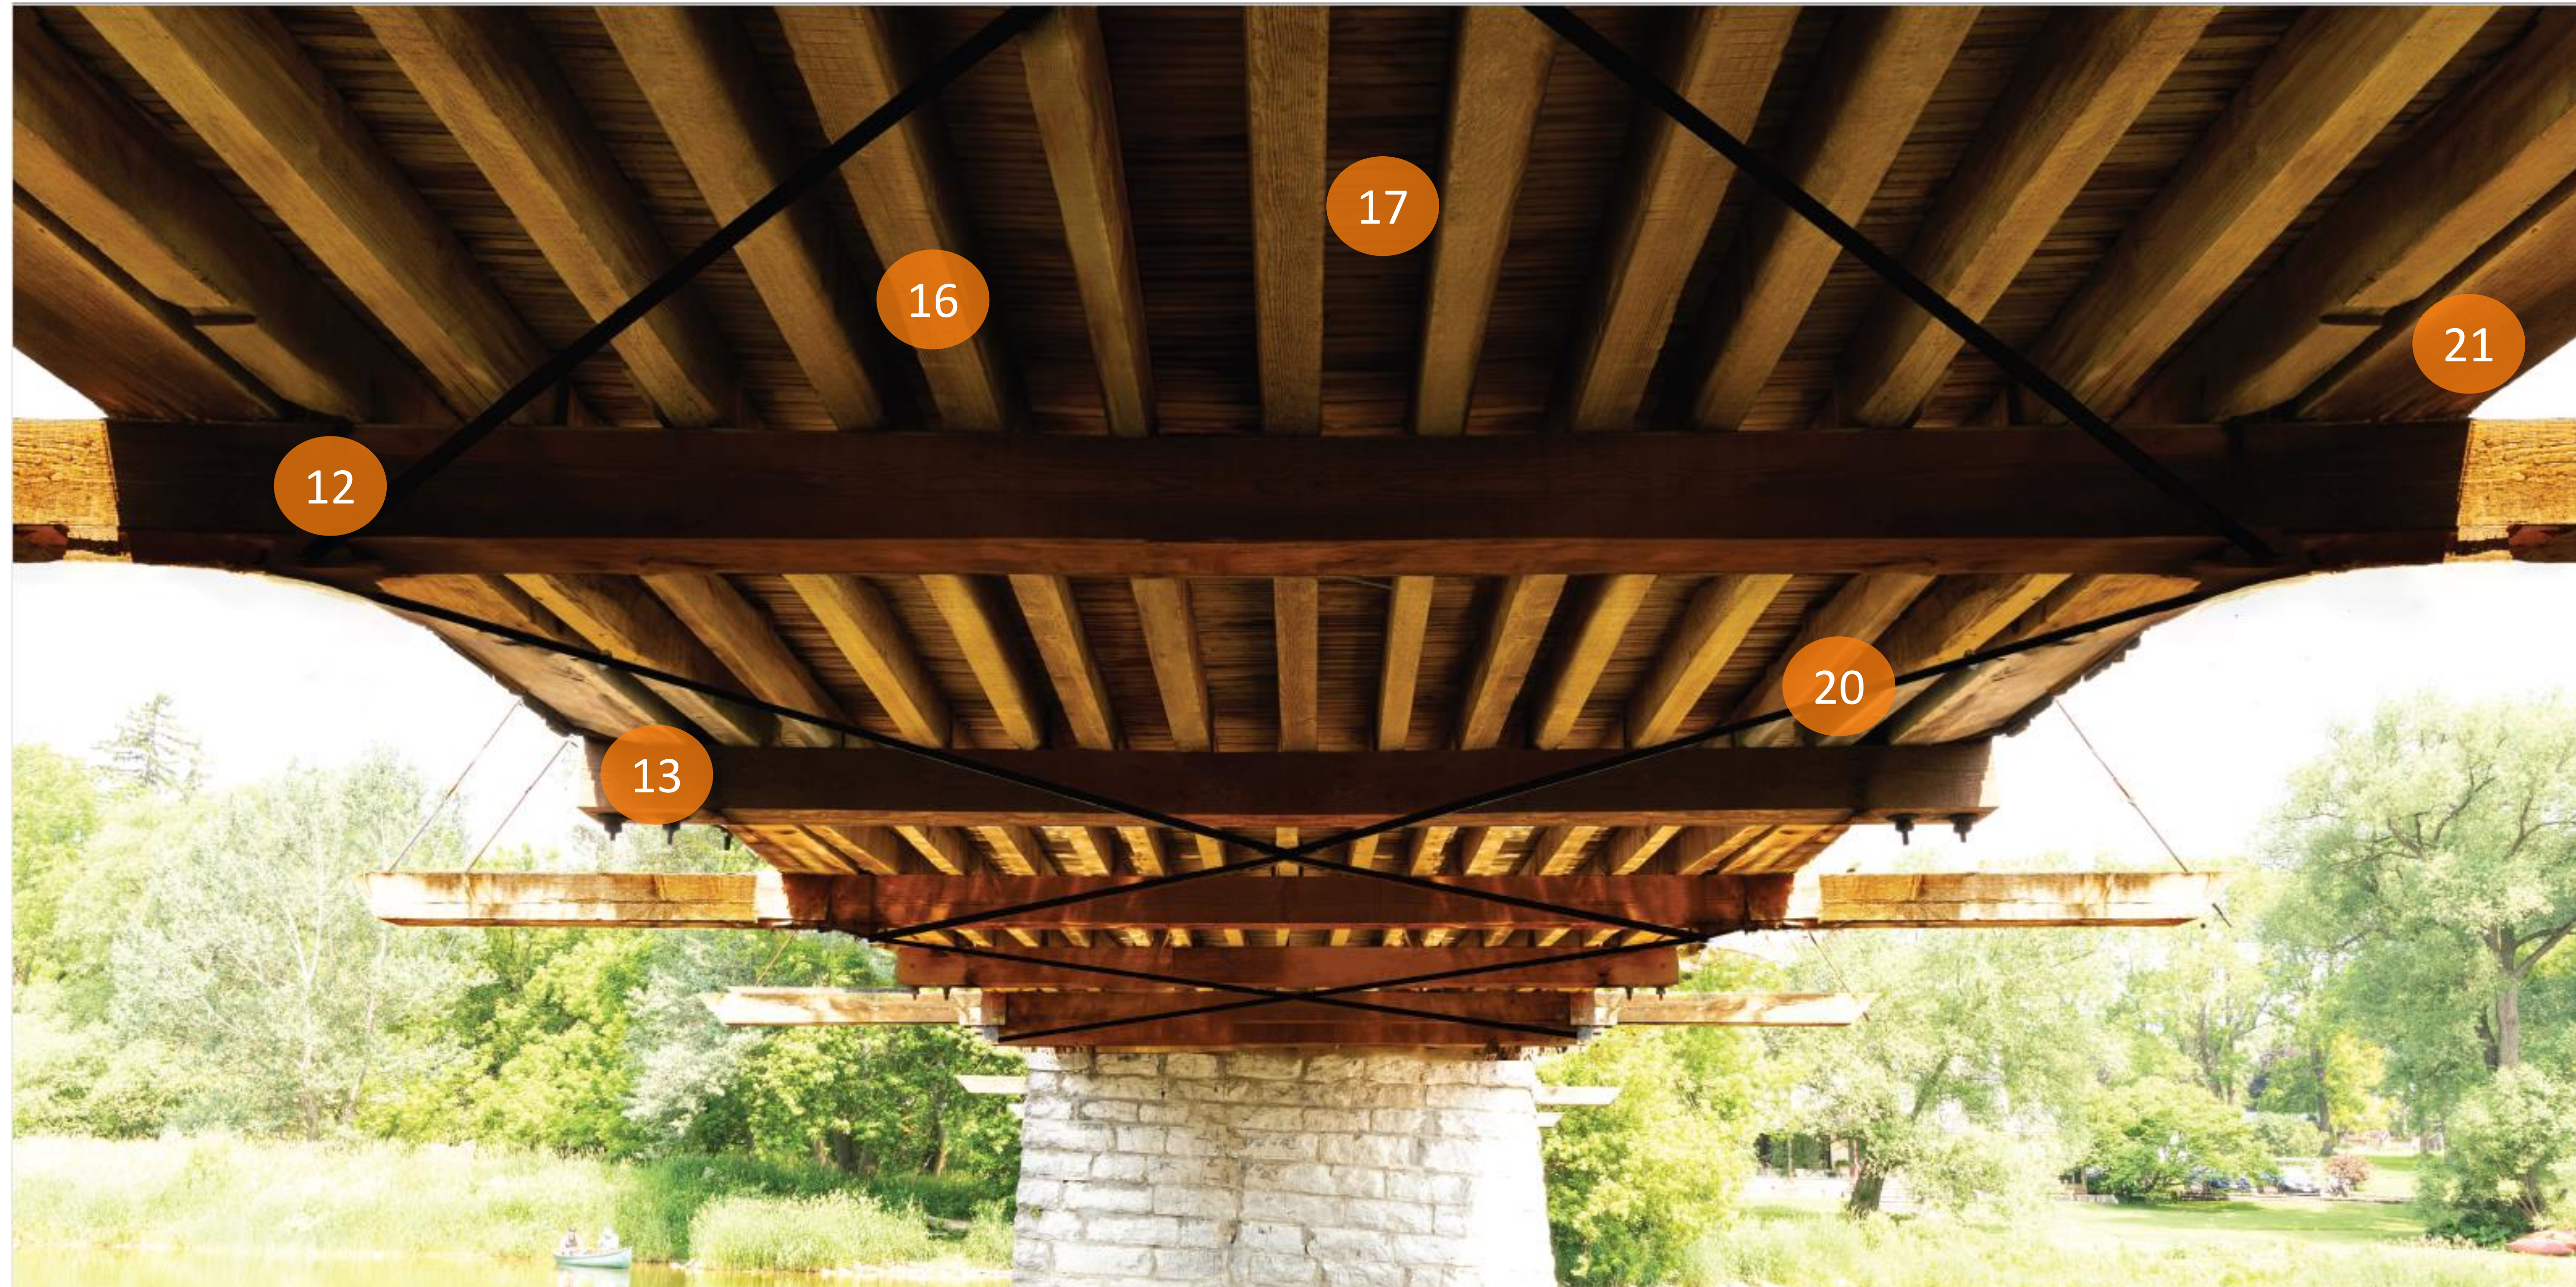
- 12 New Douglas Fir 16"x16" needle beams
- 13 New Douglas Fir 16"x16" floor beams
- 16 New sawn wood stringers
- 17 New nail-laminated wood deck
- 20 New steel rod cross-bracing
- 21 New Douglas Fir bottom chord member

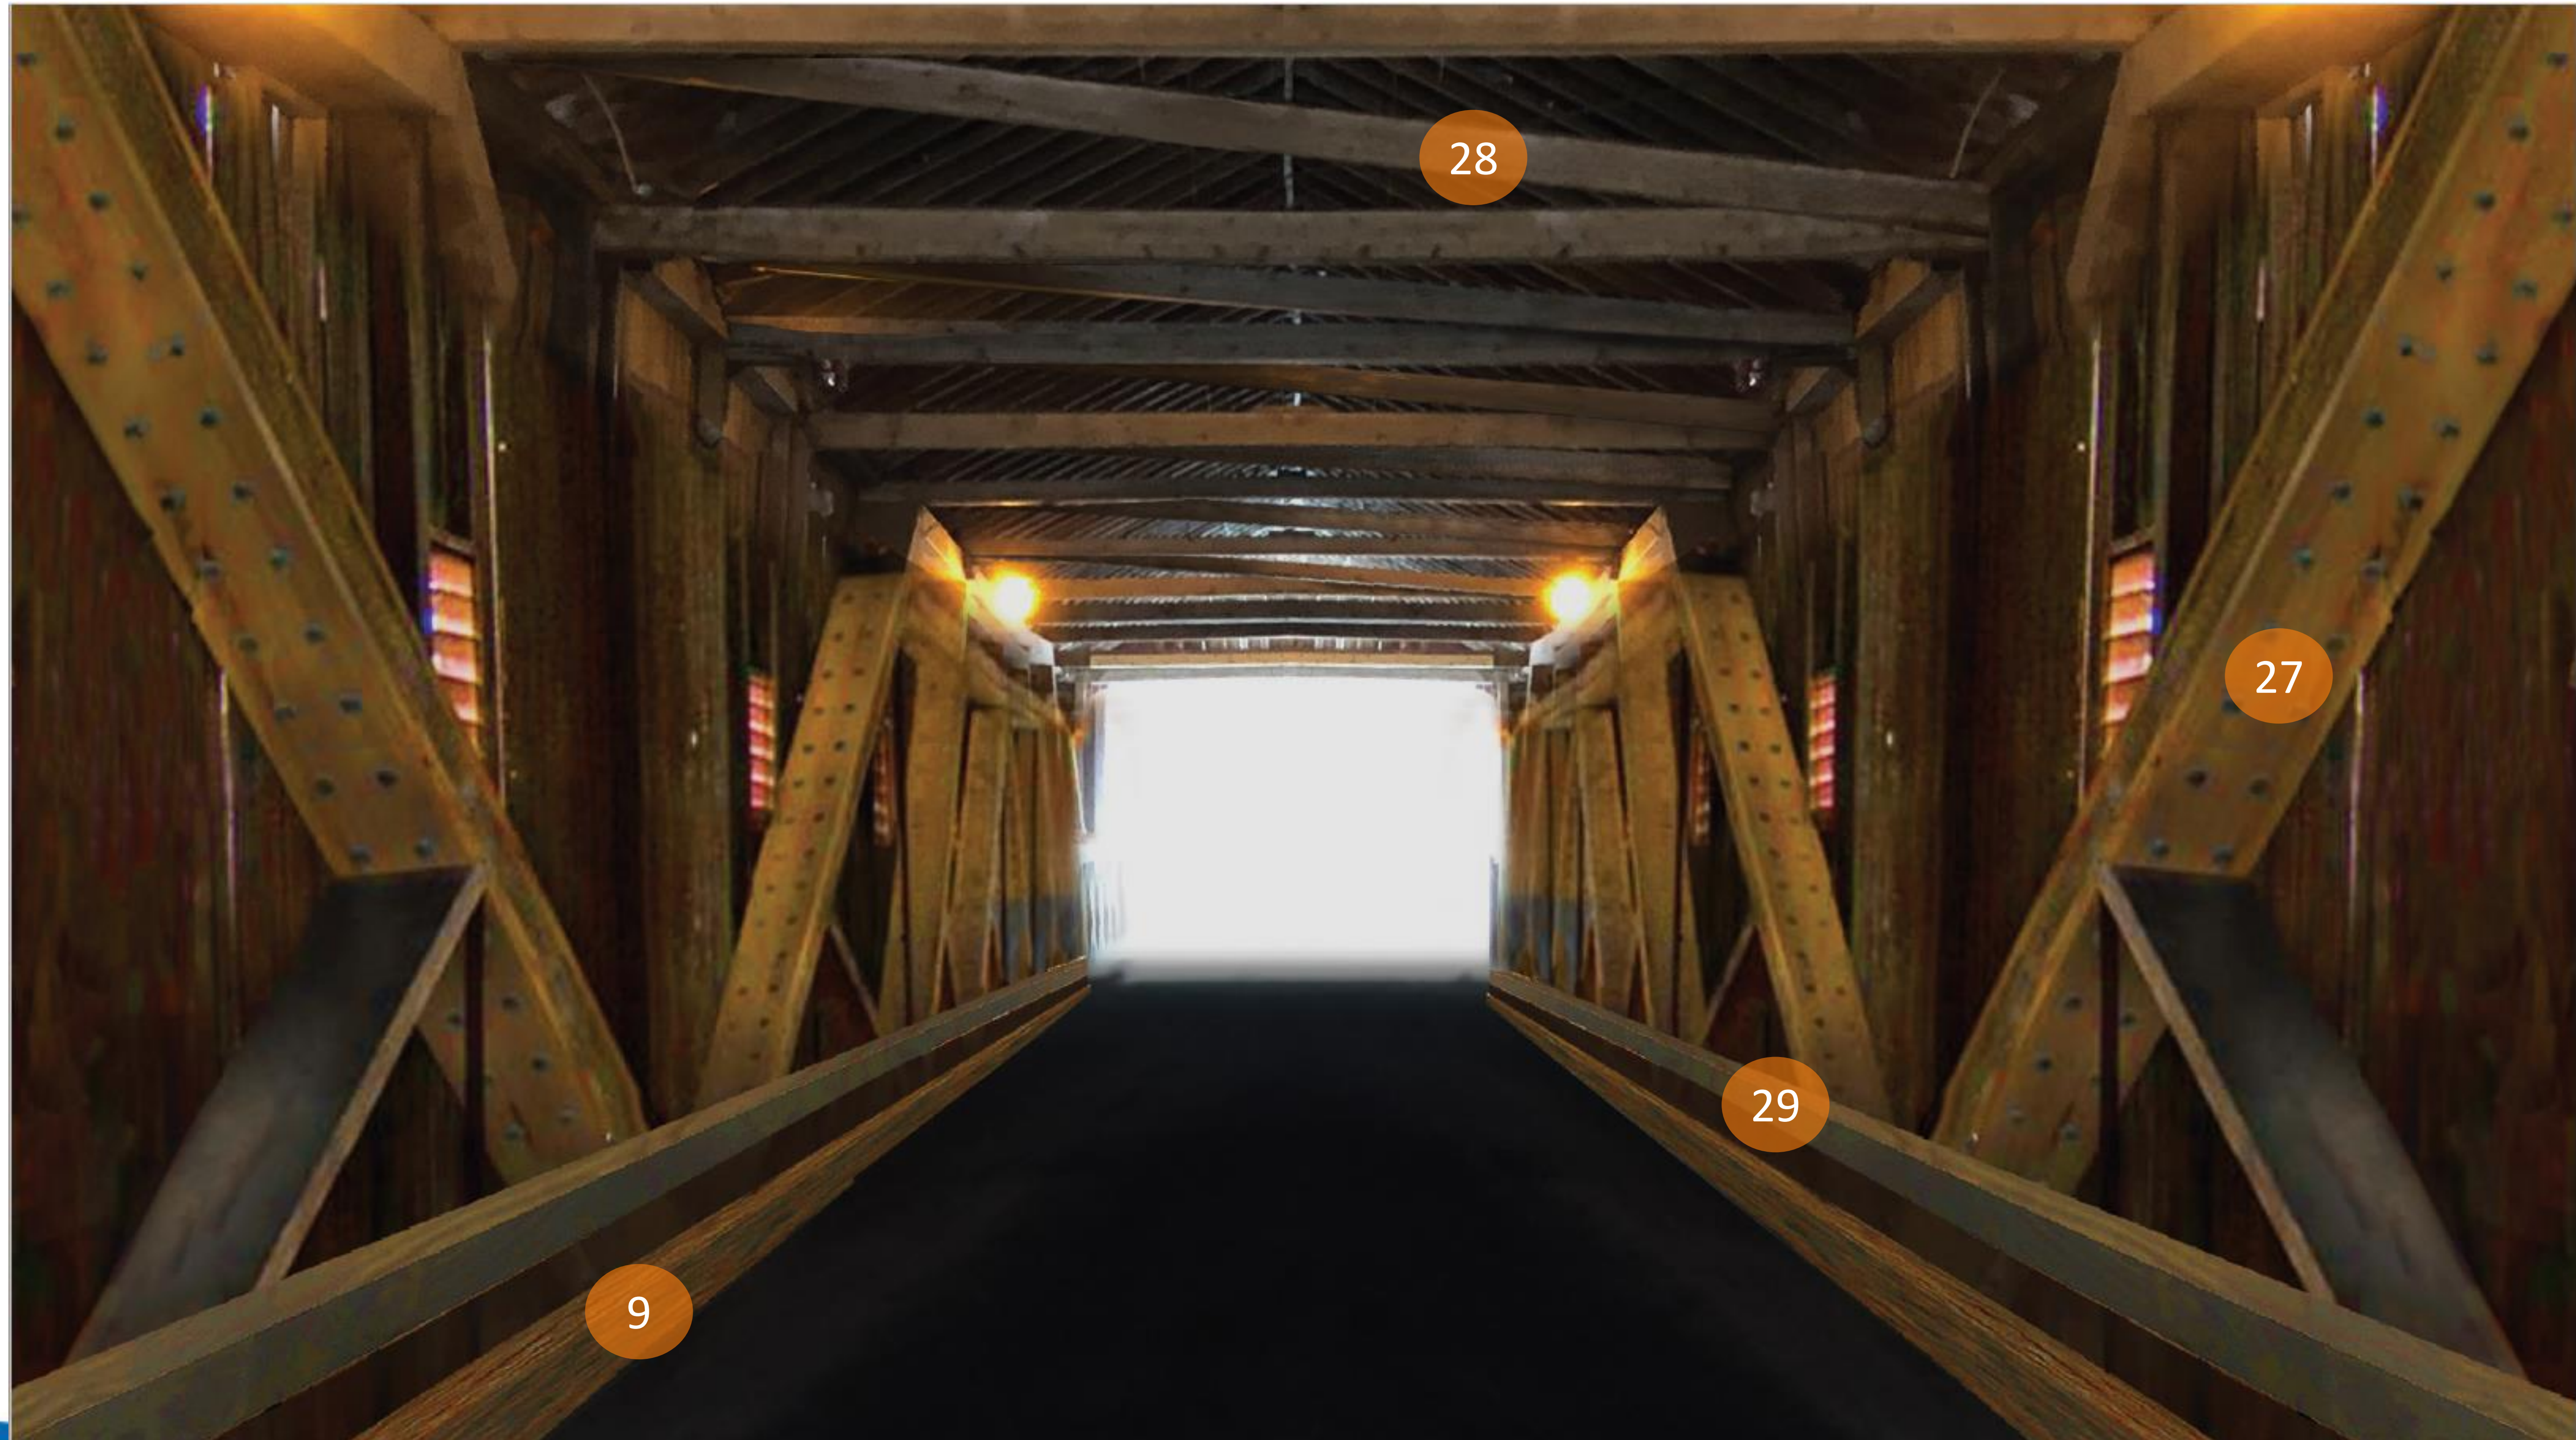
9 New wood curbs

27 Strengthen end diagonals

28 New overhead wood lateral bracing

29 New timber guiderail

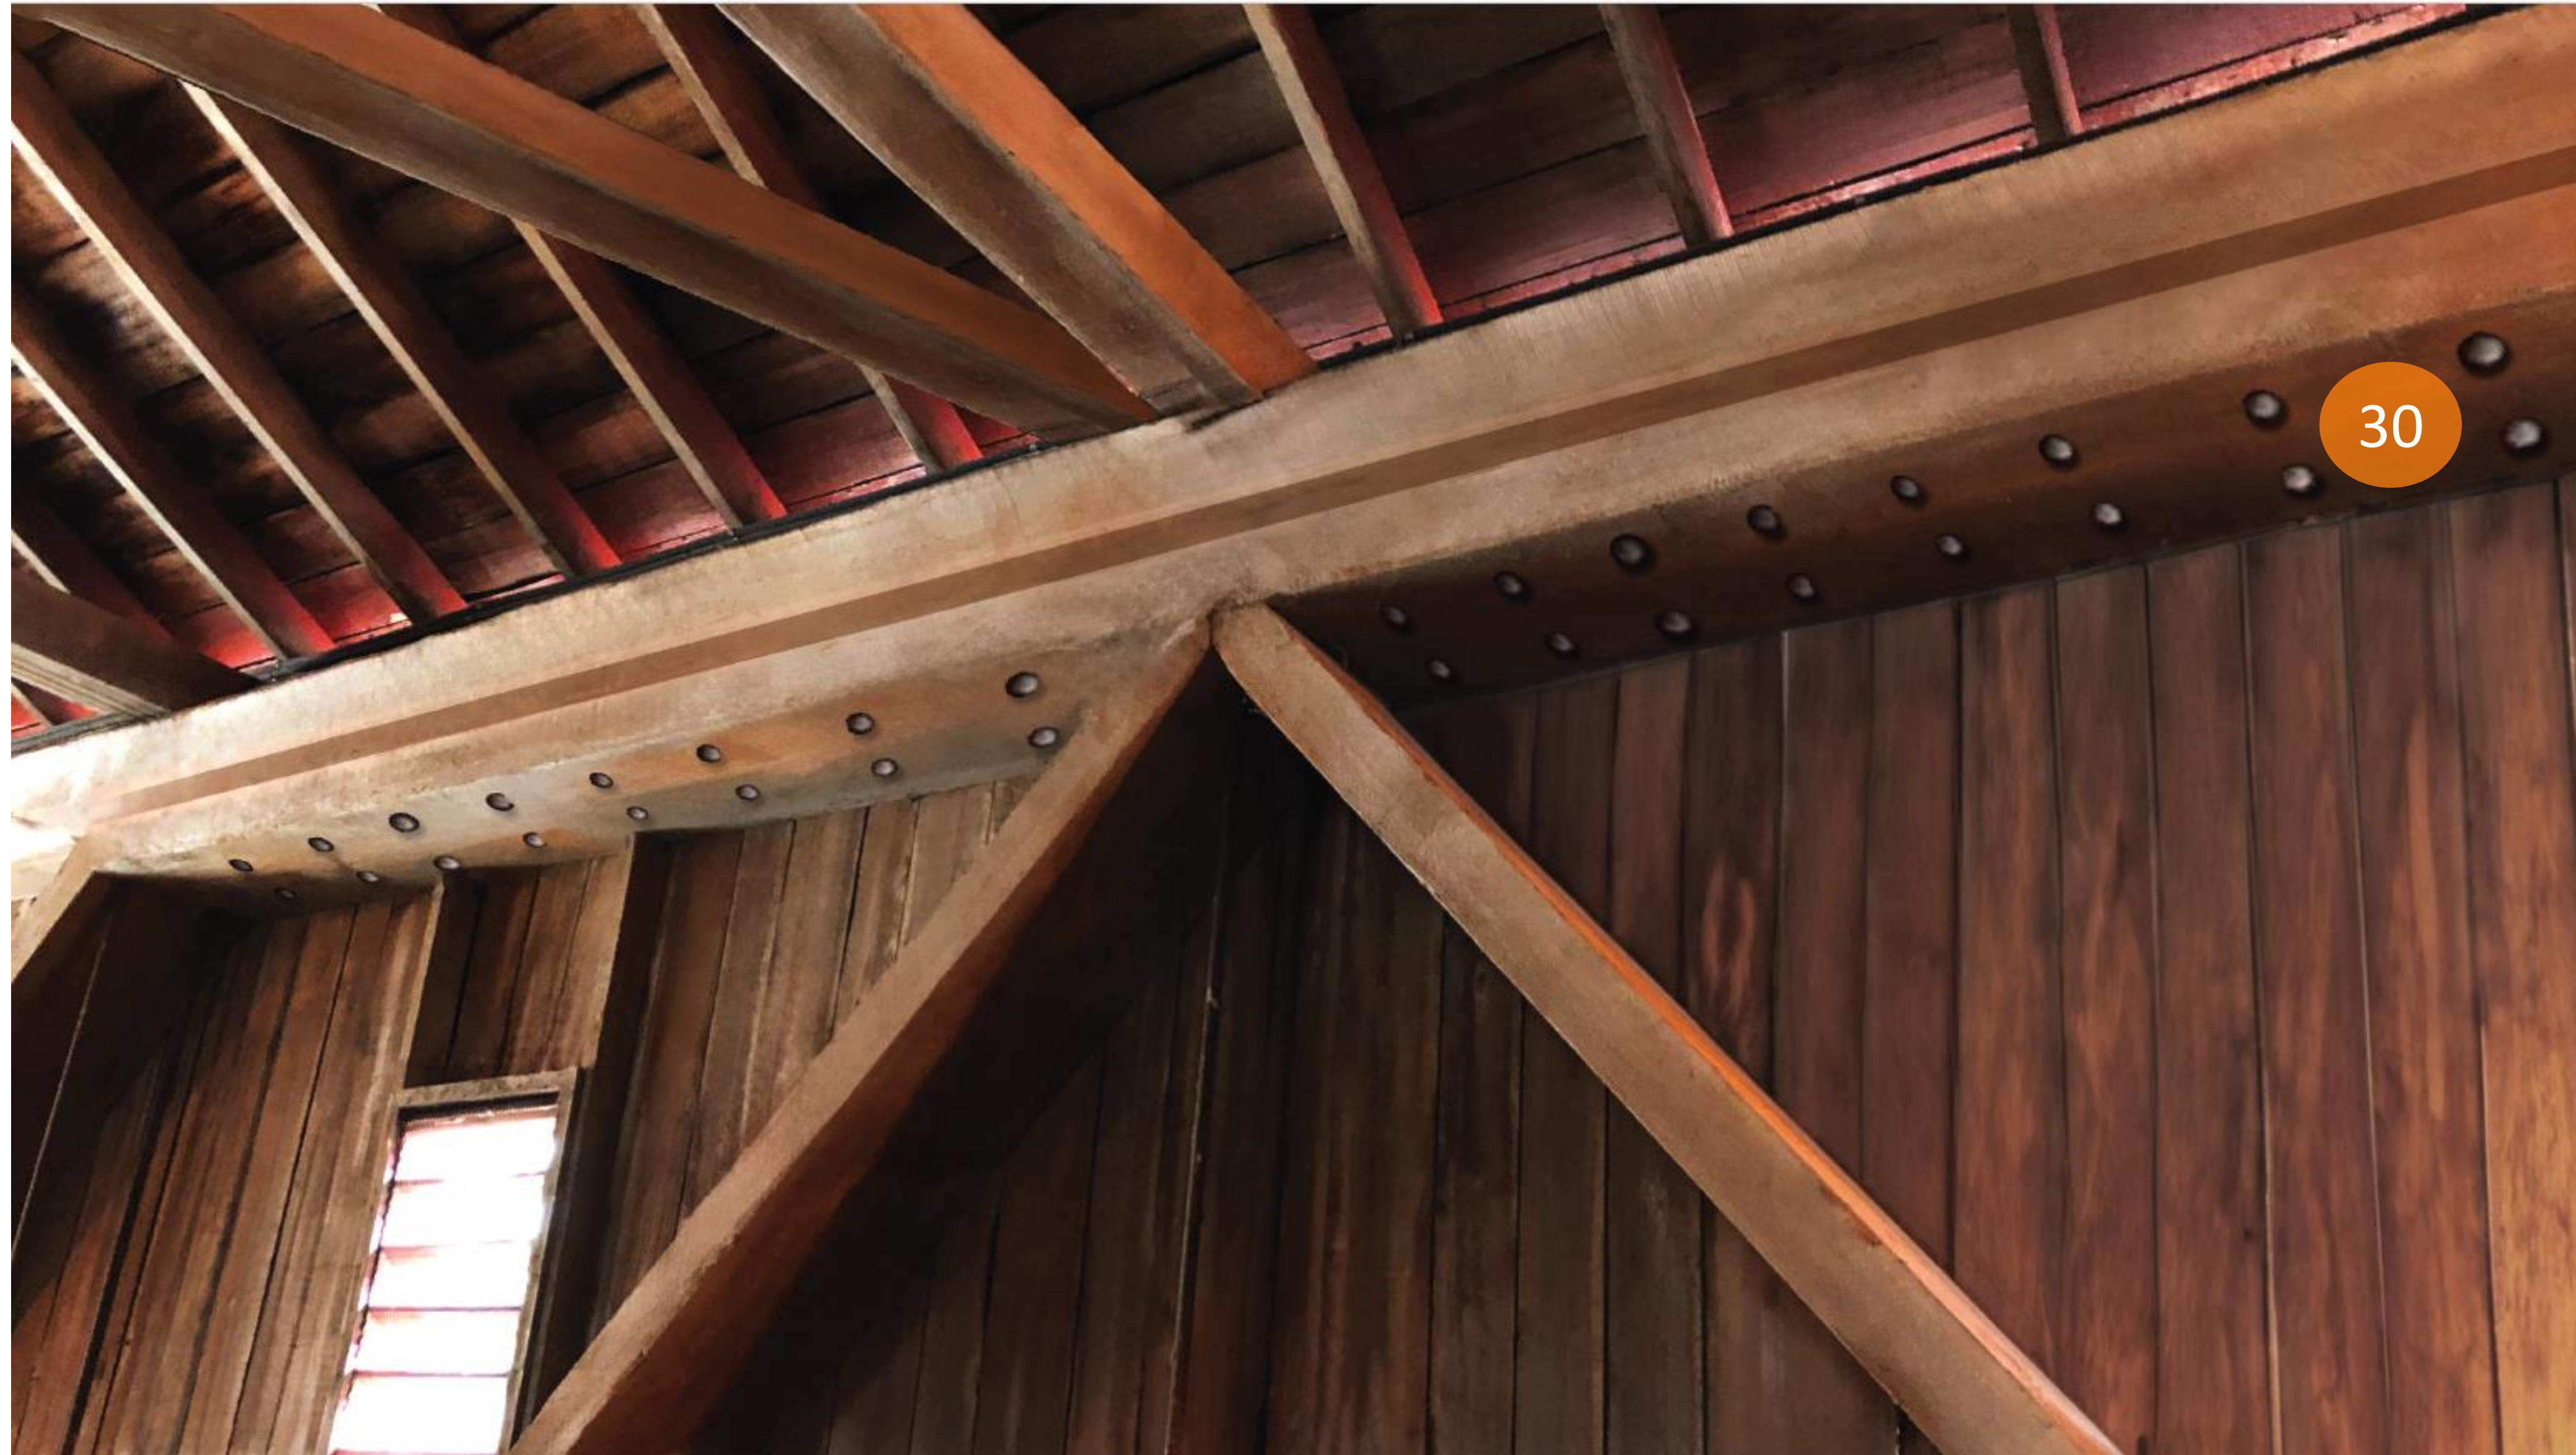
30 Reinforce top chord with lower top chord

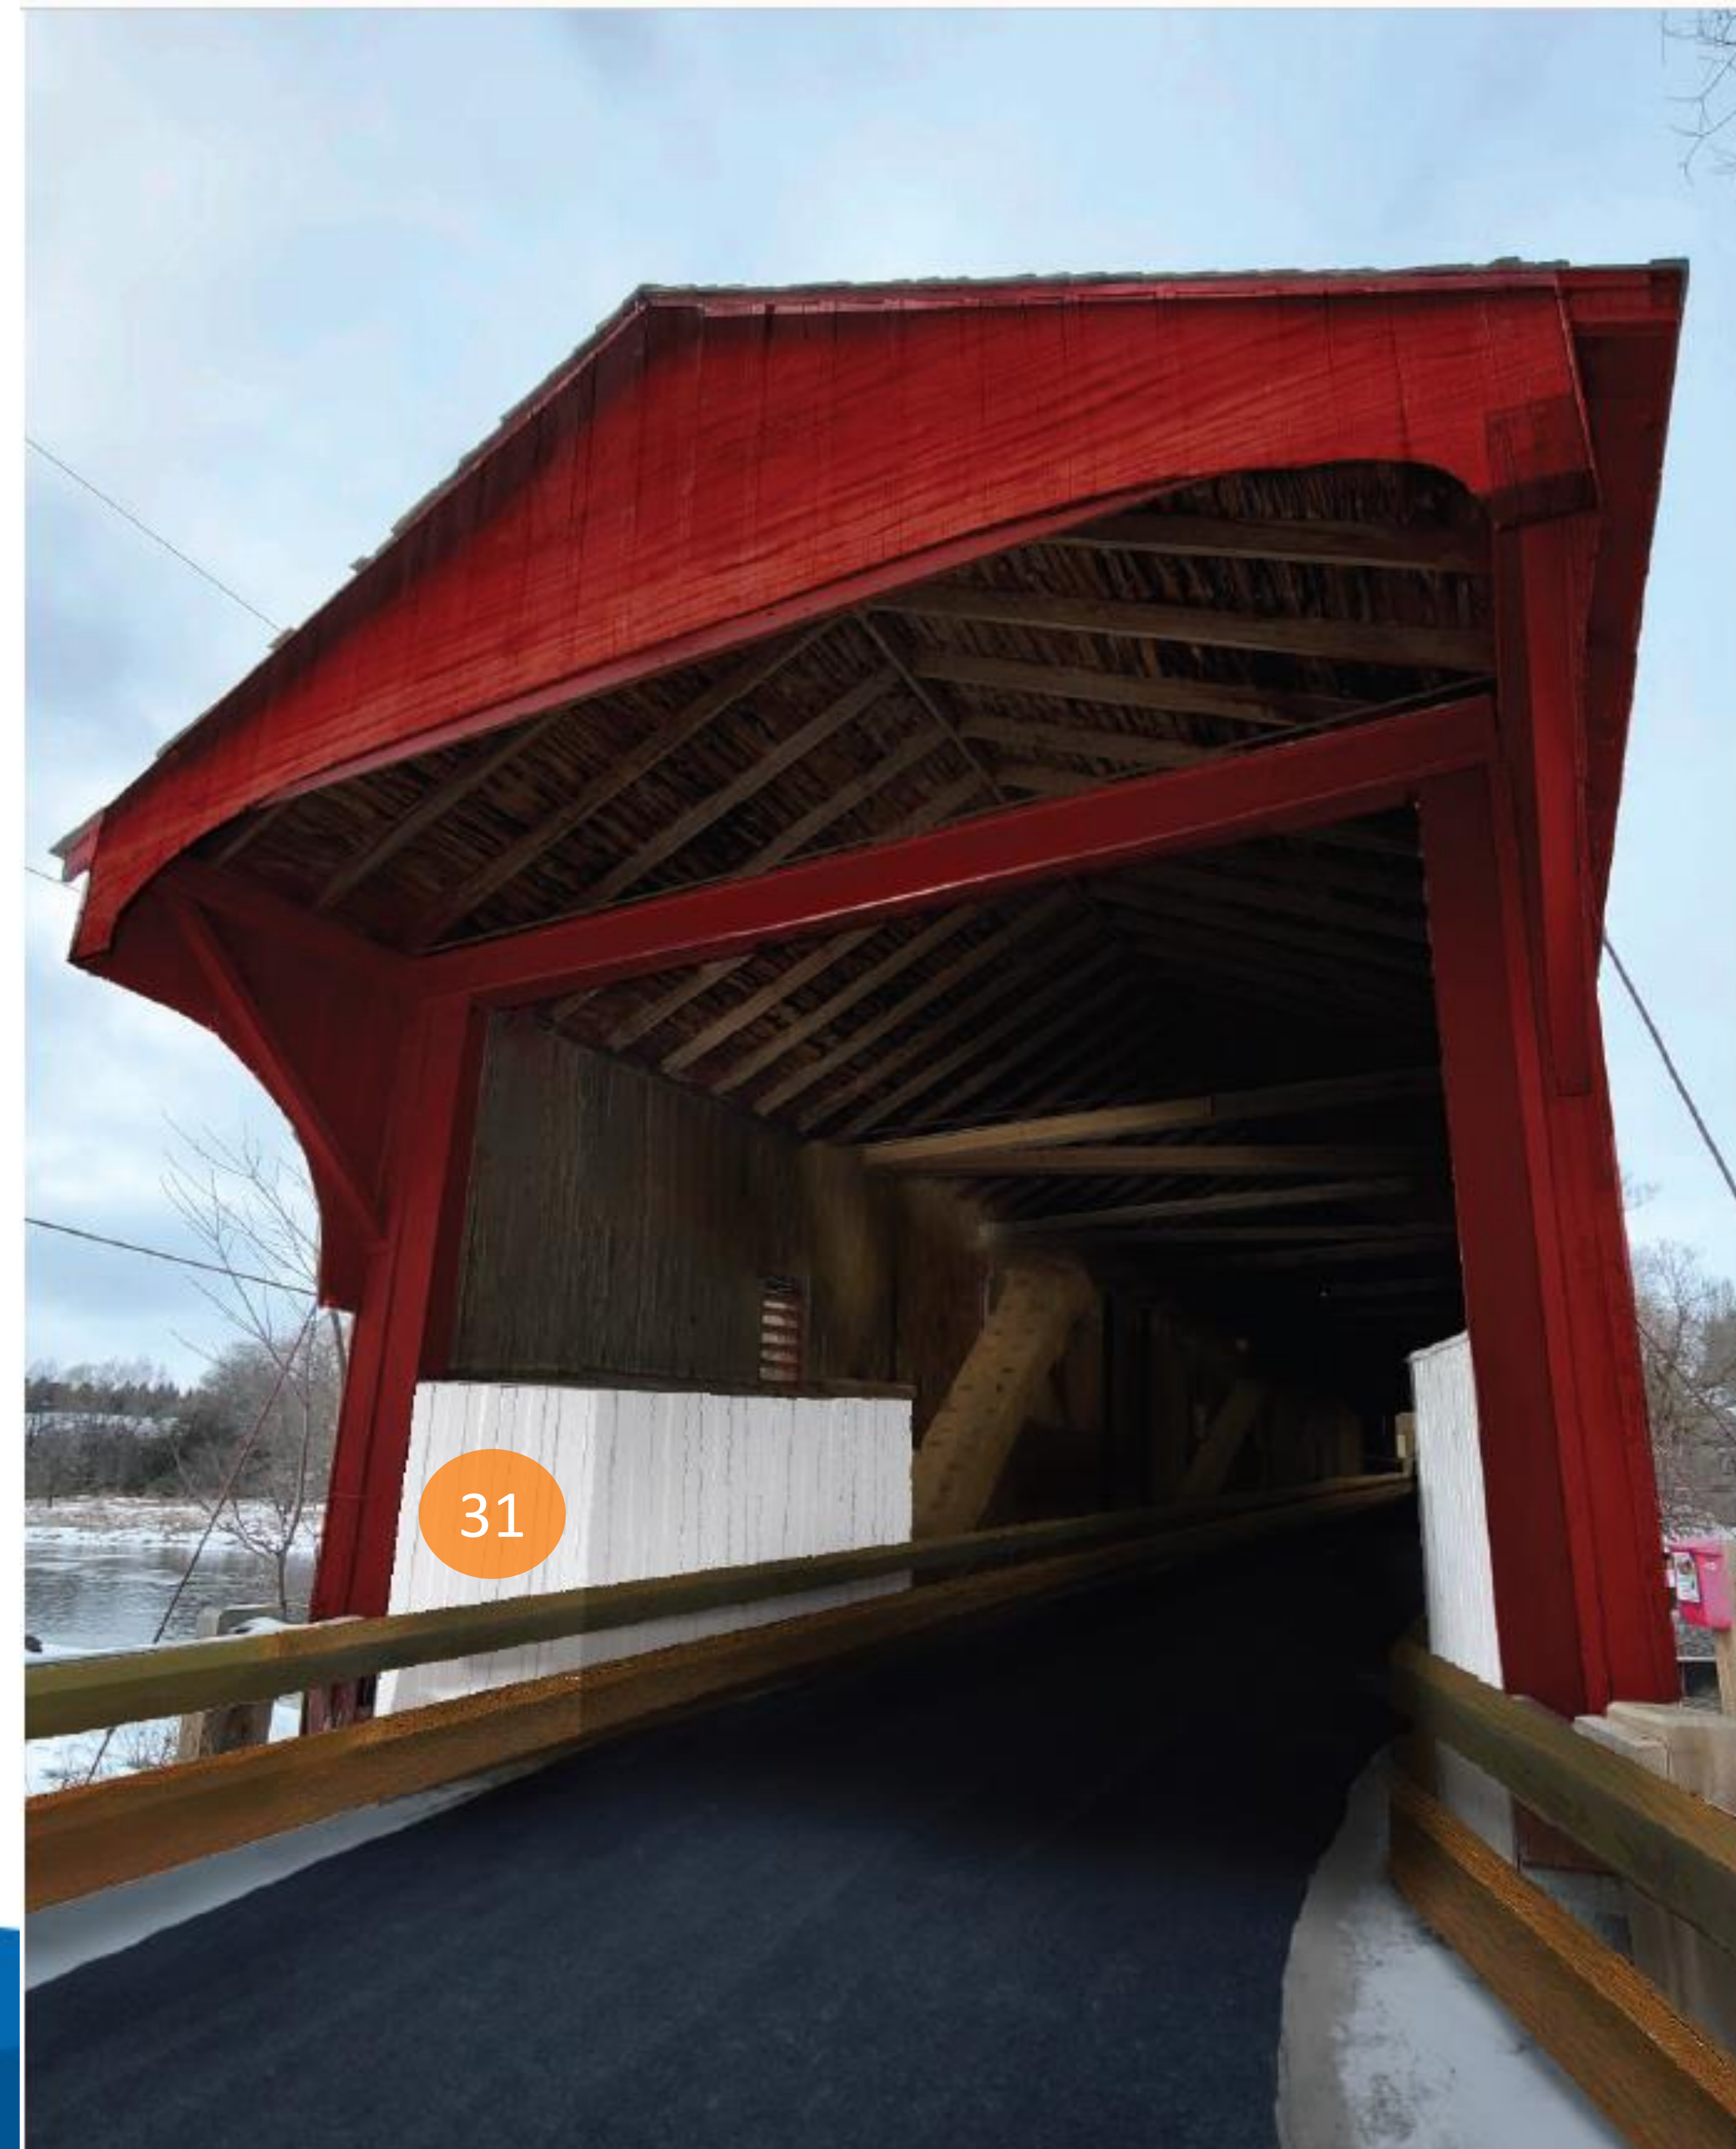
Recommended Rehabilitation Alternative – Interior Cladding

31 Reinstate interior cladding in short sections at each end of the bridge

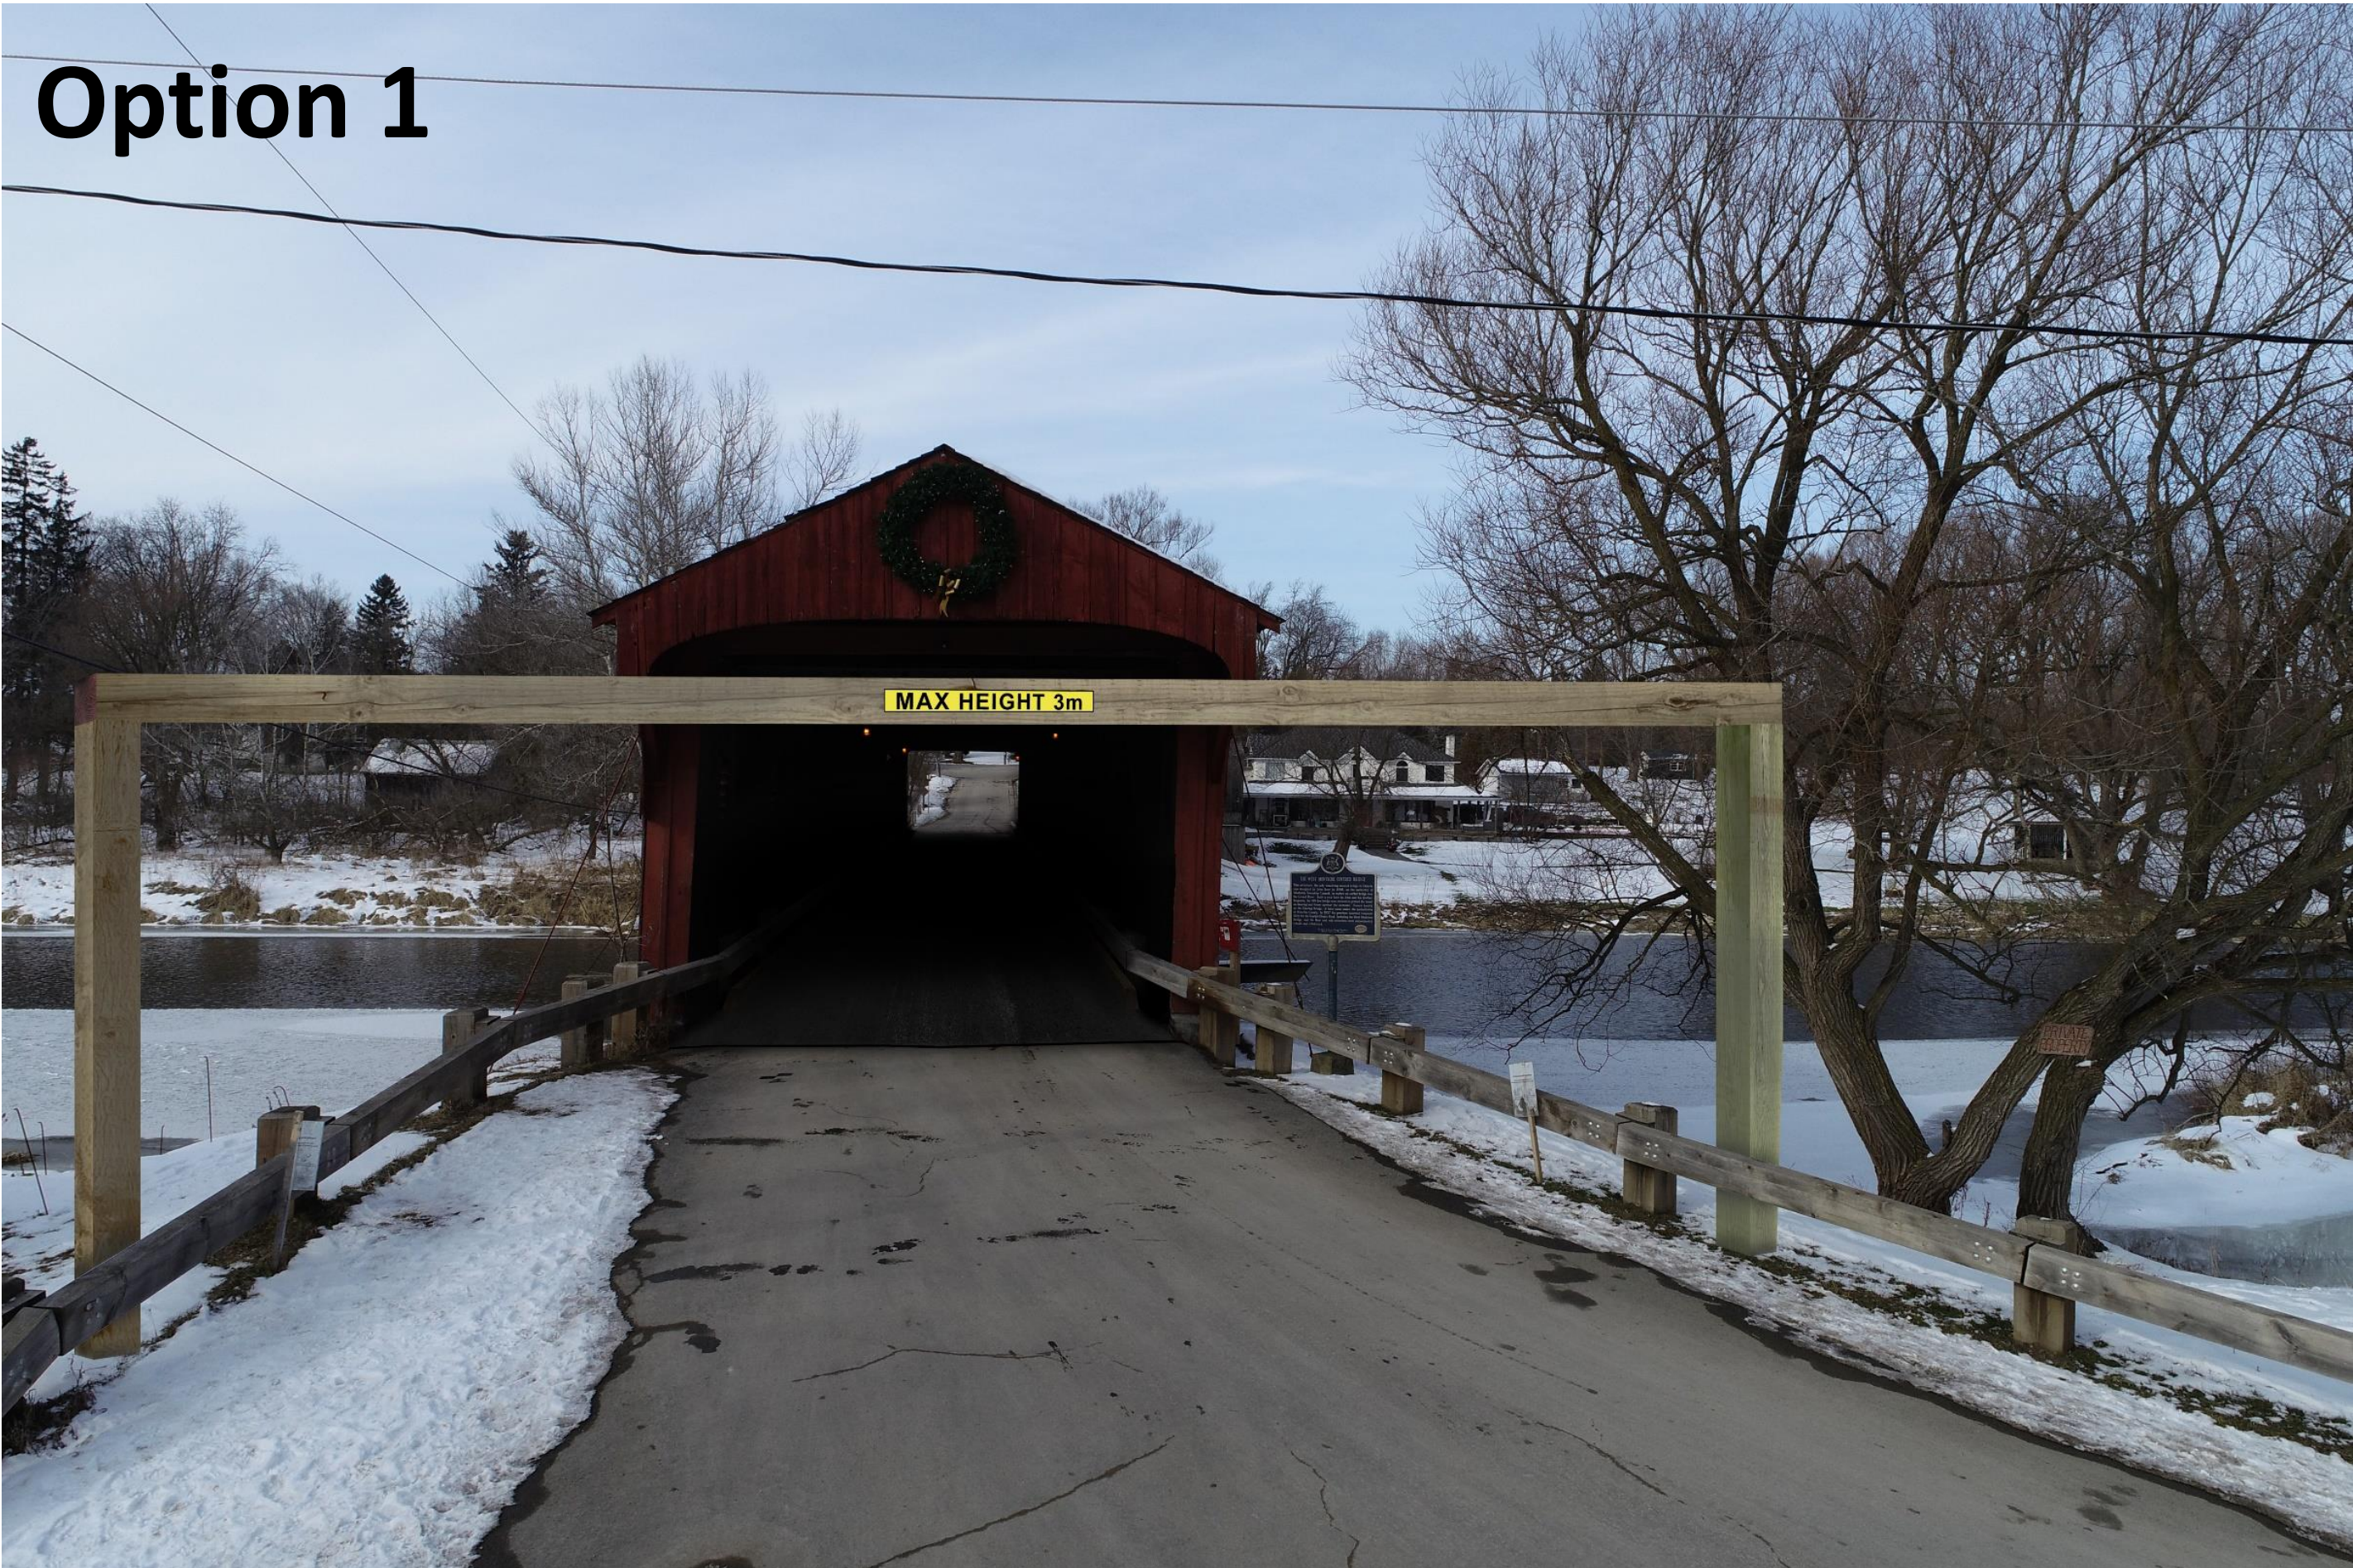
Option 1

Proposed Improvement #25 – Height Restrictor Bar Options for Public Input

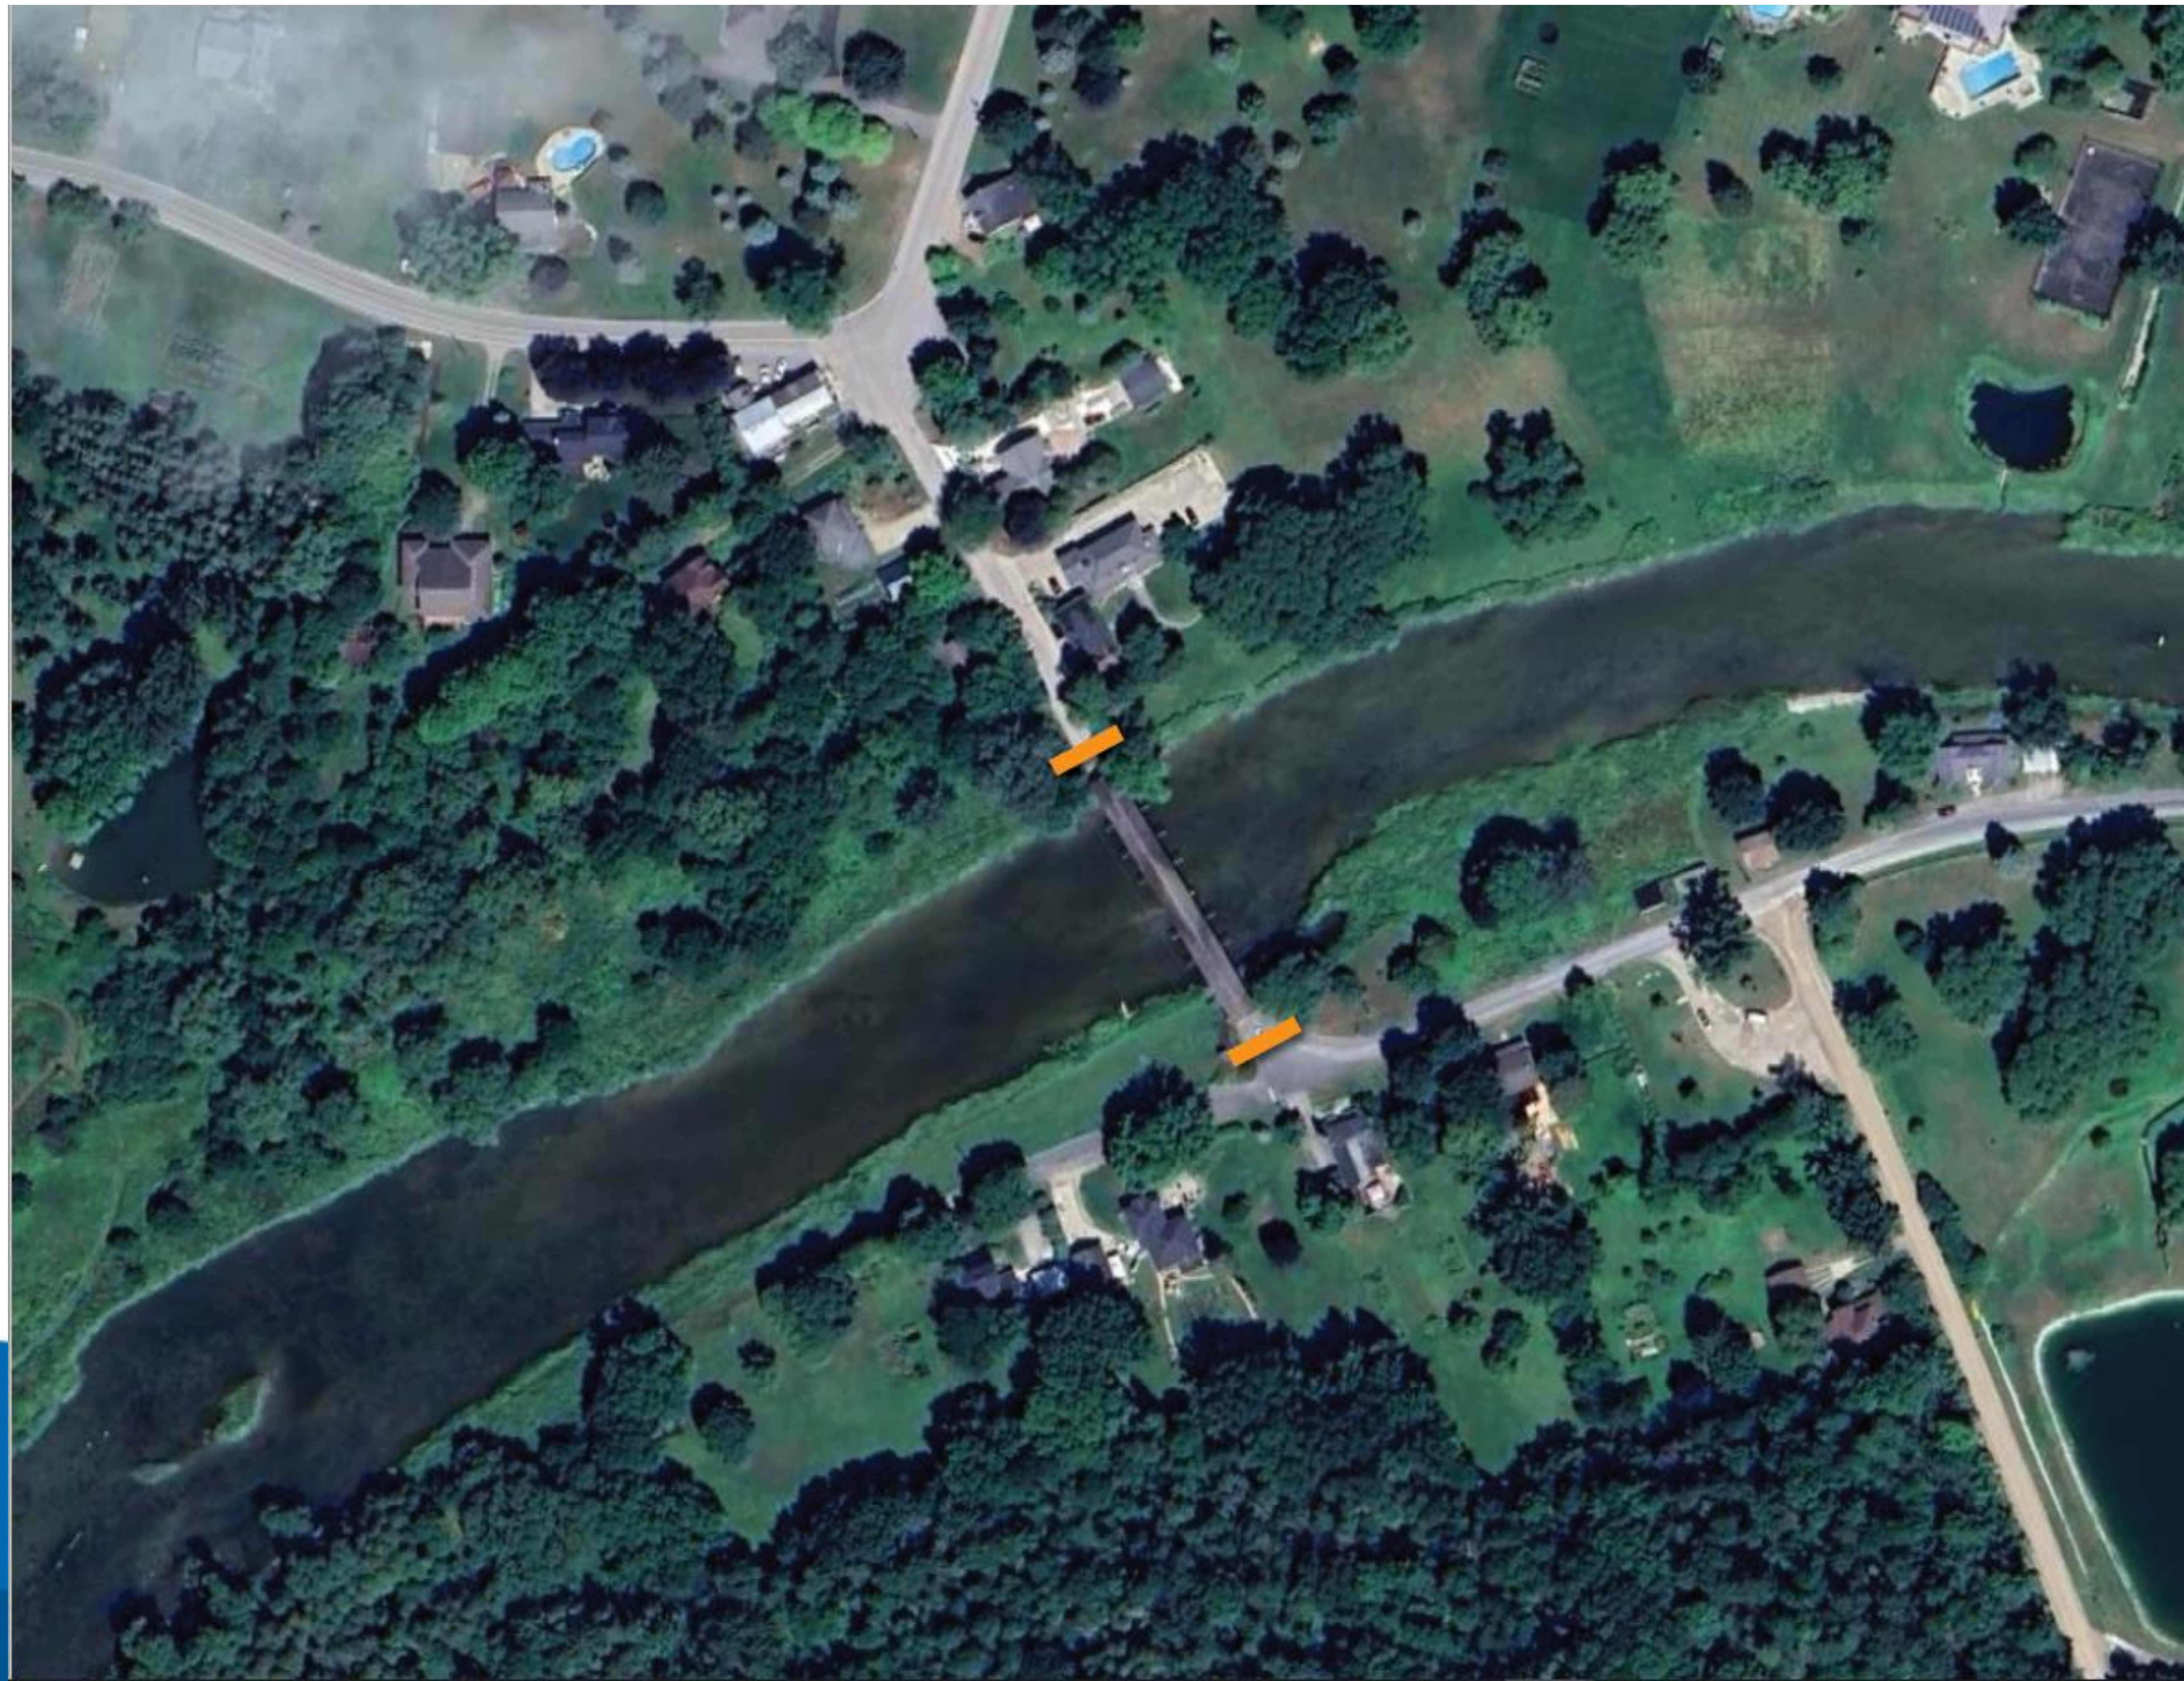
Proposed Location of Height Restrictor Bars
