HERITAGE COMMITTEE MEETING

**VOLUME 1: CULTURAL HERITAGE EVALUATION REPORT
STRUCTURE 400172 (BEITZ' BRIDGE)**

**GREENHOUSE ROAD
GEOGRAPHIC TOWNSHIP OF WATERLOO
WATERLOO COUNTY
REGIONAL MUNICIPALITY OF WATERLOO, ONTARIO**

**VOLUME 2: HERITAGE IMPACT ASSESSMENT
STRUCTURE 400172 (BEITZ' BRIDGE)**

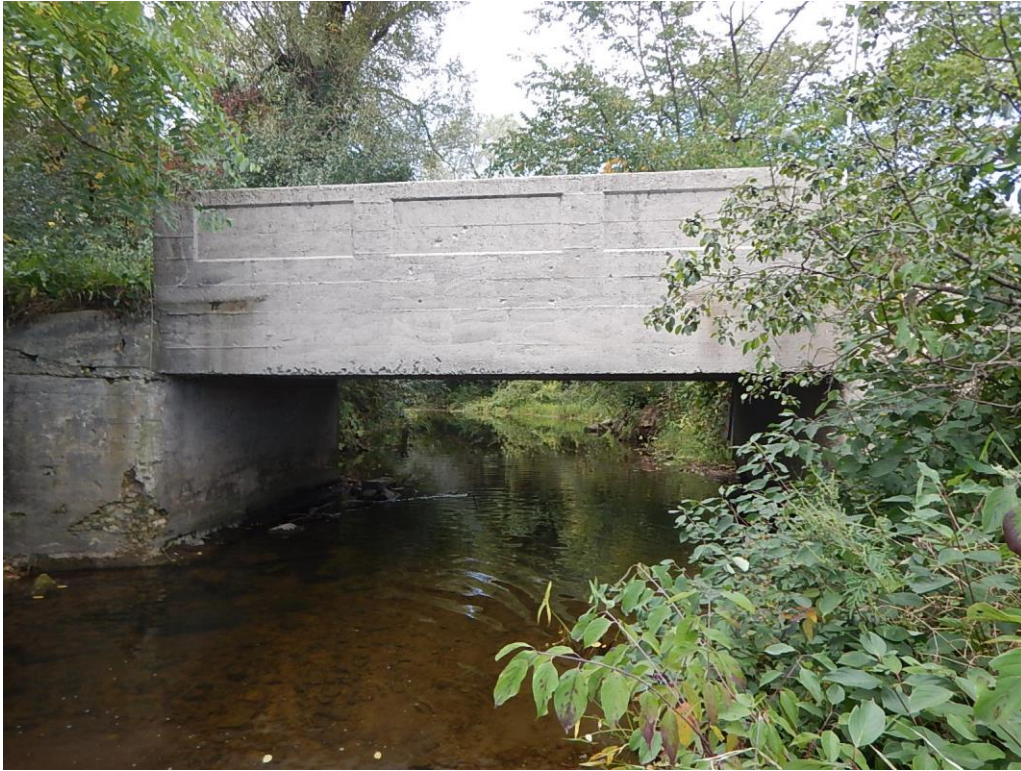
Figure 2: Photograph of the West Elevation of Structure 400172 ("Beitz' Bridge), ca. 2017
Source: Courtesy of GM BluePlan

The superstructure of Structure 400172 is described as a single span cast-in-place concrete T-beam and slab. The deck structure consists of a cast-in-place concrete slab with a gravel wearing surface. There are no visible deck drains. The deck slab is integrated with and supported by longitudinal T-beams. The transverse diaphragms (distributor beams) were cast-in-place along with the deck structure, thus forming a monolithic deck system. This gives the bridge a final appearance of a girder bridge when viewed from underneath or from a side elevation.

The abutments are cast-in-place concrete and form the legs of the deck system. The abutments sit on the bridge foundation which is not visible from the right-of-way. The bridge includes its original barrier system consisting of cast-in-place concrete parapet walls without railings. The solid barriers have been embossed to add a decorative element.

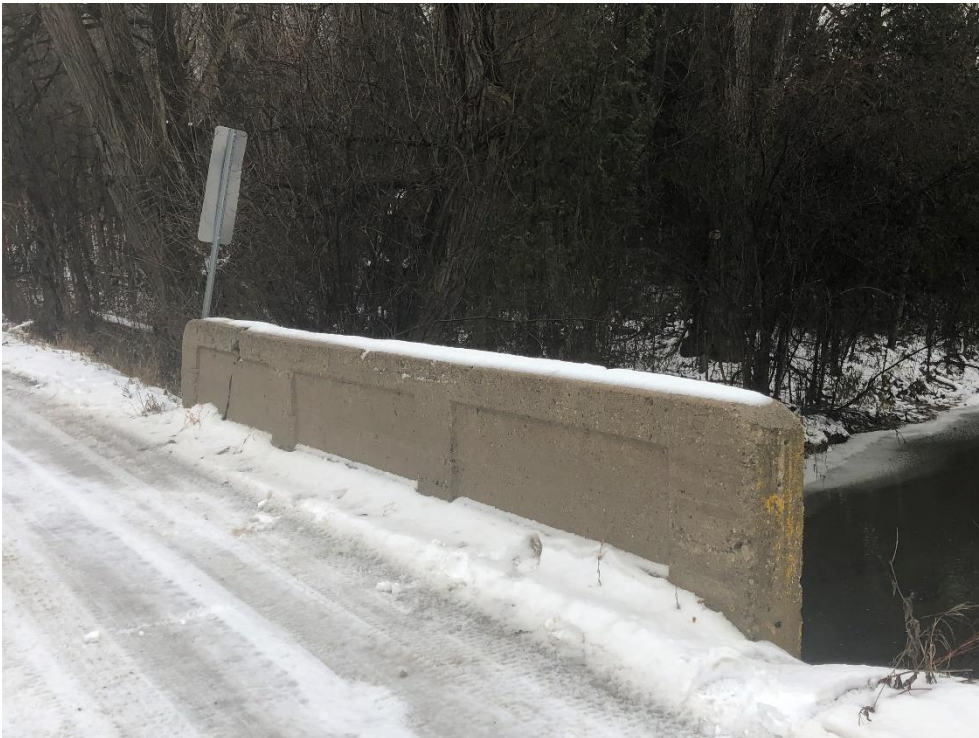
Plate 4: View of the east parapet barrier.

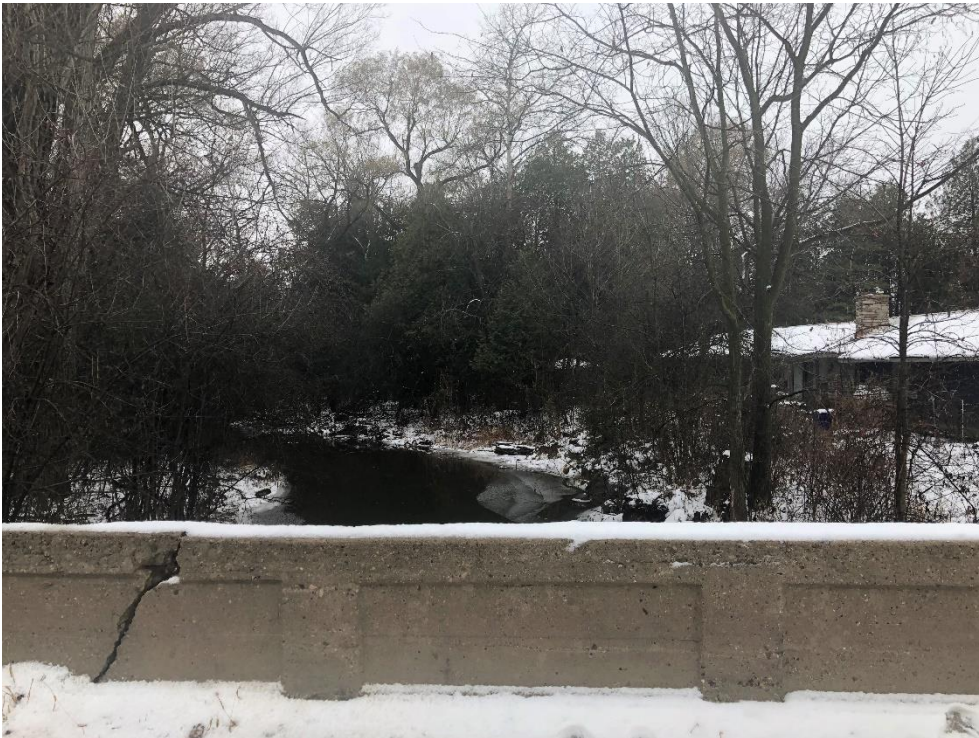
According to the available reference documents, no rehabilitation has been undertaken on the subject bridge. A telephone conversation with the Beitz family, who occupy the farm to the southeast of the bridge, reported that the bridge was hit by a farm machine which resulted in the cracked barrier (personal communication 07 November 2019).

Plate 6: Close-up of the west parapet barrier. Note the crack due to the damage caused by the farm machine.

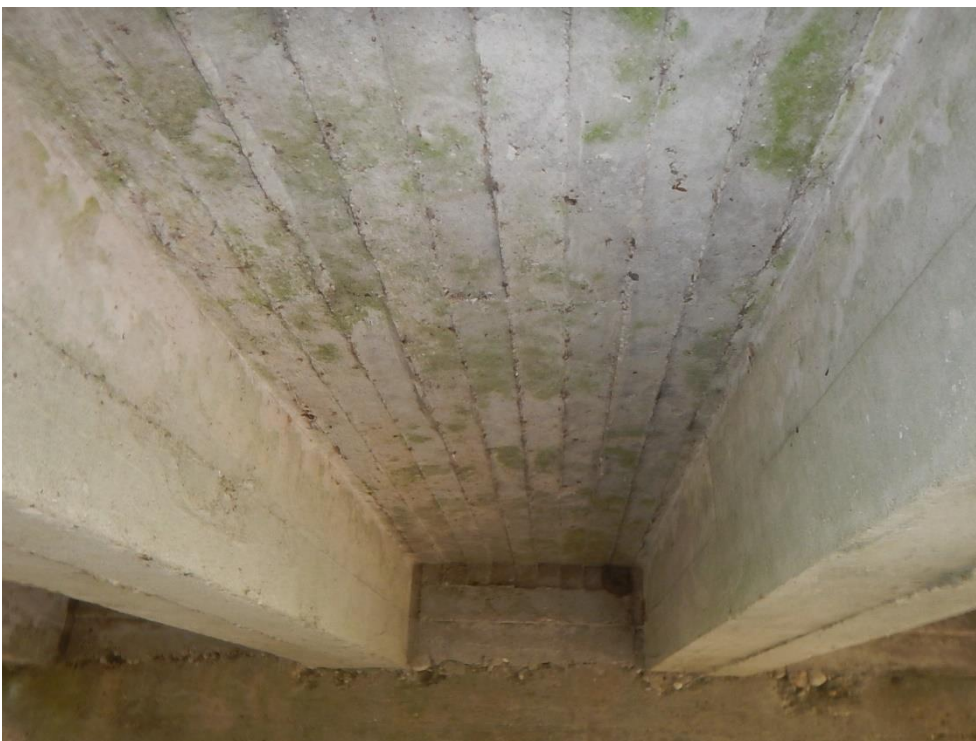
Plate 10:
Underside view of
bridge- north
girder end. Note
the "T" joints and
2x4 marks visible
under the deck.

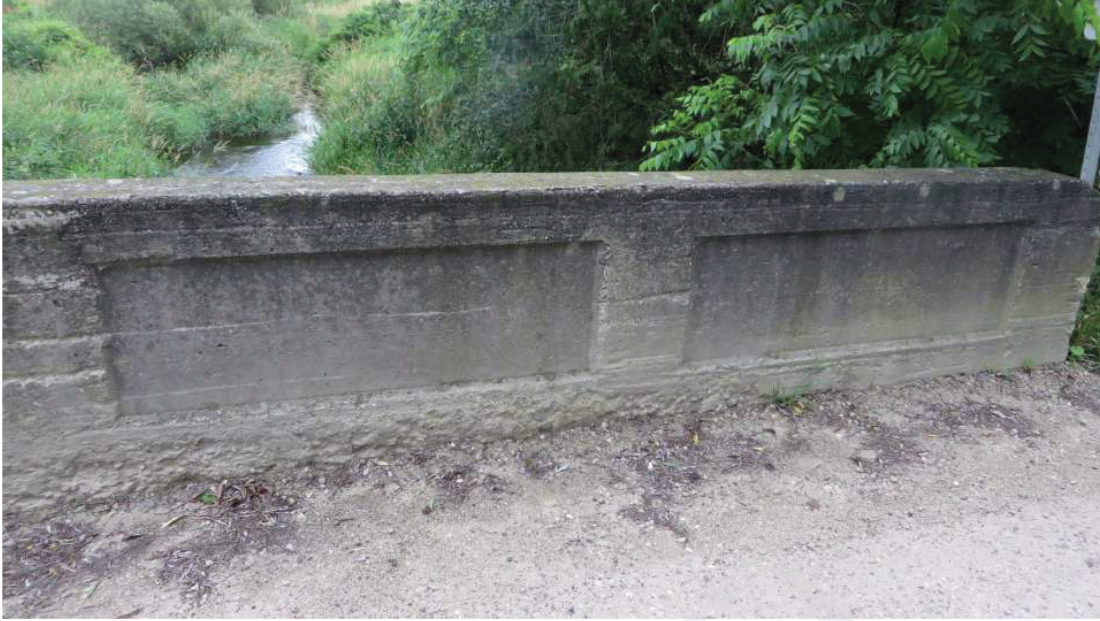
West barrier

Comments: Wide vertical crack at SW; 1.5m section @ SW has failed, but remains in place; Medium to severe scaling; Abrasions

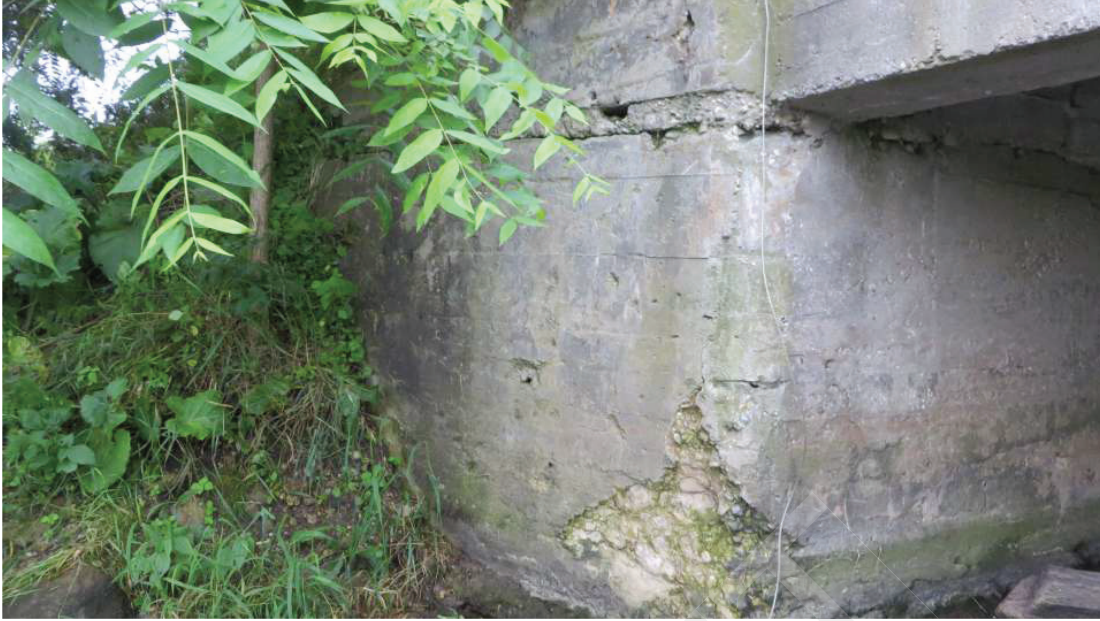
Southwest wingwall

Comments: Severe delamination, spalling and disintegration; Severe erosion at waterline

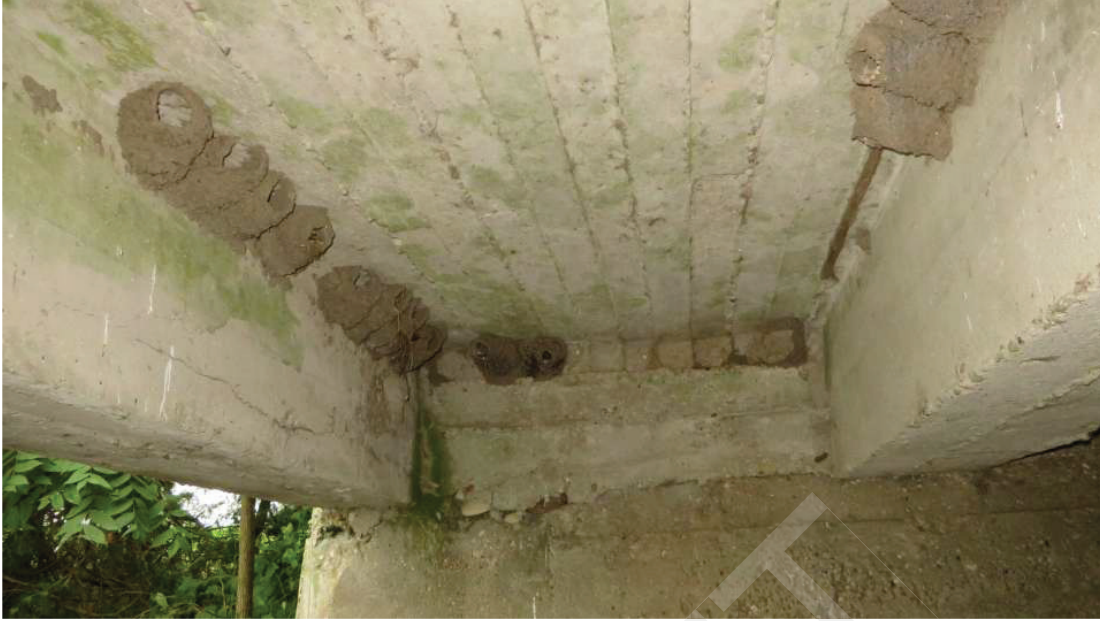
North girder end

Comments: Severe delamination with wide cracks at girder ends

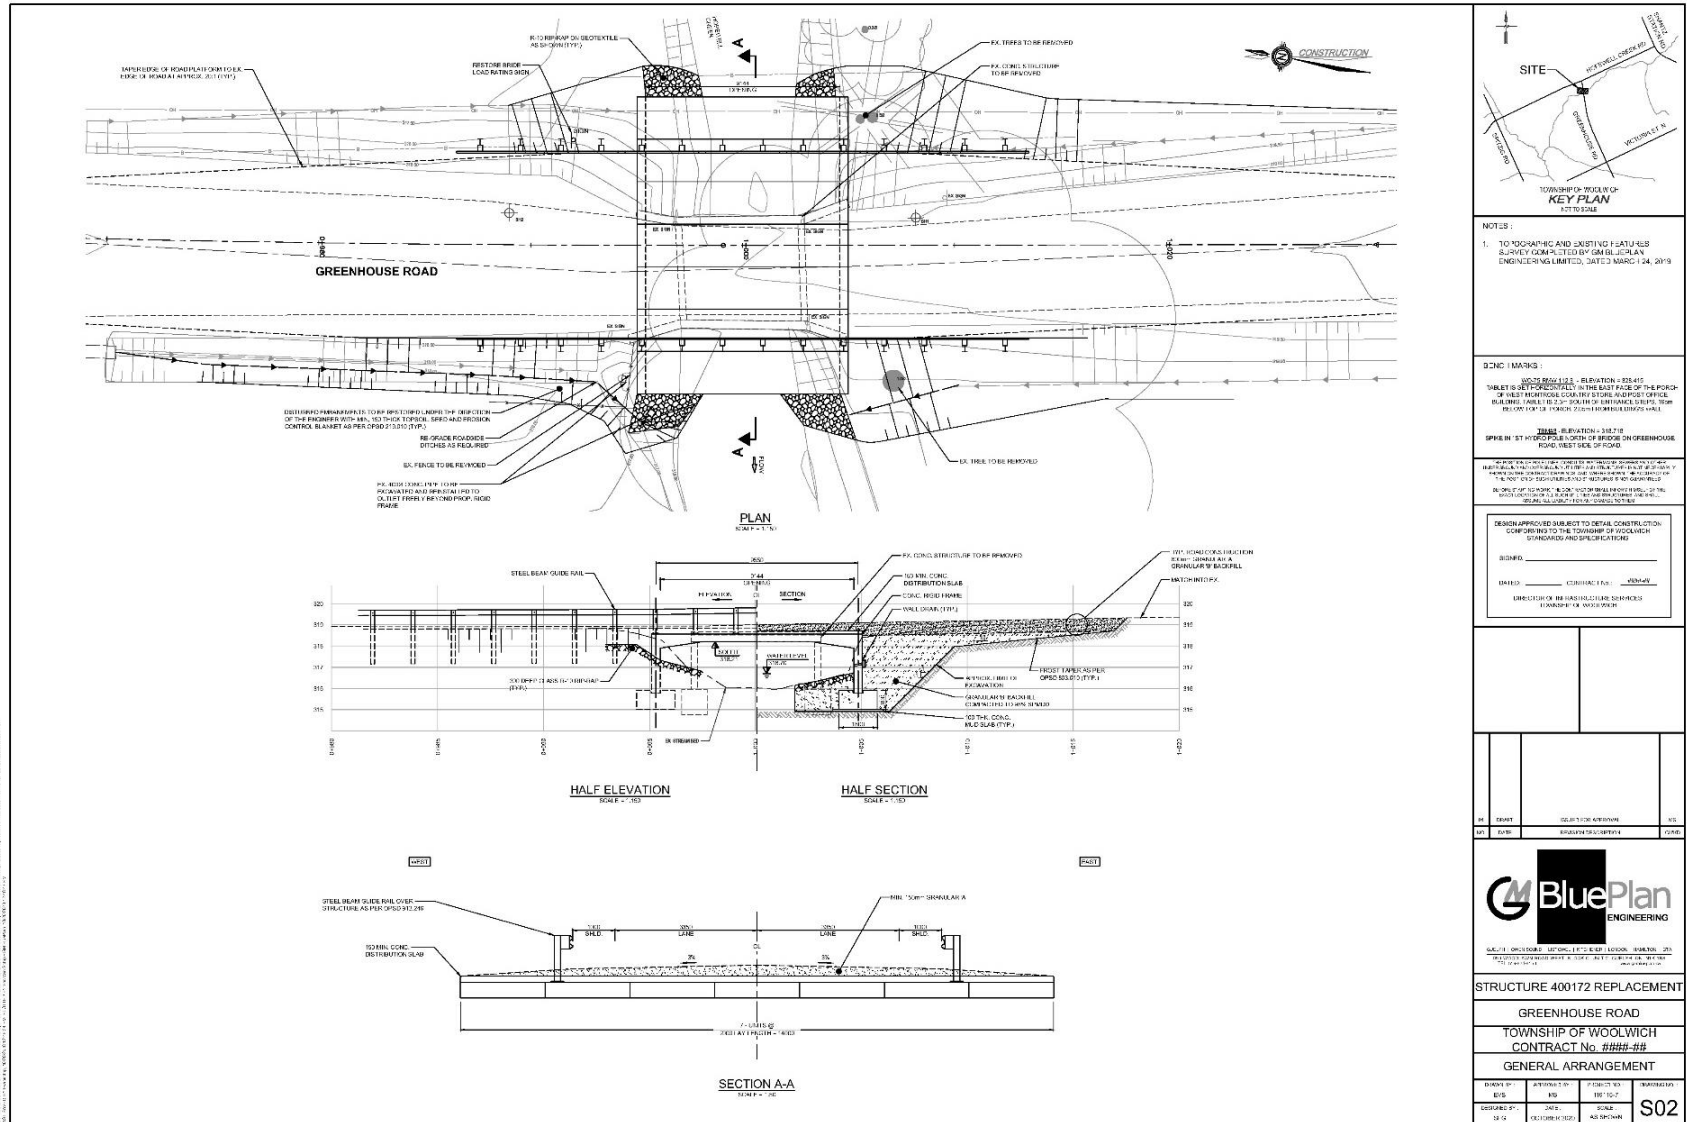
Figure 4: Structure 400172 Replacement, General Arrangement Drawing

The replacement bridge is anticipated to be 14 m in overall width and feature a total road and shoulder width of 8.7 m. The increased width of the replacement bridge is required to accommodate two lanes of Greenhouse Road vehicular traffic, the Township of Woolwich's standard road cross section. The replacement bridge is also anticipated to have an increased span length, which will increase the hydraulic capacity of the structure and reduce localized flooding in Hopewell Creek. The proposed replacement bridge is anticipated to be 9.55 m in length with an opening of 9.14 m, an increase in length of approximately 2.2 m from the original structure. The proposed concrete slab structure is anticipated to feature seven precast concrete distribution slabs 9550 mm in length, 2000 mm in width, and 150 mm in thickness. The deck and approaches are anticipated to feature steel beam guiderails.

While the preferred alternative from the heritage perspective involves the retention of the subject bridge with rehabilitation, as identified as part of the preliminary heritage assessment, this is not feasible within the project goals that include road and hydraulic capacity increases. In addition to the insufficient transportation and hydraulic capacity of the existing structure, rehabilitation of the existing bridge was also considered to be cost-prohibitive due to the advanced state of deterioration of structural elements.
